Preliminary Peak Stage and Streamflow Data at Selected USGS Streamgaging Stations for the South Carolina Flood of October 2015

Open-File Report 2015–1201
Version 1.1, November 2015

By Toby D. Feaster, John M. Shelton, and Jeanne C. Robbins

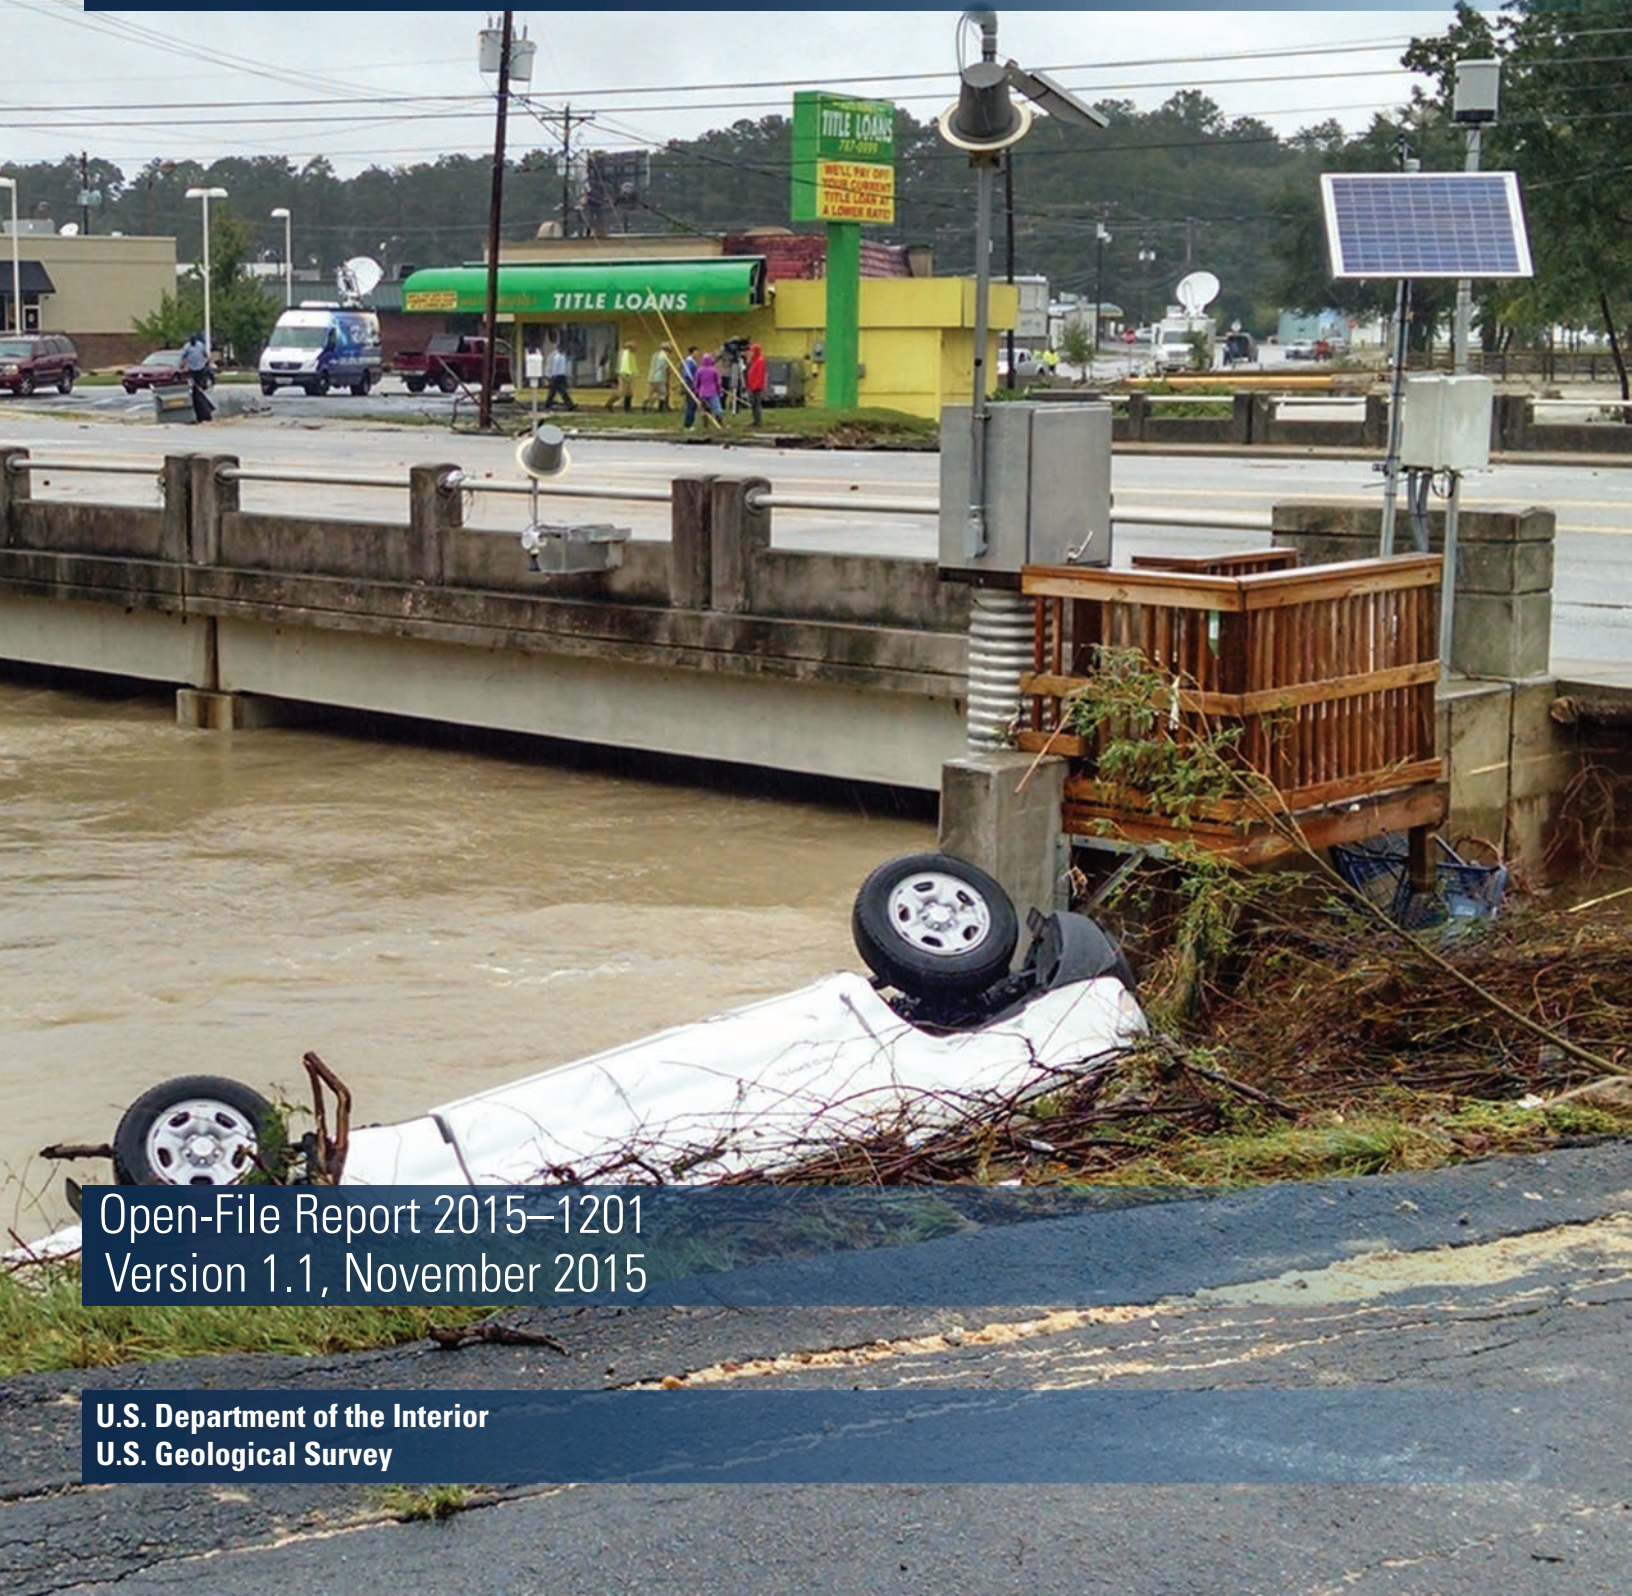
Cover: Left bank looking upstream toward U.S. Geological Survey station 02169570, Gills Creek at Columbia, S.C. Streamgaging station is located on the downstream side of the bridge on U.S. Highways 378 and 76 (Devine St.).

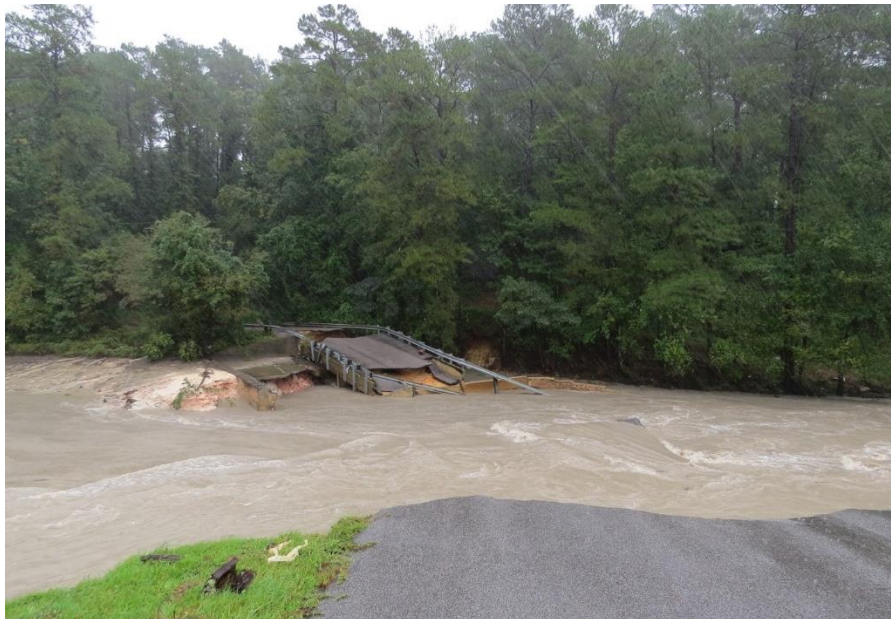
Figure 5. Cary Lake Dam Failure at Skii Lane
Photo Source: Wes Tyler, SC Climatology Office

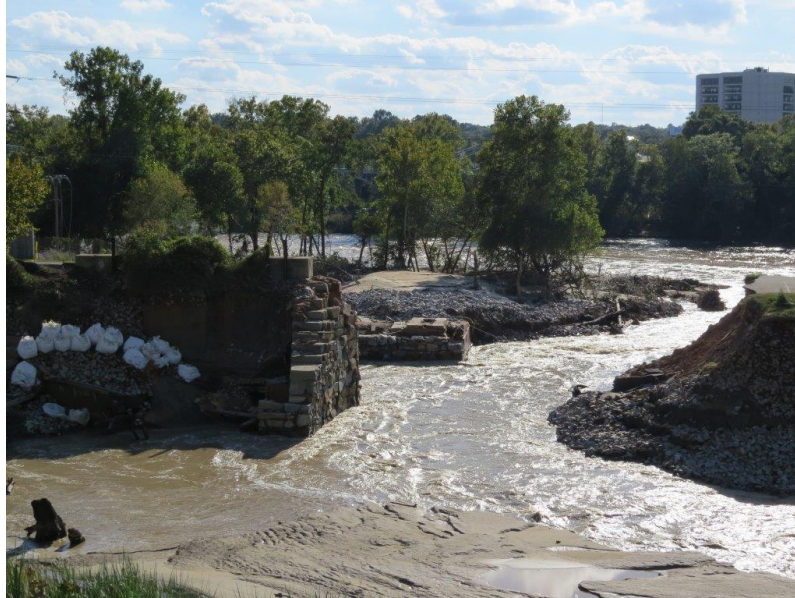
Figure 9. Columbia Canal breach
Photo Source: Wes Tyler, SC Climatology Office

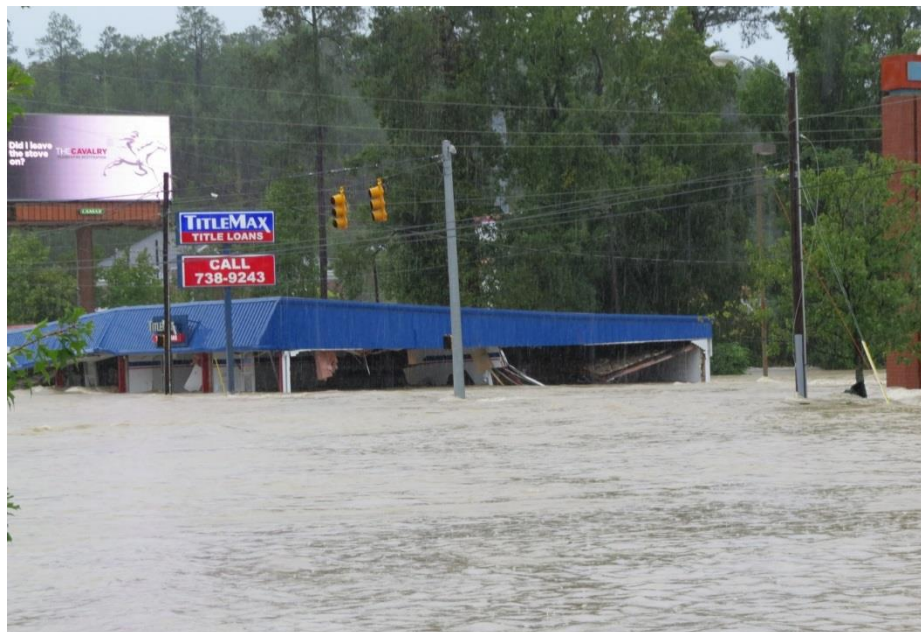
Figure 10. Title Max building collapse in Garners Ferry Road business section.
Photo Source: Wes Tyler, SC Climatology Office

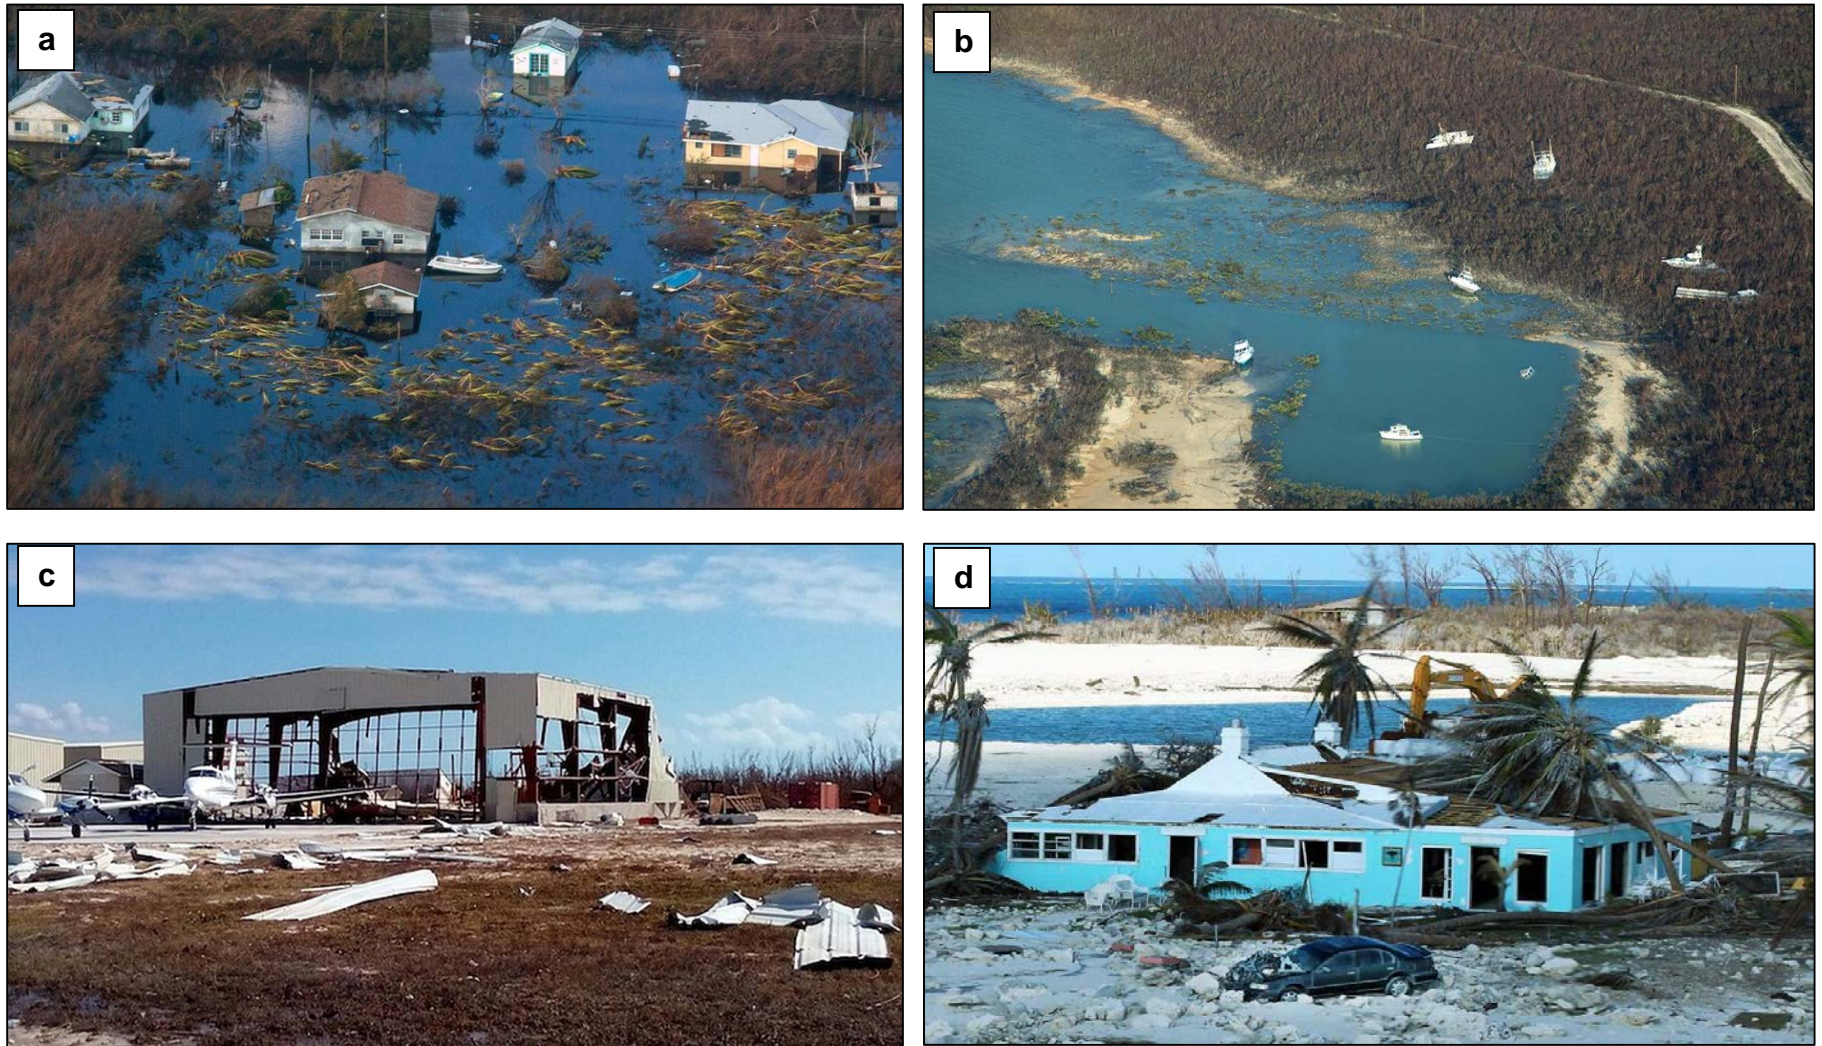
Figure 8. Damage photos from the Bahamas after Hurricane Joaquin. (a) South Long Island (AP/Tim Auyen) (b) South Long Island (AP/Tim Auyen) (c) Crooked Island airport (*Tribune 242*) (d) Pittstown on Crooked Island (*El Nuevo Herald*/Pedro Portal)
