# I-95 Planning and Design Resiliency Planning Grant

BRIDGE INVESTMENT PROGRAM PLANNING GRANT

The I-95 Bridges Over the Great Pee Dee River Planning Grant  
(I-95 P.D. River Bridges)

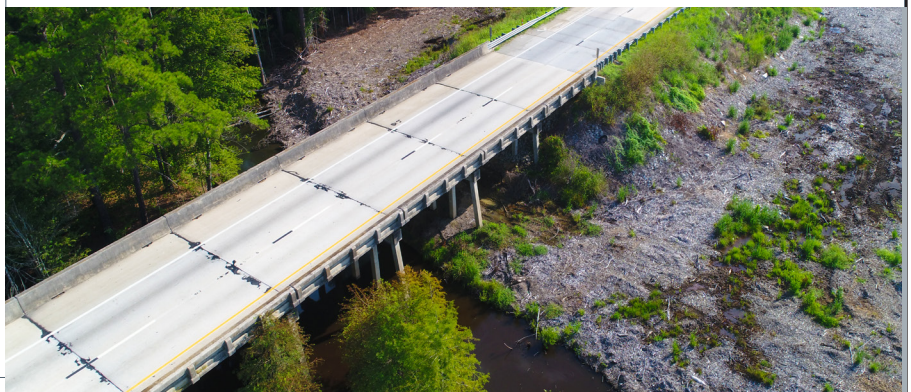
**Figure 2: Expansion Joints in Need of Repair**

- 2017 - I-95 SB \$3.59M: Rehab patching structural overlay with expansion joint and bearing rehabilitation, painting of structural steel (Figure 2);
- 2018 - I-95 NB \$4.25M: Rehab patching and structural overlay
- 2019 & 2020 - I-95 NB \$4.04M: Emergency repairs to include installation of two permanent crutch bents; and
- 2021 & 2022 - I-95 NB \$3.16M: Emergency bridge maintenance on crutch bents at Piers H, I, J and K.

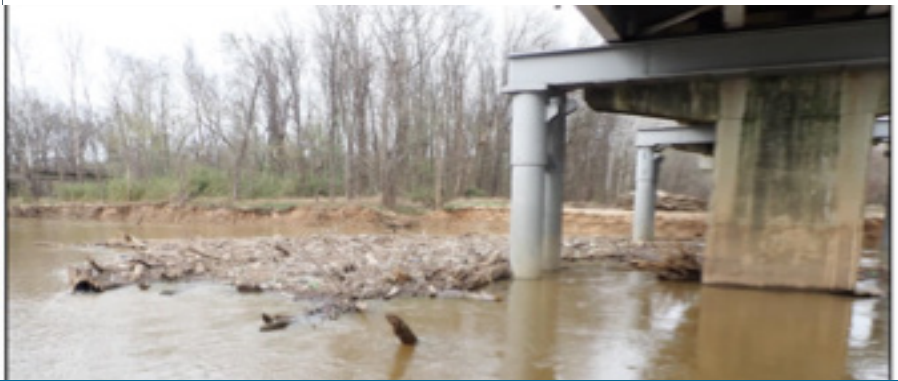
**Figure 3: East Face, Crutch Bent with Timber Debris Buildup**

The bridges are at further risk due to the ongoing impact of extreme weather events (Figure 3). Interstate I-95 is a major hurricane evacuation route. Hurricanes such as 2018's Hurricane Florence created high flows in the river nearly reaching the bridge decks and causing significant scour issues around the bridge foundations. This has created the need to install crutch bents to strengthen the integrity of the I-95 bridges until a more permanent solution can be found. Timber buildup is common on the Pee Dee River bridges. Timber obstructions can restrict water flow and increase scour and structural damage, especially during high flow events such as those experienced during storms.

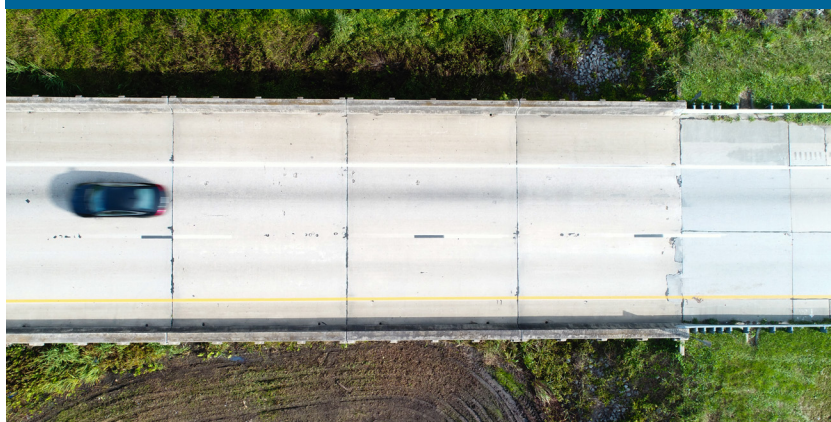
Figure 5: Current bridge shoulder widths

Stretches of the I-95 bridges do not meet the current federal standard of a minimum of 4-foot left and right shoulders, as shown in Figure 5. The lack of shoulders is a safety issue because it creates little to no opportunity for:

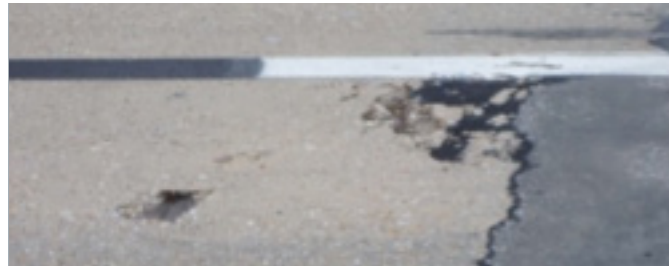
**Figure 7: Concrete Spall/Delamination on Roadway Deck at Span 1**

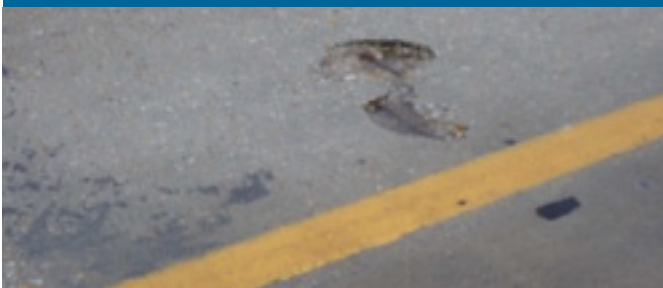
**Figure 8: Concrete Spall/Delamination on Roadway Deck w/ Exposed Rebar at Span 5**

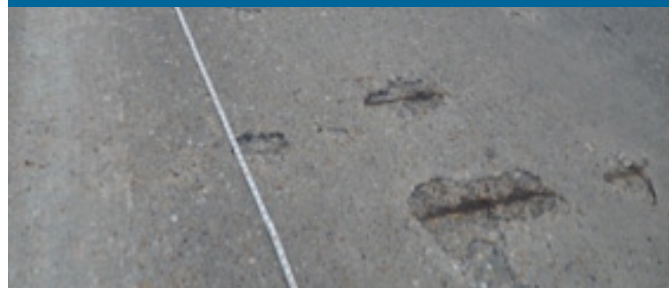
**Figure 9: Concrete Spall/Delamination on Roadway Deck w/ Exposed Rebar at Span 3**

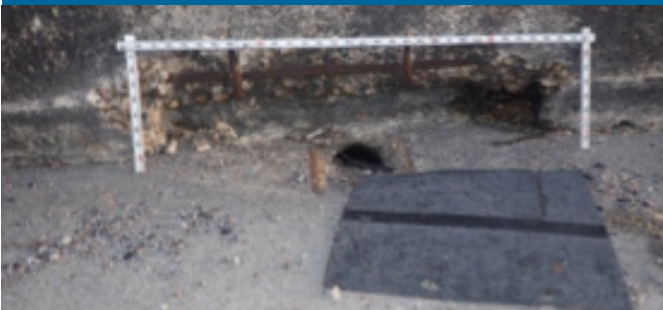
**Figure 10: Concrete Spall of South Bridge Rail Deck Drain w/ Exposed Rebar**

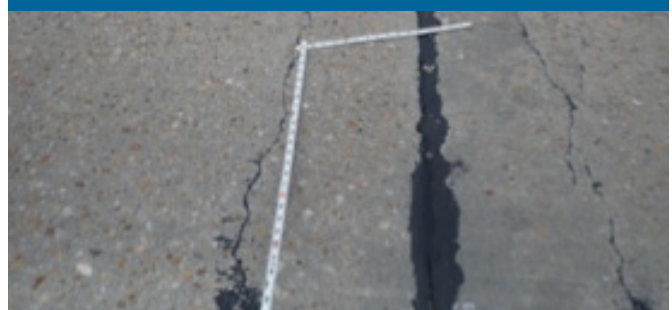
**Figure 11: Map Cracking at all Spans Adjacent to Joints**

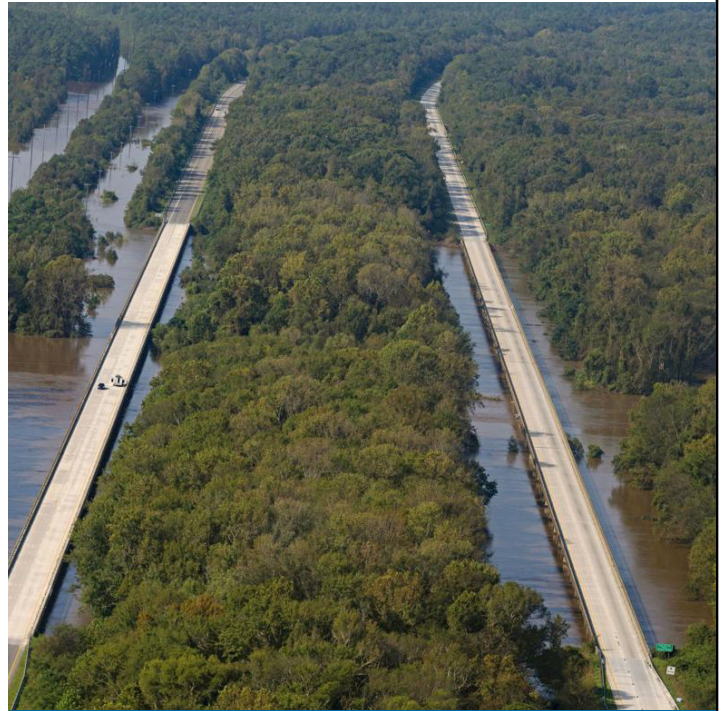
**Figure 14: Flooding during Hurricane Florence eroded the land around the Great Pee Dee River Bridge piers**

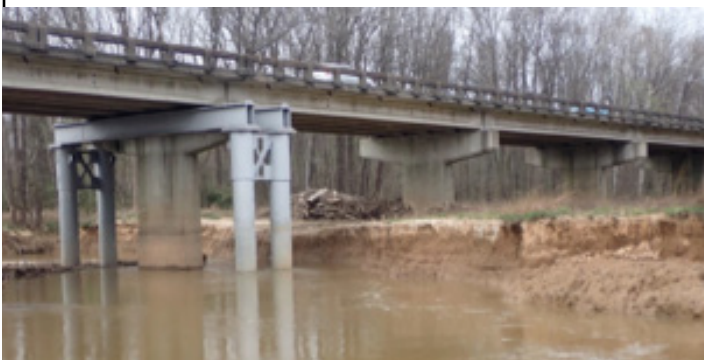
**Figure 15: East Embankment, Crutch Bent with Eroding Bank in Background**

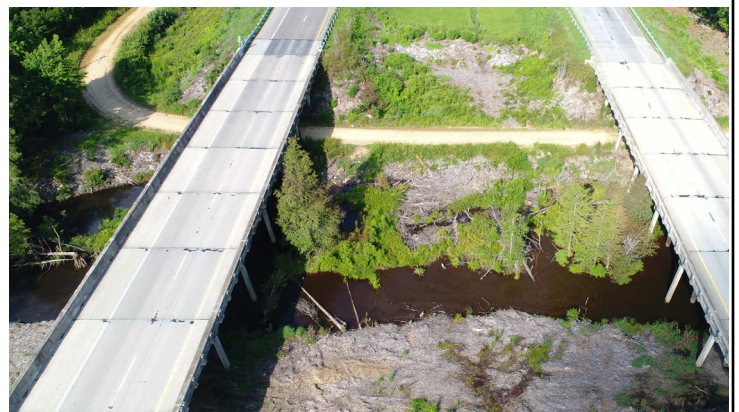
**Figure 16: Timber Debris Eroding into Channel**

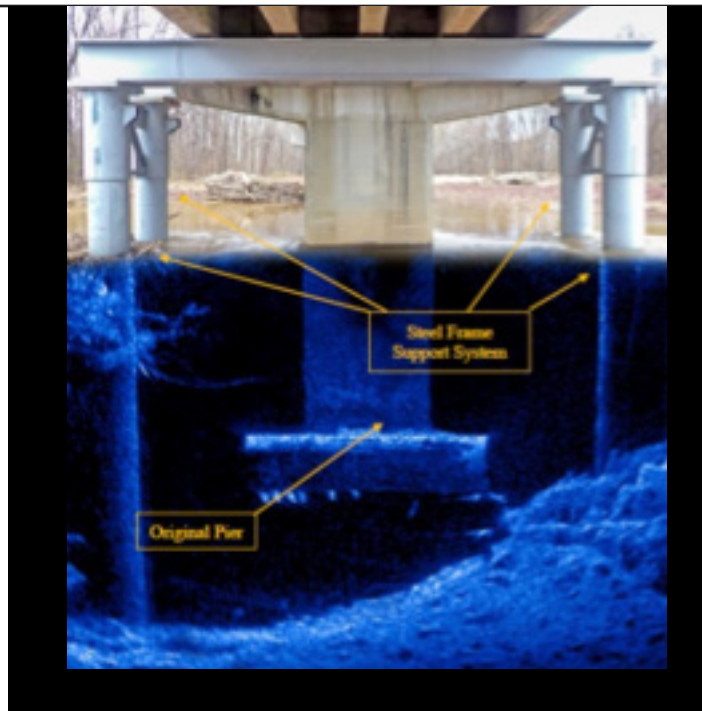
**Figure 17: Crutch Bent at Bent 26**

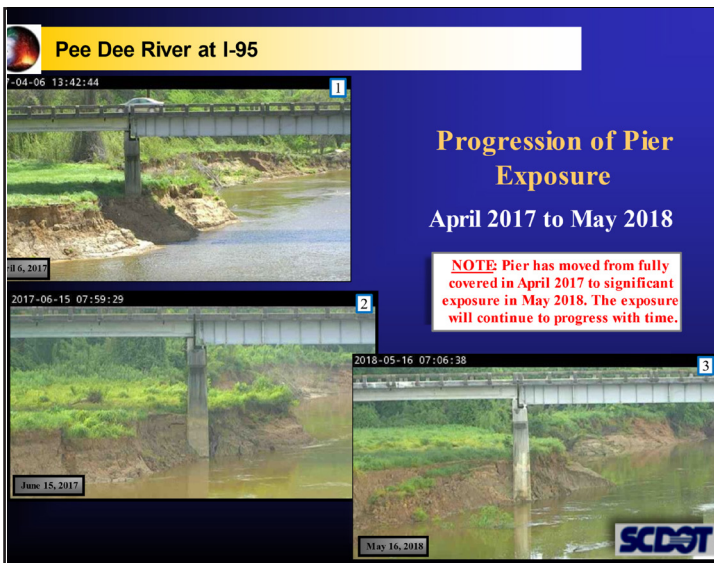
**Figure 18: Recent Bank Failures, SCDOT, June 2018**

- Develop an improved scour protection to improve the bridges' long-term resiliency by taking into account meteorological, hydrological and other trend data and assessments to develop protection recommendations and will seek further strategies from design build teams during construction procurement (Figures 18-19).
