# **D-1: PHASE I CULTURAL RESOURCES SURVEY**

***RE: Phase I Cultural Resources Survey for the Proposed Widening of I-26 from Mile Marker 145-172, Orangeburg and Dorchester Counties, South Carolina and Phase I Cultural Resources Survey for the Proposed Widening of I-26 from Mile Marker 145 to 172 - ADDENDUM***

***SCDOT Project #: P041967 and 42454***

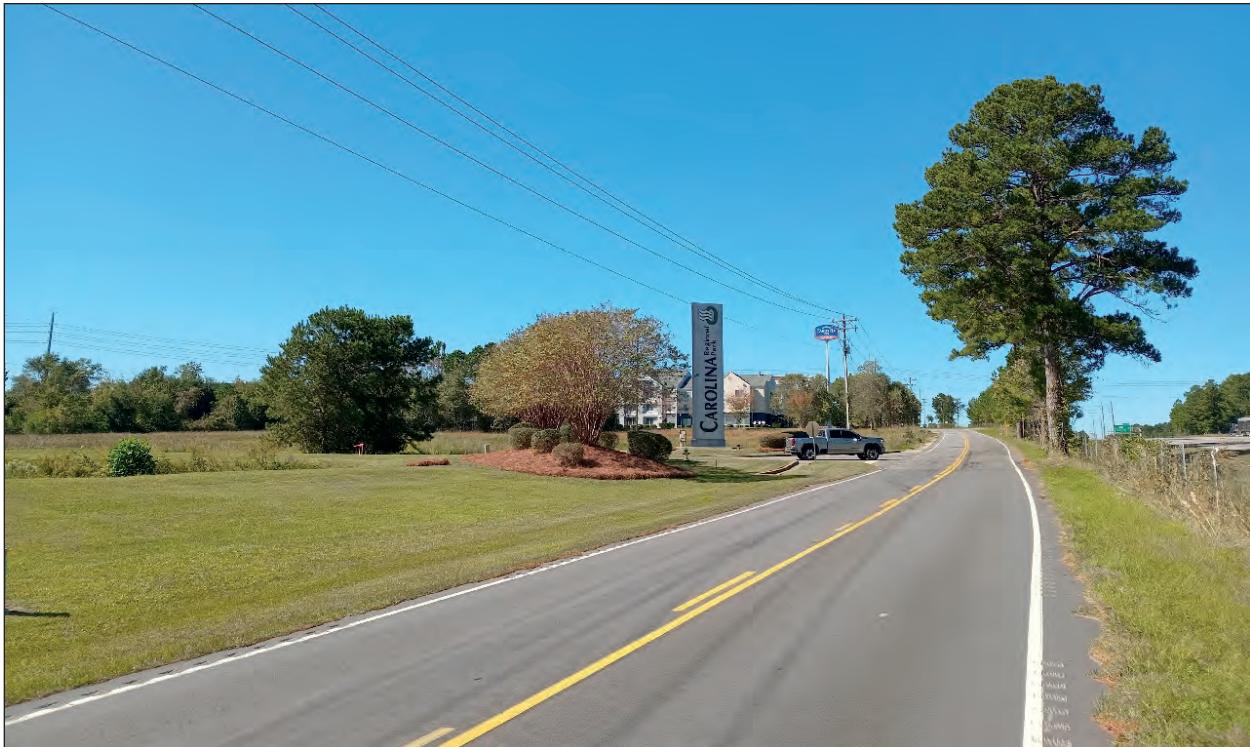
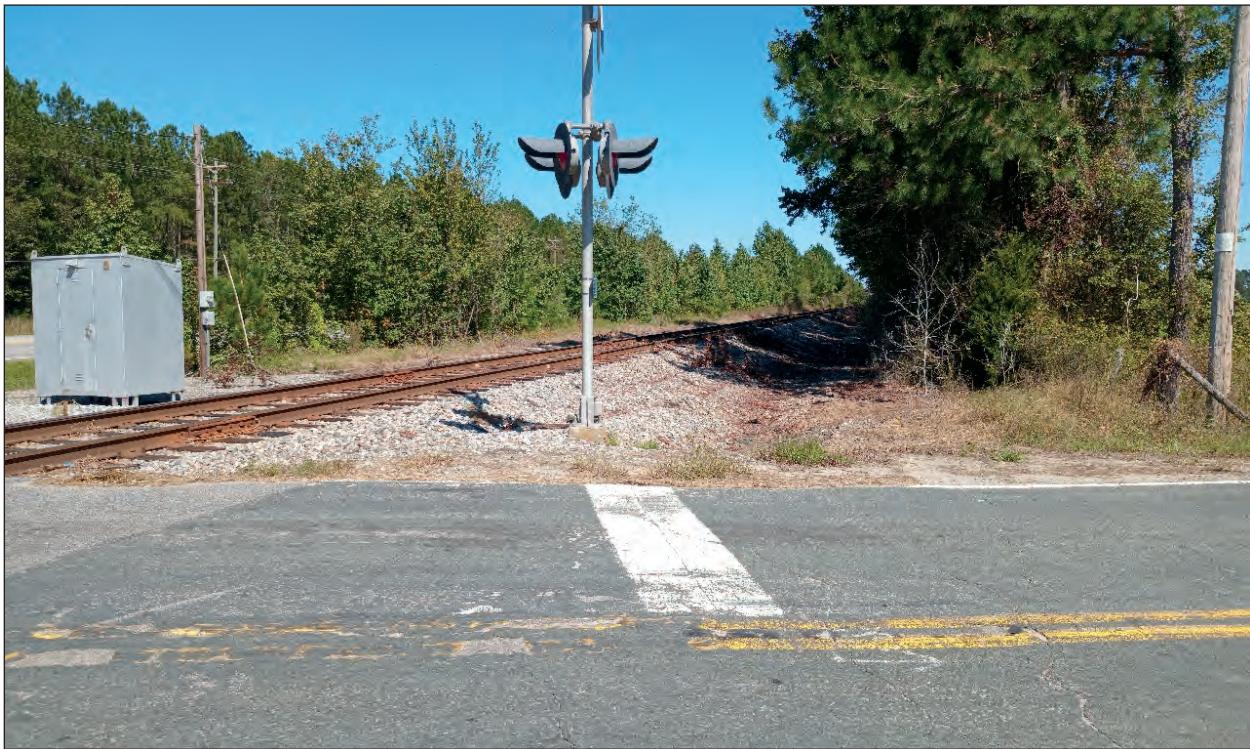
Figure 6.1.  
Examples of Conditions in the PSA

A. Paved Frontage Road Paralleling I-26, Looking Northwest

B. Railroad Right-of-Way Parallel to Cameron Road (SC 33), Looking East

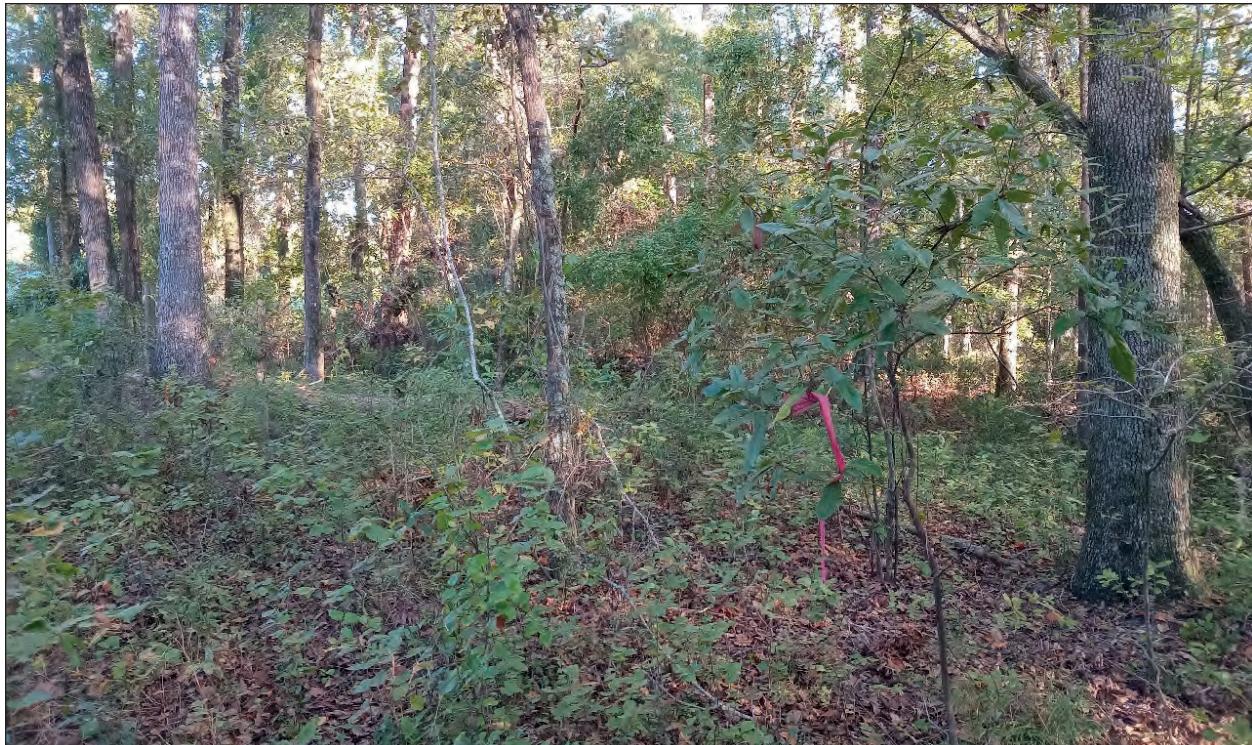
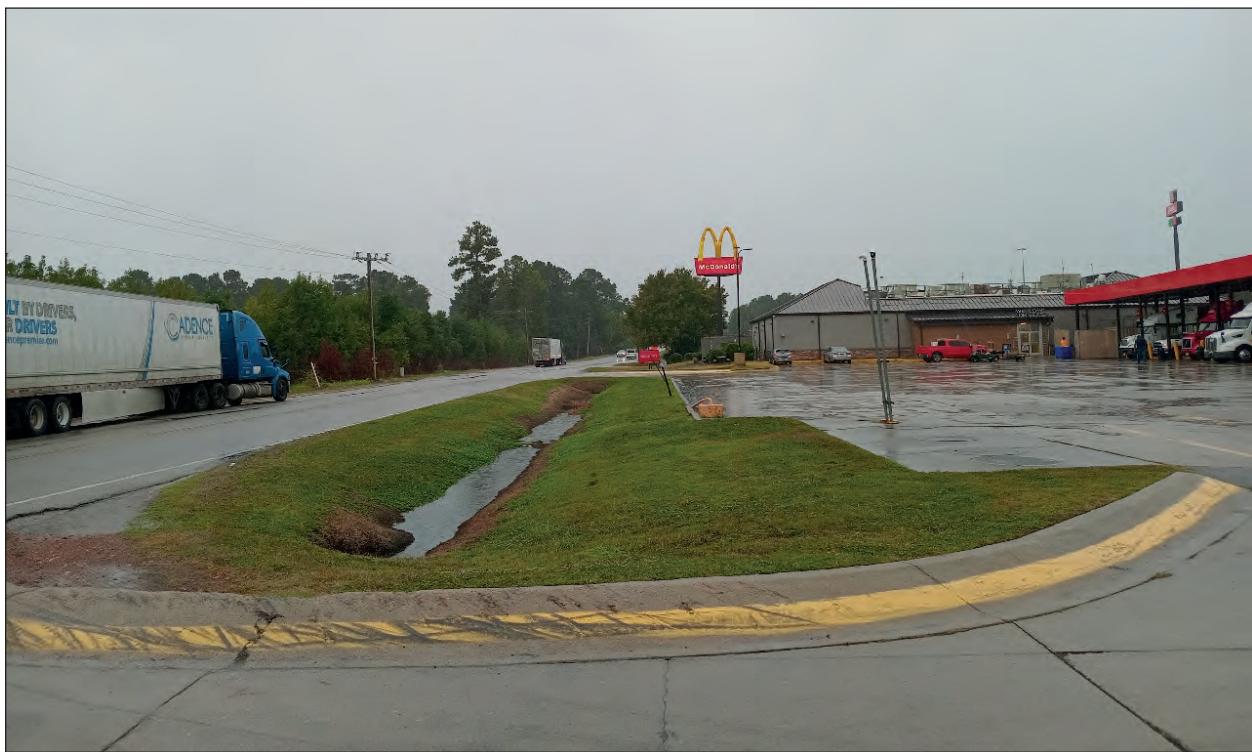
Figure 6.2.  
Examples of Conditions in the PSA

A. Low-lying Area with Poorly-drained Soils in Delineated Wetland, Looking Northwest

B. Area of Commercial Development, Looking East

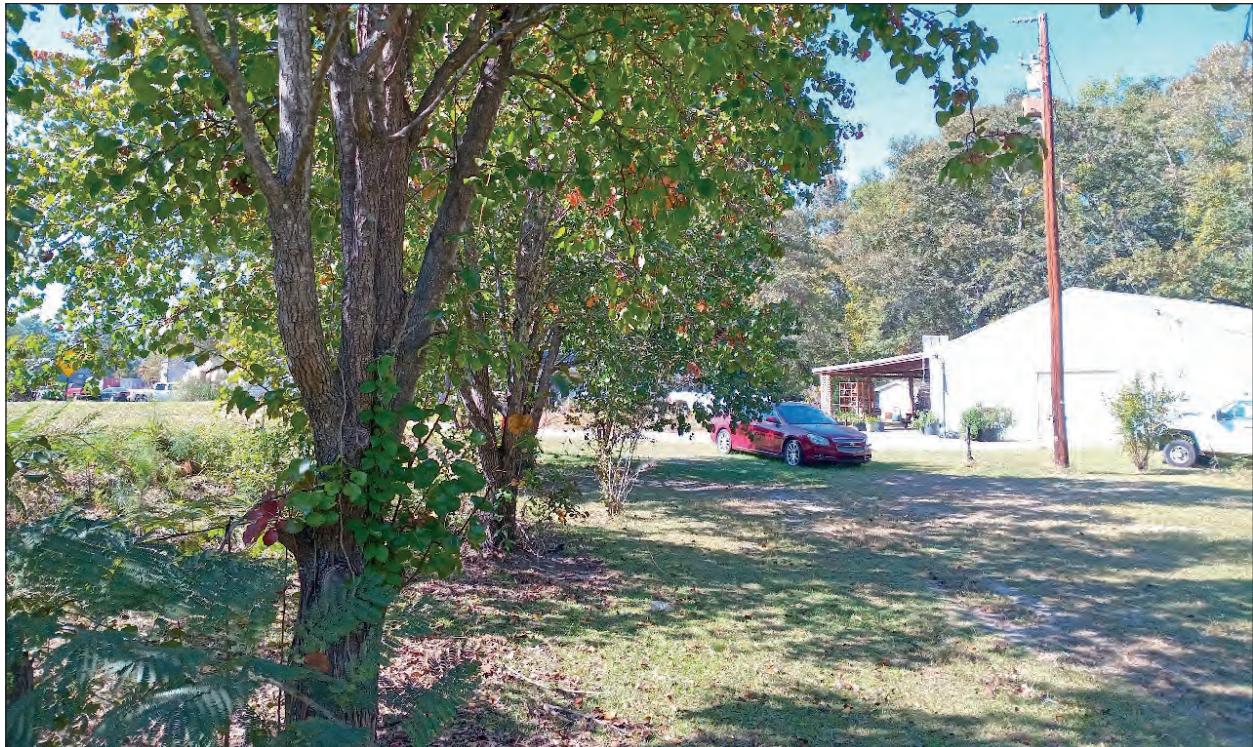
Figure 6.3.  
Examples of Conditions in the PSA

Instances in which the model was inaccurate were typically caused by artificial landforms that were created because of the I-26 or frontage road construction and grading (Figure 6.3).

A. Residential Area, Looking Northwest

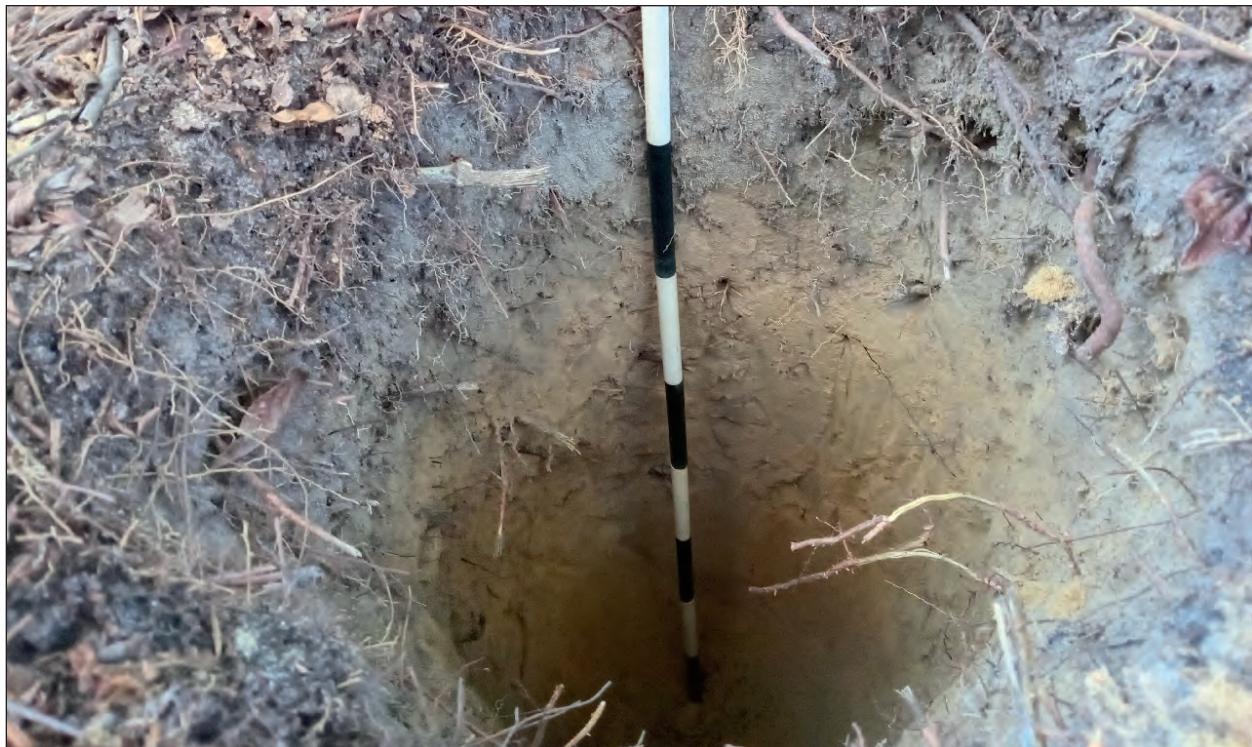
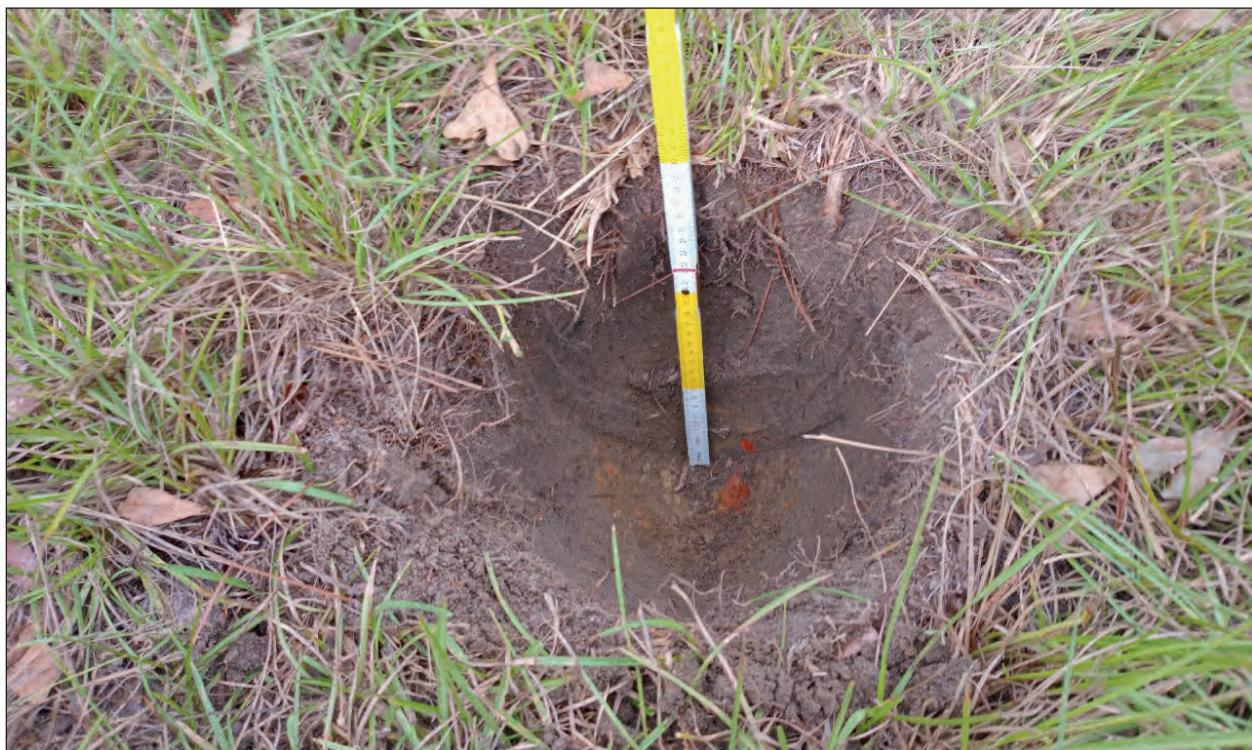
Figure 6.4.  
Examples of Soil Profiles in the PSA

Fieldwork identified a general prevalence of well-drained soils with areas of poorly drained soils adjacent to rivers, creeks, and wetland areas within the PSA. Two to three strata were identified in most shovel tests. Very well drained shovel tests in the PSA had deeper sandy deposits that typically consisted of 30–40 cm of grayish brown (10YR 5/2) to dark brown (10YR 3/3) sandy loam over a sandy E horizon ranging from light yellowish brown (10YR 6/4) to dark yellowish brown (10YR 4/6) in color that was between 40–80 cmbs, which was usually overtop a yellowish brown (10YR 5/6 to 5/8) sandy clay subsoil (Figure 6.4a). The typical soil profile for tests with somewhat well drained soils consisted of 10–50 cm of dark grayish brown (10YR 4/2) to dark brown (10YR 3/3) sandy loam beneath which was a yellowish brown (10YR 5/4 to 5/8) sandy clay subsoil (Figure 6.4b).

A. Very Well-drained Soil Profile

B. Somewhat Well-drained Soil Profile

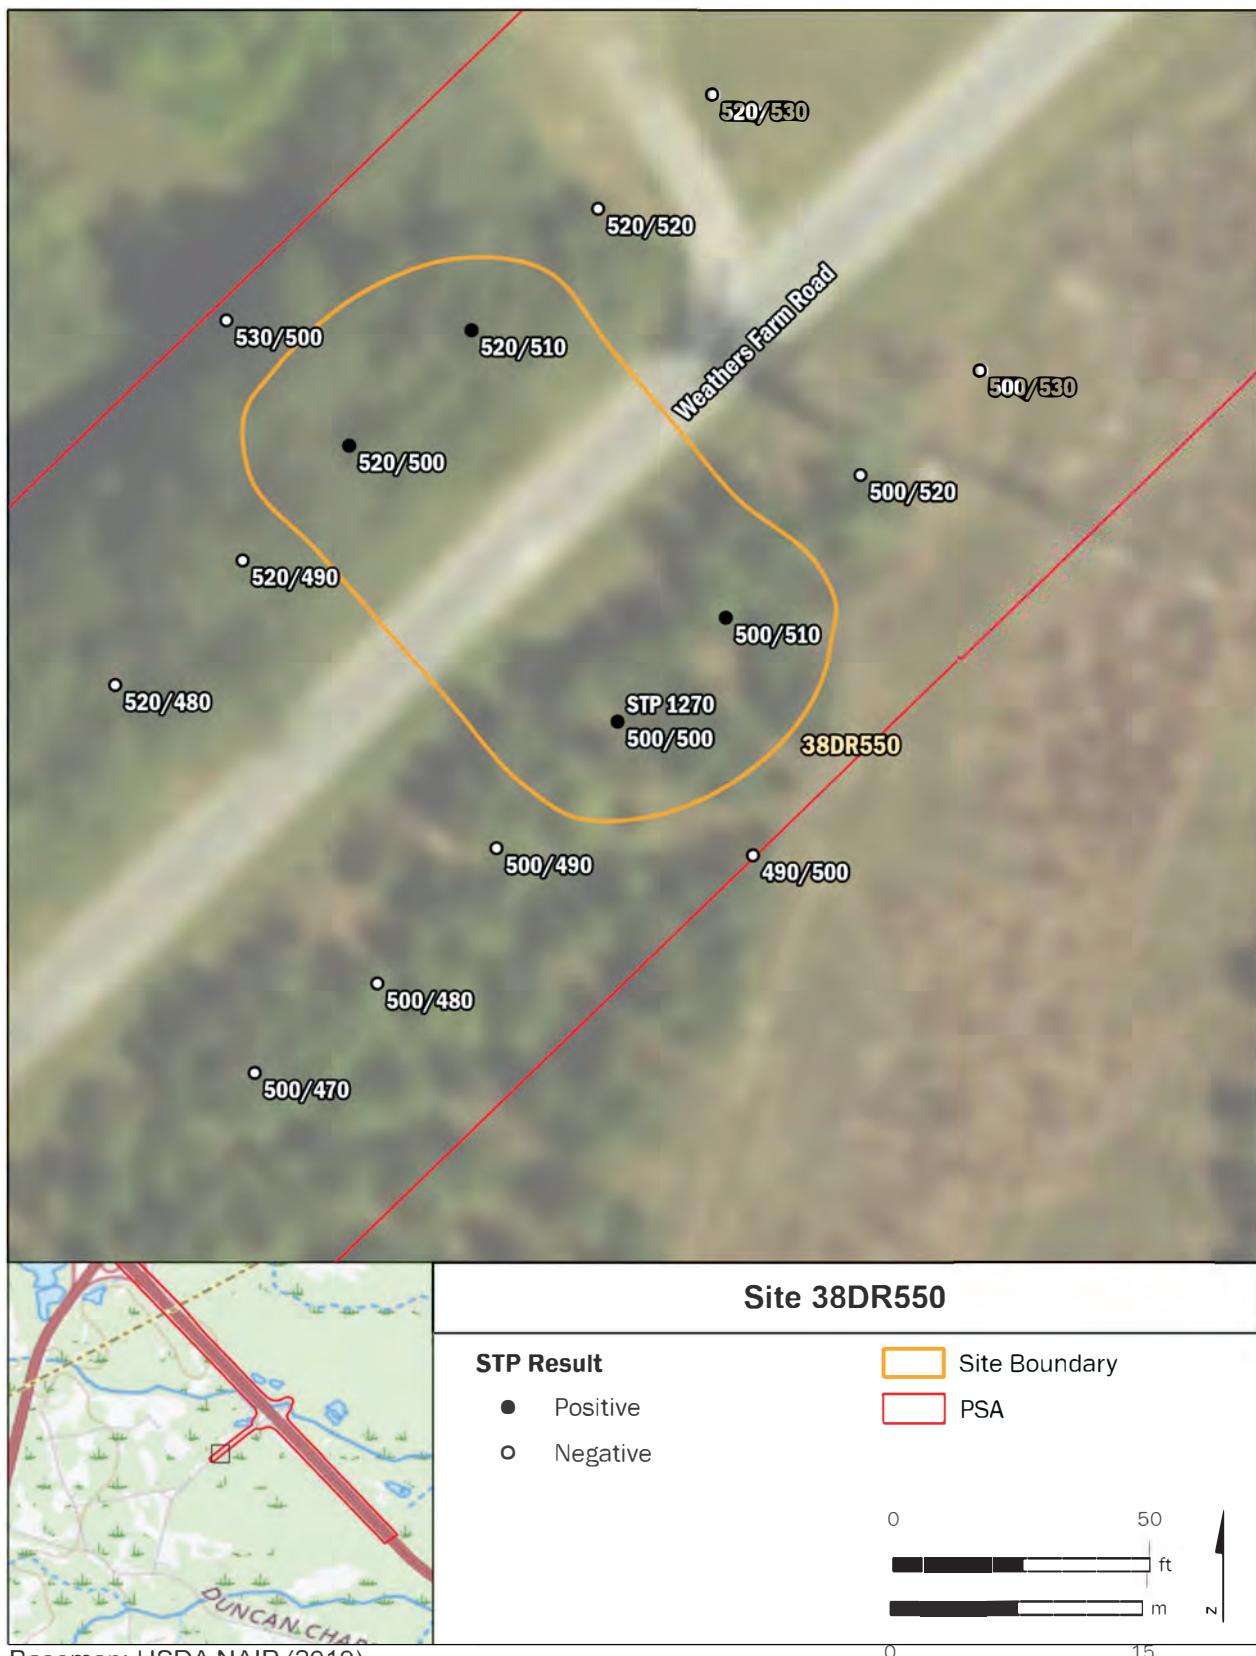
Figure 6.5.  
Site Map of 38DR0550

Eleven shovel tests were excavated at 10-meter (m) intervals to delineate and assess site 38DR0550. Three of the 11 shovel tests excavated yielded artifacts (see Figure 6.5). While survey limits prevented the complete delineation of the positive shovel tests, the portion of the artifact scatter within the PSA measures 35 by 20 m. The typical soil profile observed onsite consists of 25 cm of brown (10YR 4/3) sand (Ap horizon) over 25 cm of yellowish brown (10YR 5/4) sand (E horizon) beneath which was 10+ cm of yellowish brown (10YR 5/8) sandy clay (Bt horizon; Figure 6.7).

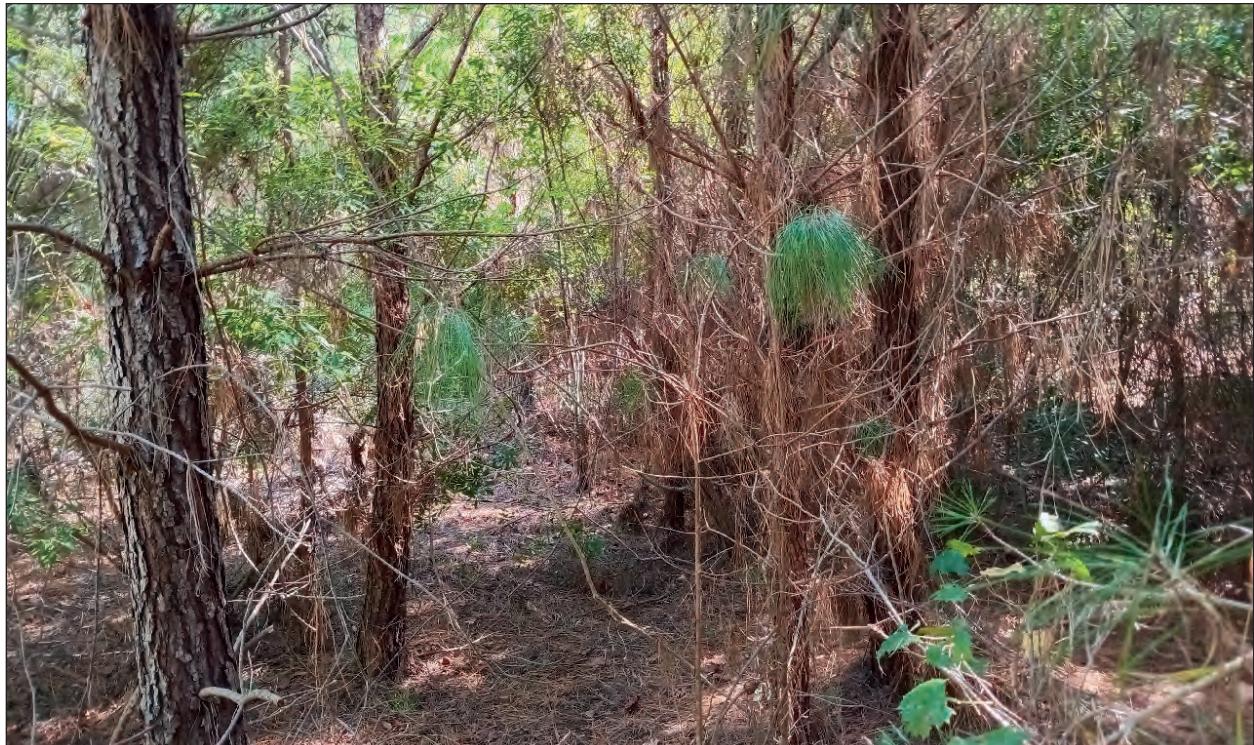
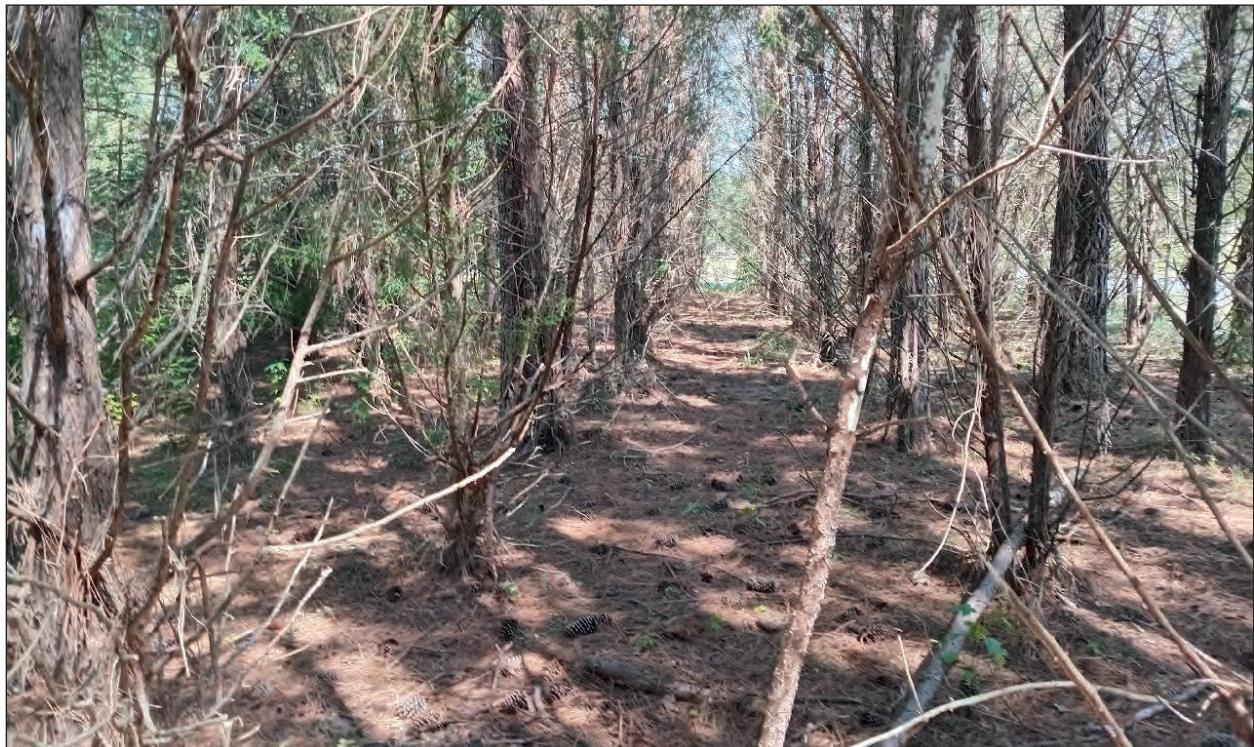
Figure 6.6.  
Current Conditions at 38DR0550

A. Dense Pine Forest with Dense Understory on South Side of Road, Looking Northeast

B. Planted Pine Stand on North Side of Road, Looking Northeast

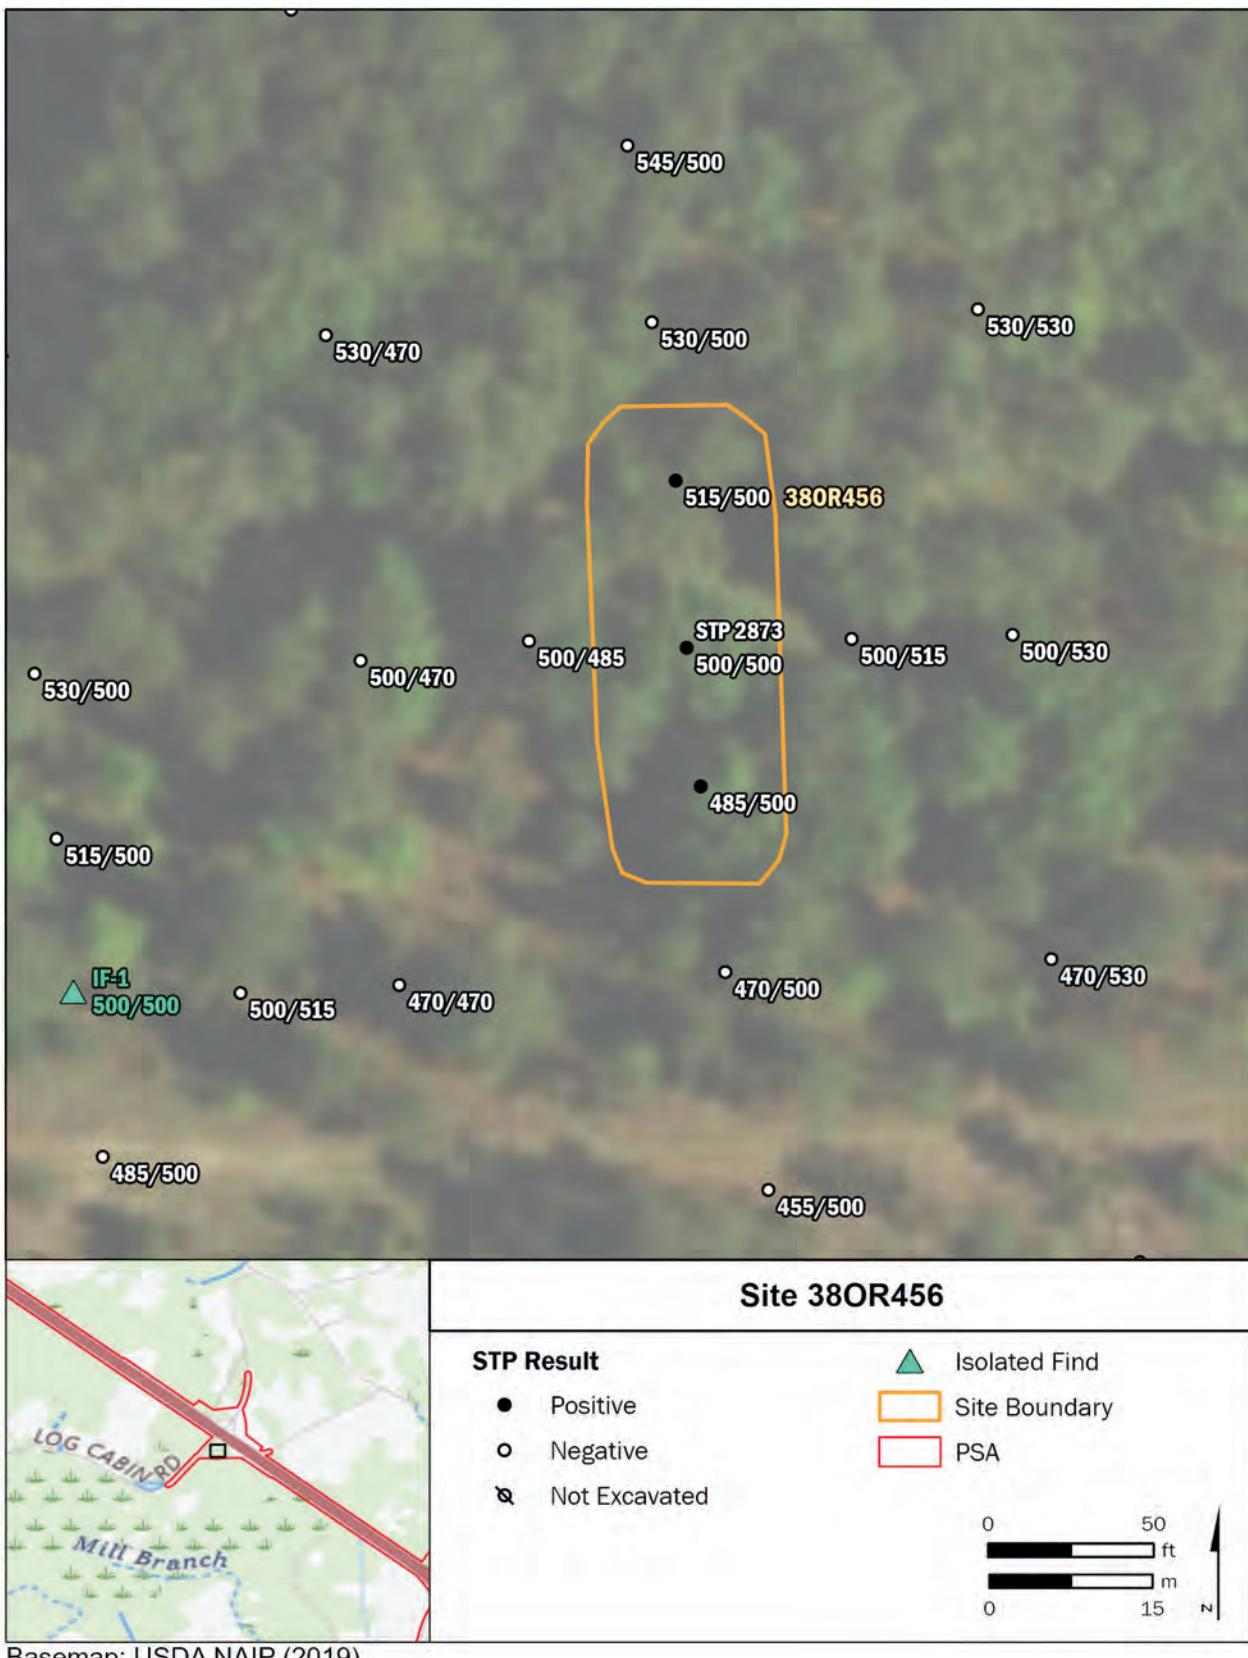
Figure 6.10.  
Site Map of 380R0456

The site measures approximately 45 m by 15 m. Three of the 11 shovel tests excavated on site yielded historic artifacts (see Figure 6.10). The typical soil profile observed onsite consists of 33 centimeters of grayish brown (10YR 5/2) sand (A horizon) over 28 centimeters of very pale brown (10YR 7/3) sand (E horizon) beneath which was 19+ cm of yellowish brown (10YR 5/6) sandy clay (Bt horizon; Figure 6.11b).

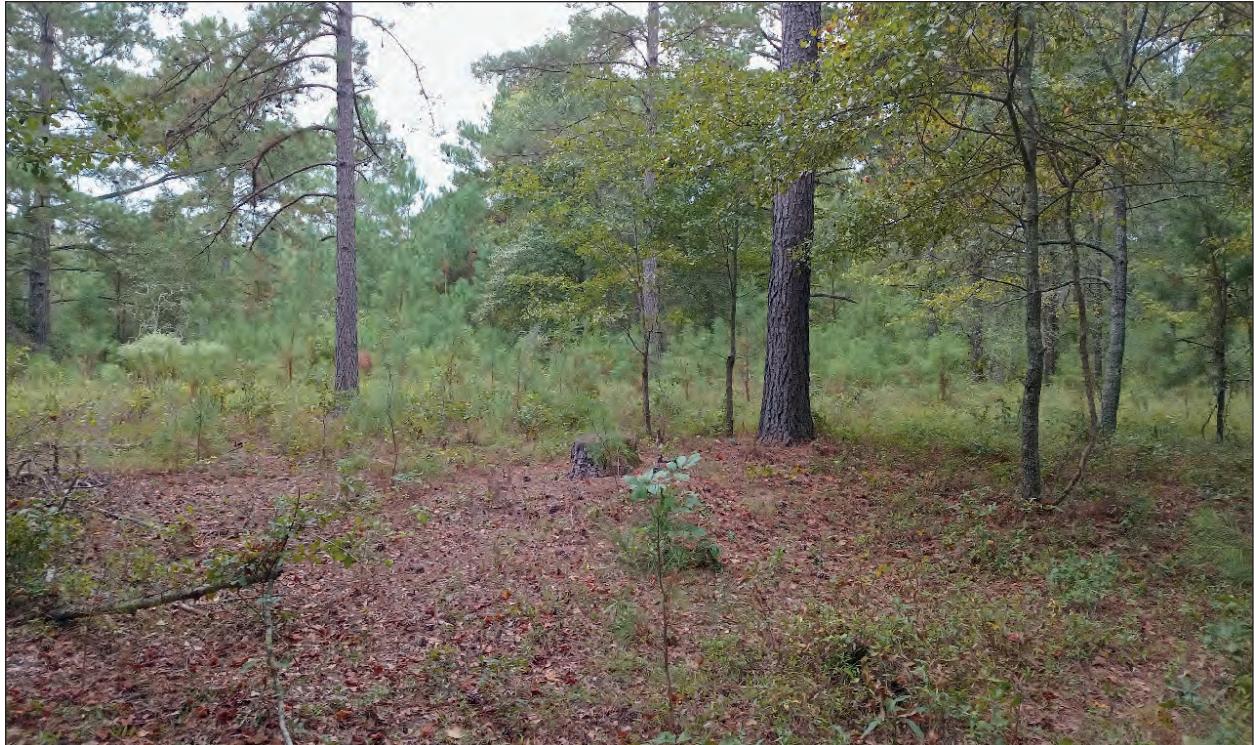
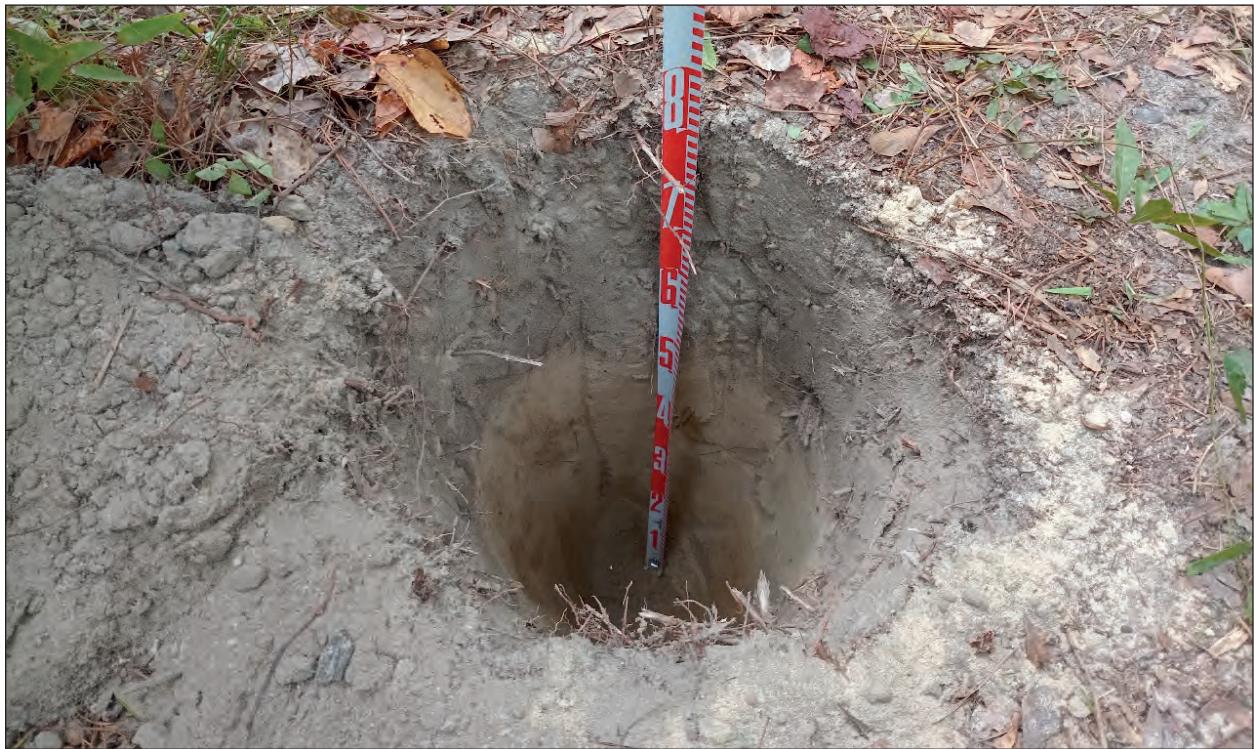
Figure 6.11.  
Current Conditions at 380R0456

A. View Across Site, Looking West

B. Soil Profile Observed at 380R0456

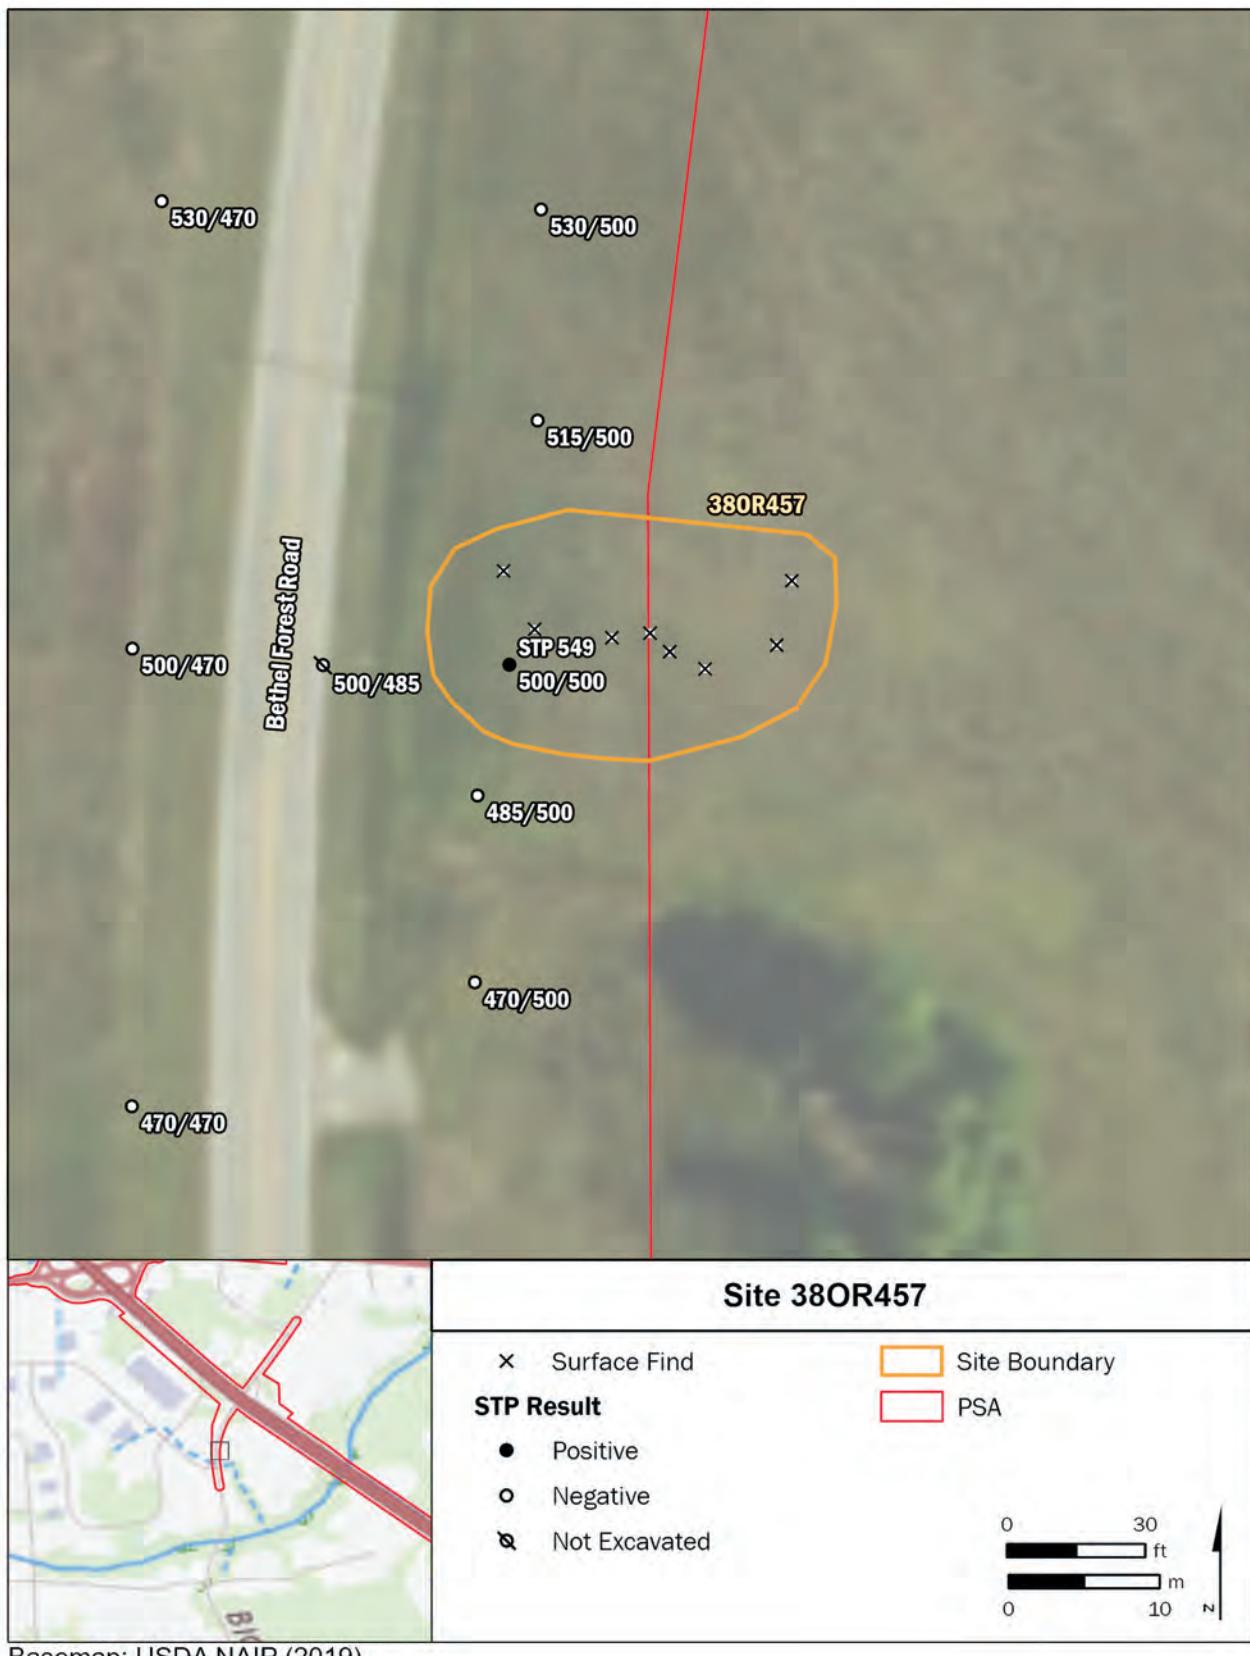
Figure 6.14.  
Site Map of 380R0457

A total of seven shovel tests were excavated at 15 m intervals in and around the surface scatter. Only one shovel test on site yielded historic artifacts (see Figure 6.14). The site measures approximately 27 m by 15 m based on the location of the positive shovel test and extent of the surface scatter. No shovel tests were excavated outside the PSA boundary so the site could not be fully delineated to the east. The typical soil profile observed on site consists of 35 cm of very dark gray (10YR 3/1) loamy sand (Ap horizon) over 10+ cm of strong brown (7.5YR 5/8) very compact clay (B horizon; Figure 6.16). The soil type recorded in the WebSoilSurvey database for the site location is Goldsboro sandy loam, which does not match the soils that were observed in the field. This could indicate that this area was modified by construction.

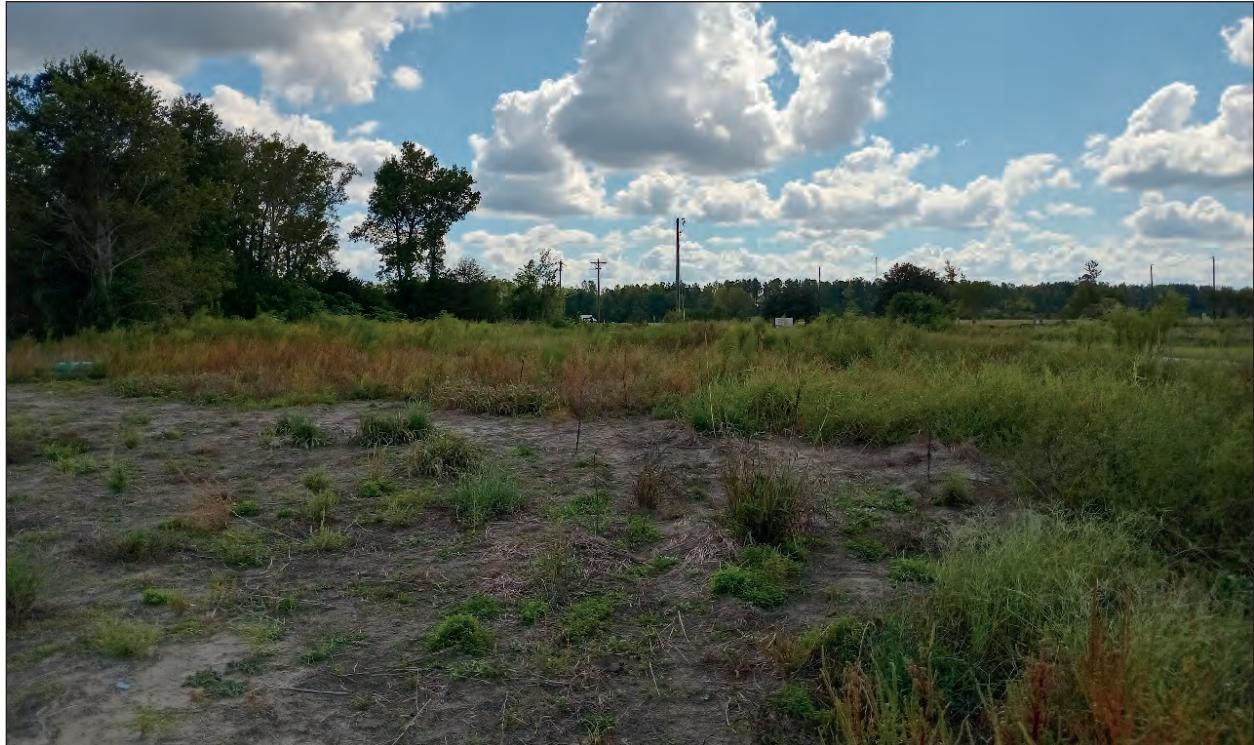
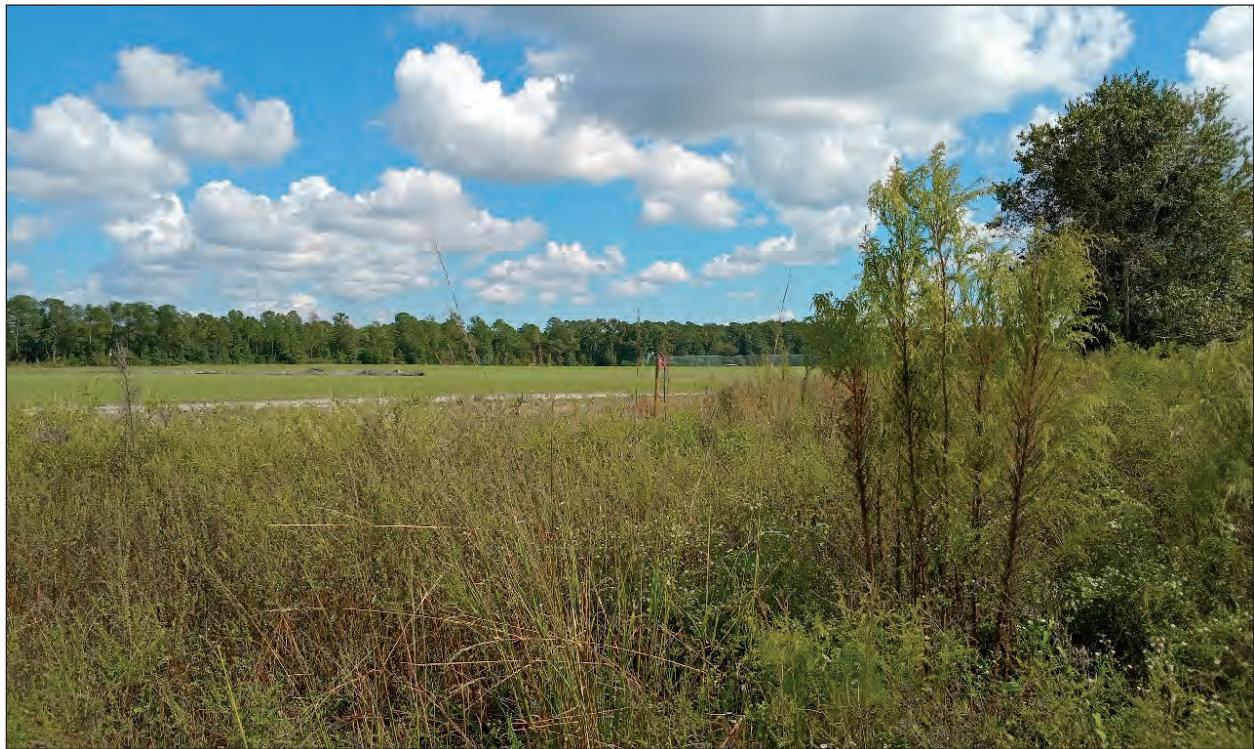
Figure 6.15.  
Current Conditions at 380R0457

A. Corner of Sod Field with Less Than 75 Percent Surface Visibility, Looking North

B. View Across Site of Tall Vegetation at Edge of Sod Field, Looking East

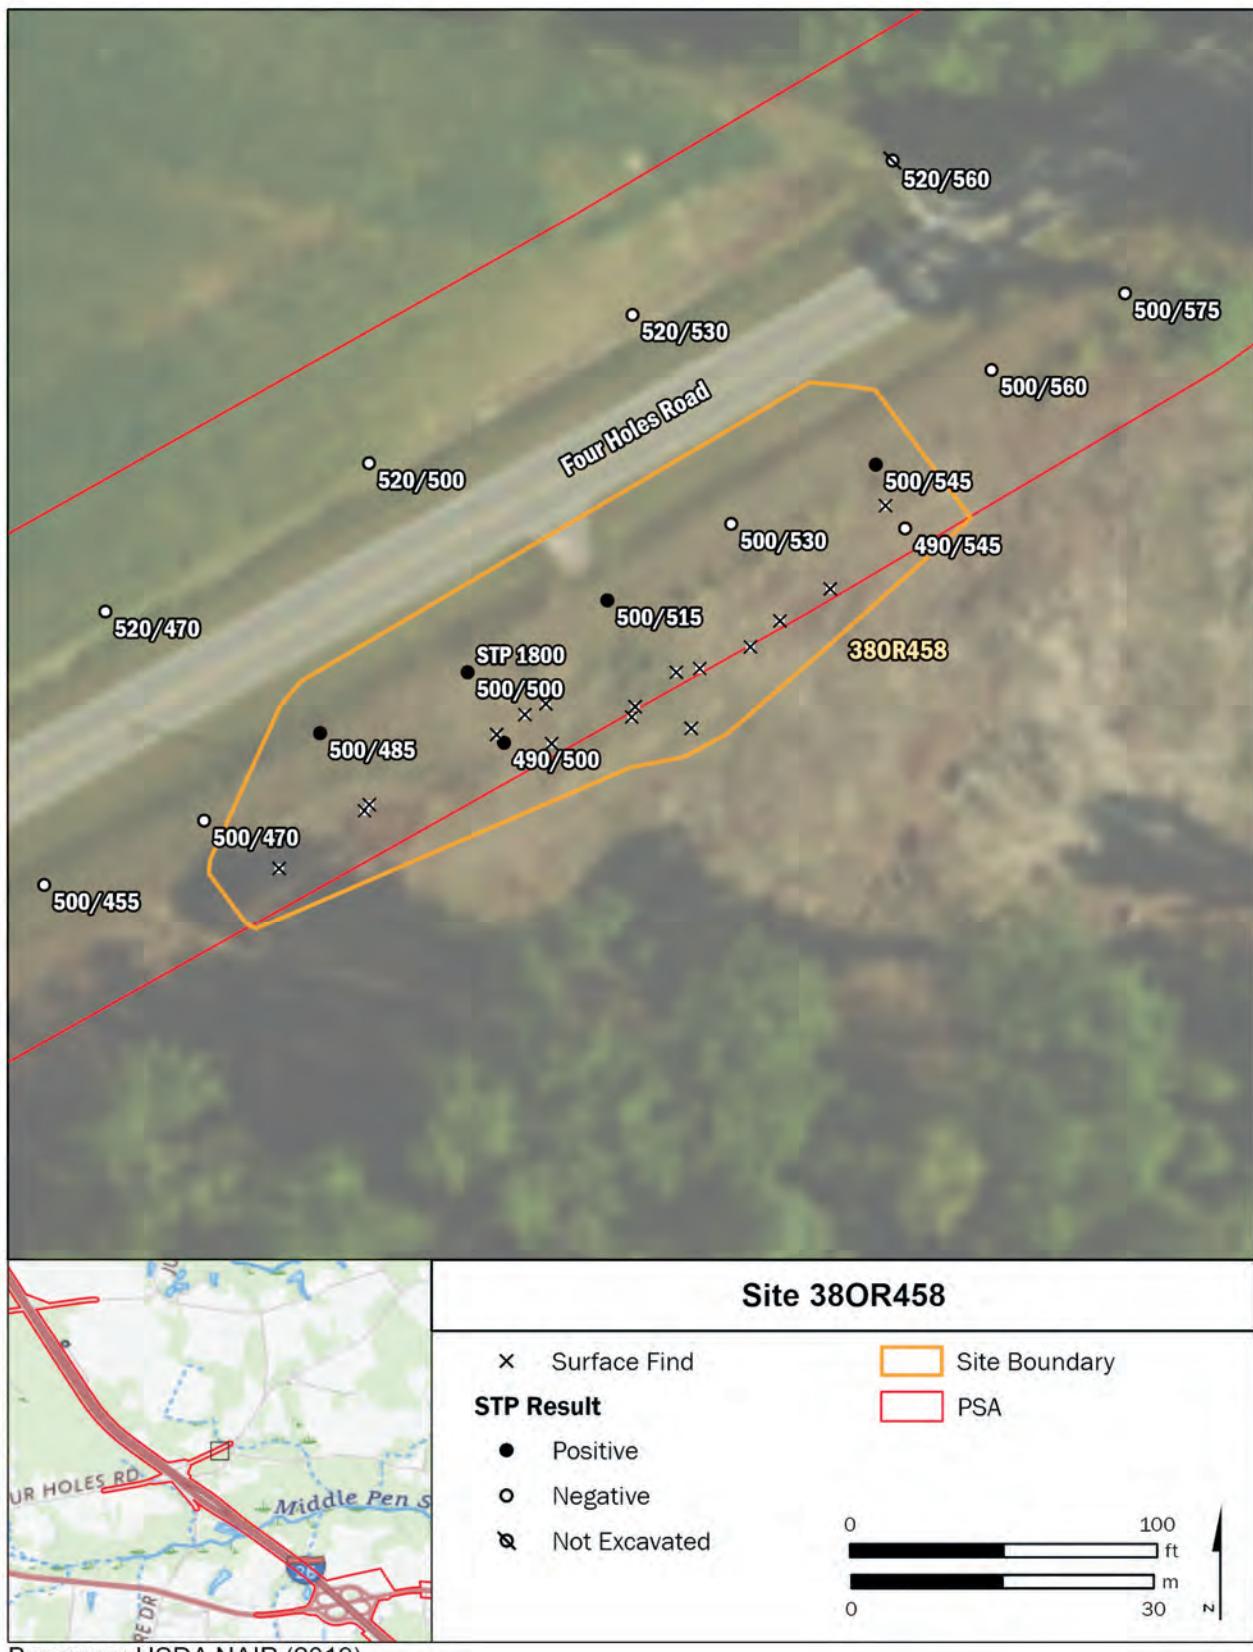
Figure 6.18.  
Site Map of 380R0458

Site 380R0458 is a late nineteenth-century to mid-twentieth century artifact scatter located in the north portion of the PSA (see Appendix A: Map 10 of 32). The site is located on the south side of 4 Holes Rd, approximately 350 ft (450 m) east of I-26 and approximately 6.6 mi (10.7 km) southeast of Orangeburg, SC (Figure 6.18). The site consists of historic artifact scatter located in a recently logged and overgrown field with less than 25 percent ground surface visibility (Figures 6.19).

Five of the 13 shovel tests excavated on site yielded historic artifacts. These positive STPs were all parallel to the road on either side of a remnant paved driveway (see Figure 6.18). The site measures approximately 80 m by 25 m, but could not be fully delineated to the south since the site extends outside of the PSA boundary. The typical soil profile observed on site consists of 15 cm of grayish brown (10YR 5/2) sand (Ap horizon) over 55 cm of light yellowish brown (10YR 6/4) sand (E horizon) beneath which was 10+ cm of yellowish brown (10YR 5/8) sandy clay subsoil (Bt horizon; Figure 6.20).
