# **D-1: PHASE I CULTURAL RESOURCES SURVEY**

***RE: Phase I Cultural Resources Survey for the Proposed Widening of I-26 from Mile Marker 145-172, Orangeburg and Dorchester Counties, South Carolina and Phase I Cultural Resources Survey for the Proposed Widening of I-26 from Mile Marker 145 to 172 - ADDENDUM***

***SCDOT Project #: P041967 and 42454***

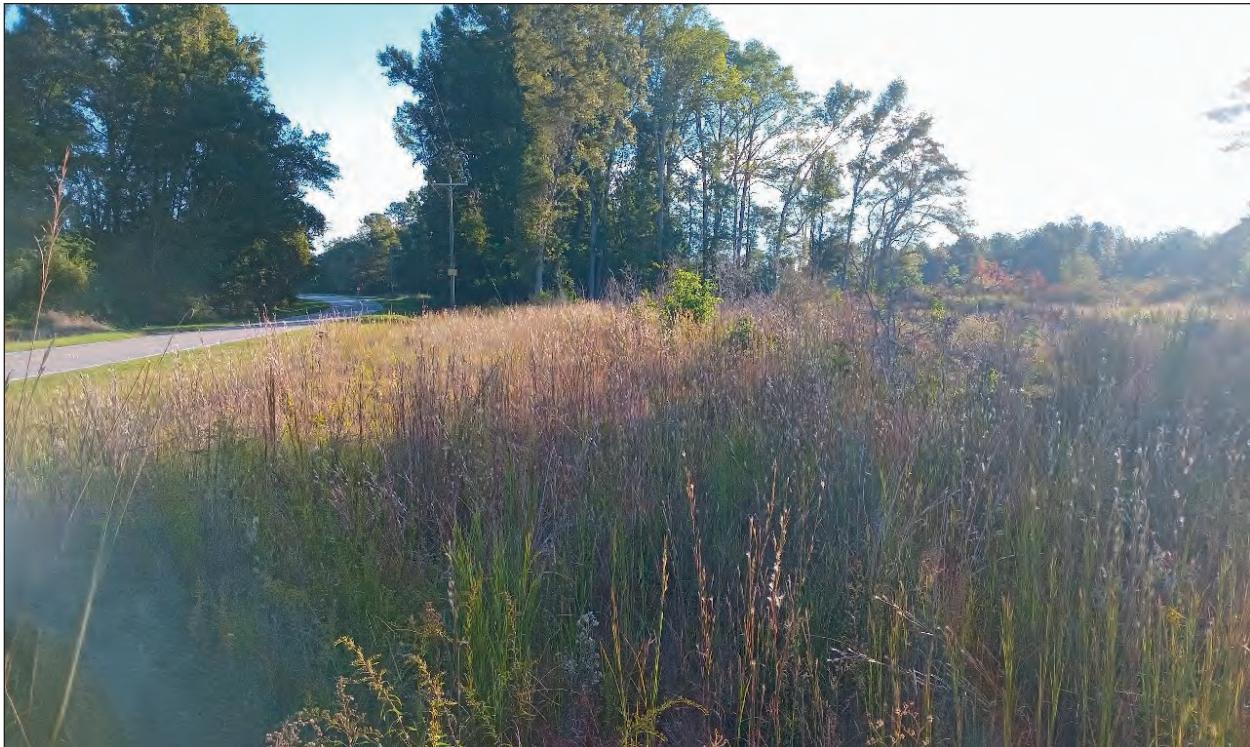
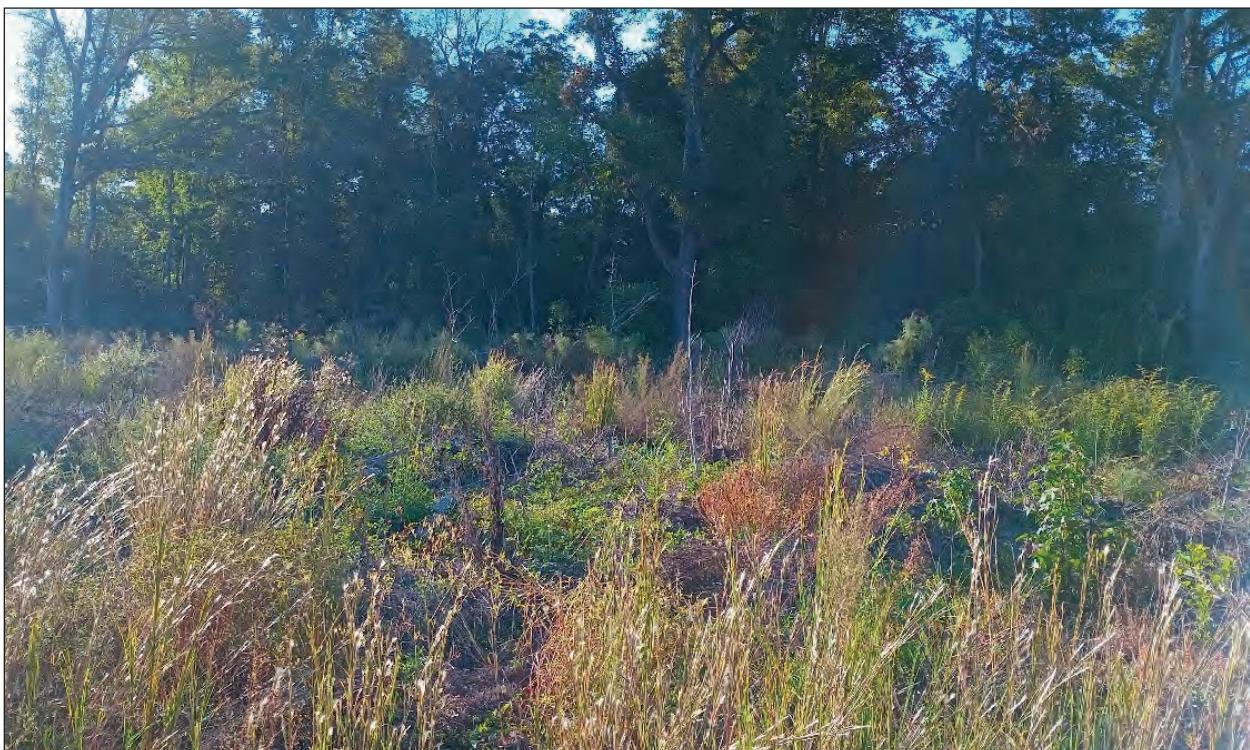
Figure 6.19.  
Current Conditions at 380R0458

Site 380R0458 is a late nineteenth-century to mid-twentieth century artifact scatter located in the north portion of the PSA (see Appendix A: Map 10 of 32). The site is located on the south side of 4 Holes Rd, approximately 350 ft (450 m) east of I-26 and approximately 6.6 mi (10.7 km) southeast of Orangeburg, SC (Figure 6.18). The site consists of historic artifact scatter located in a recently logged and overgrown field with less than 25 percent ground surface visibility (Figures 6.19).

A. View Across Site in Overgrown Field, Looking East

B. View of Surface Scatter in Recently Logged and Overgrown Ground Cover, Looking South

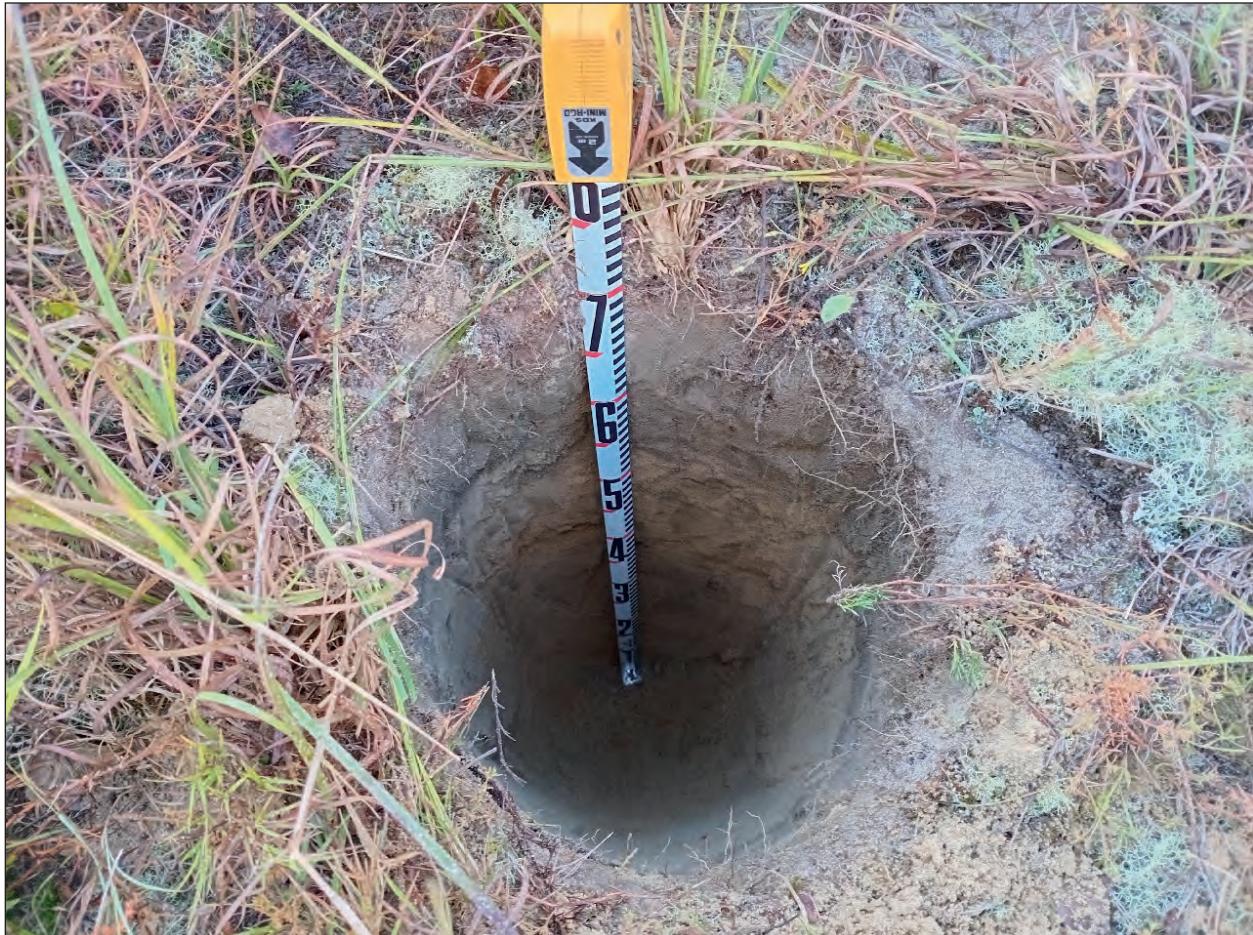
Figure 6.20.  
Soil Profile Observed at 380R0458

Five of the 13 shovel tests excavated on site yielded historic artifacts. These positive STPs were all parallel to the road on either side of a remnant paved driveway (see Figure 6.18). The site measures approximately 80 m by 25 m, but could not be fully delineated to the south since the site extends outside of the PSA boundary. The typical soil profile observed on site consists of 15 cm of grayish brown (10YR 5/2) sand (Ap horizon) over 55 cm of light yellowish brown (10YR 6/4) sand (E horizon) beneath which was 10+ cm of yellowish brown (10YR 5/8) sandy clay subsoil (Bt horizon; Figure 6.20).

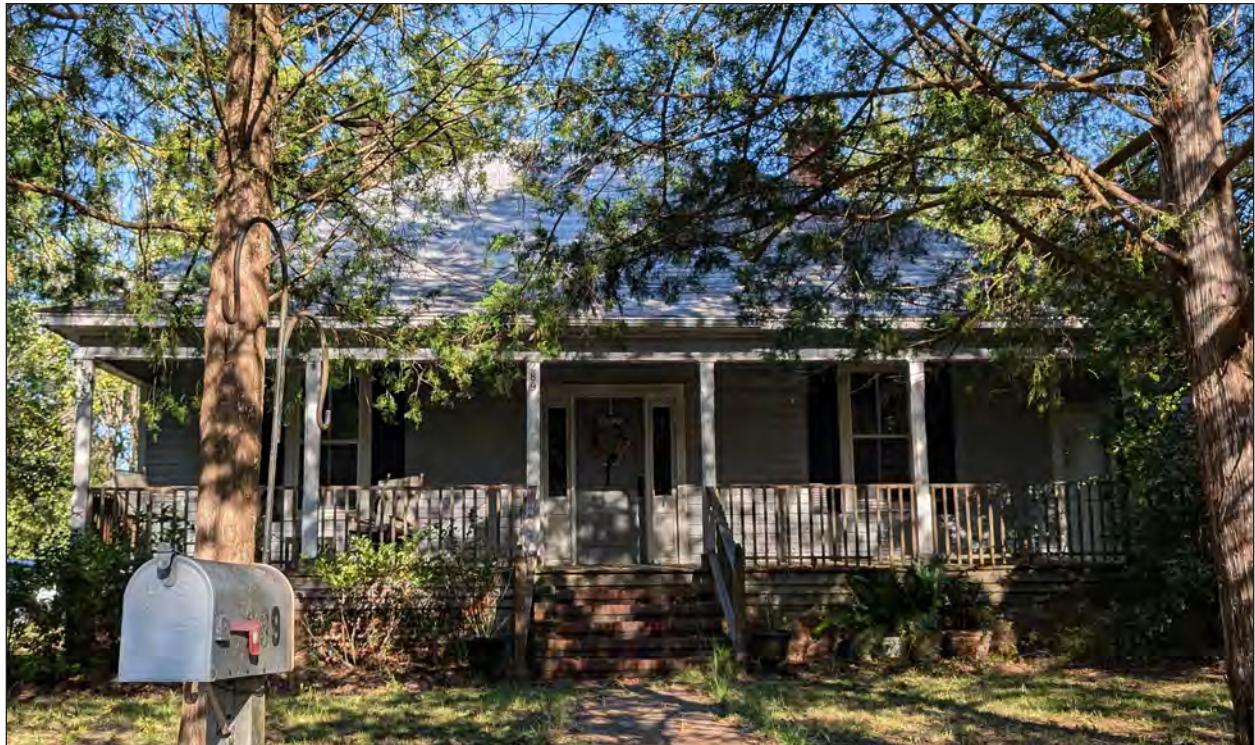
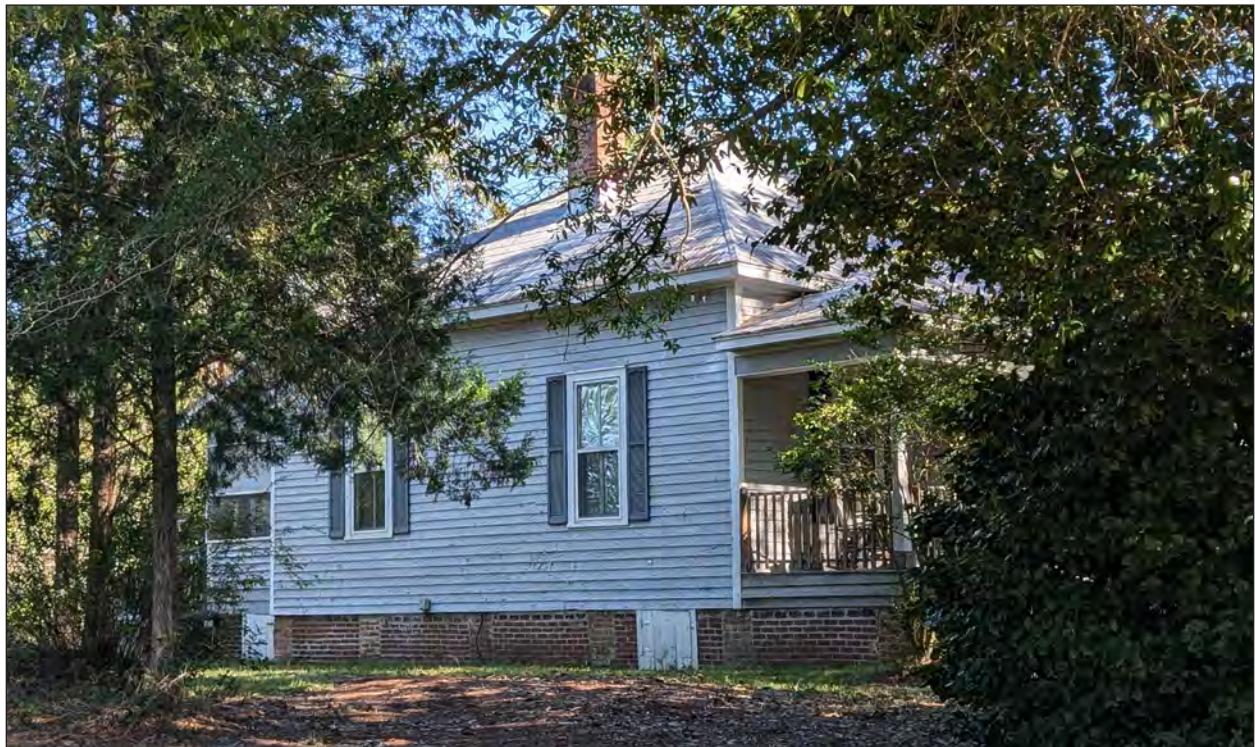
Figure 7.12.  
SHPO Site Number 0988

A. Façade, Looking West

B. Oblique, Looking Northwest

SHPO Site Numbers 0988-0988.02 were evaluated for NRHP eligibility under Criteria A, B, and C. Background research did not indicate that the property was associated with any historically significant events or persons. Therefore, they are recommended not eligible for the NRHP under Criteria A or B. The resources were evaluated under Criterion C for architectural significance. All three are early twentieth-century buildings, but they are not distinctive or noteworthy examples of their building types, which are common in South Carolina. SHPO Site Number 0988 appears to have received no fewer than three additions, with the add-on that extends the façade on the north end and disrupts its original symmetry having been added since the house was surveyed by NSA in 2000 (Hamby et al. 2000). Similarly, both outbuildings have undergone alterations in the form of additions or added non-historic materials. Therefore, they are recommended not eligible for the NRHP under Criterion C.

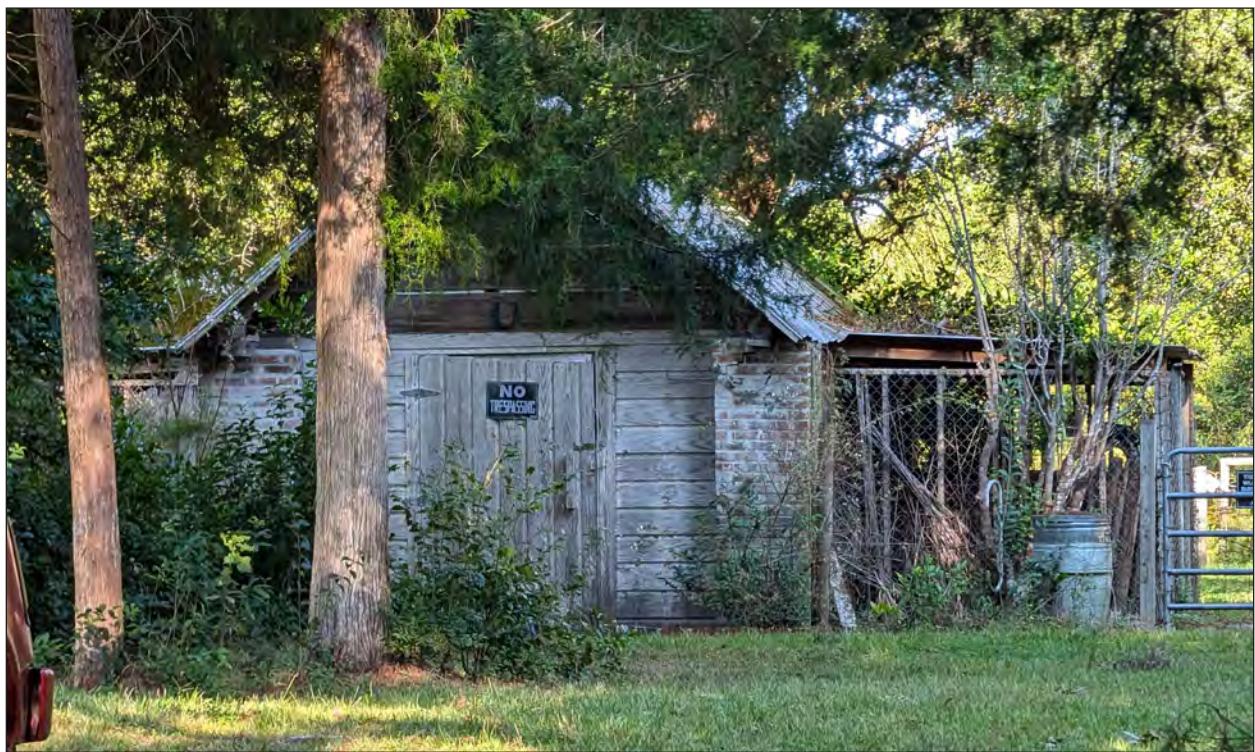
B. SHPO Site Number 0988.02, Looking Southwest

SHPO Site Number 0988.02 is a front-gabled shed that faces south from its site approximately 70 feet west of the main house. The building appears to have a combination masonry and frame structure, with the side elevations composed of brick that wraps onto the façade the width of three bricks on both sides, creating a vernacular column effect. The façade is set back the depth of two bricks and is clad with novelty siding to just above the door, while the gable end contains wide one-by flushboards. A wooden door is centered in the façade, and there are shed roof extensions from the main roof on both sides to create covered storage areas. The main and shed roofs have corrugated metal cladding, and the foundation is not visible (see Figure 7.13).

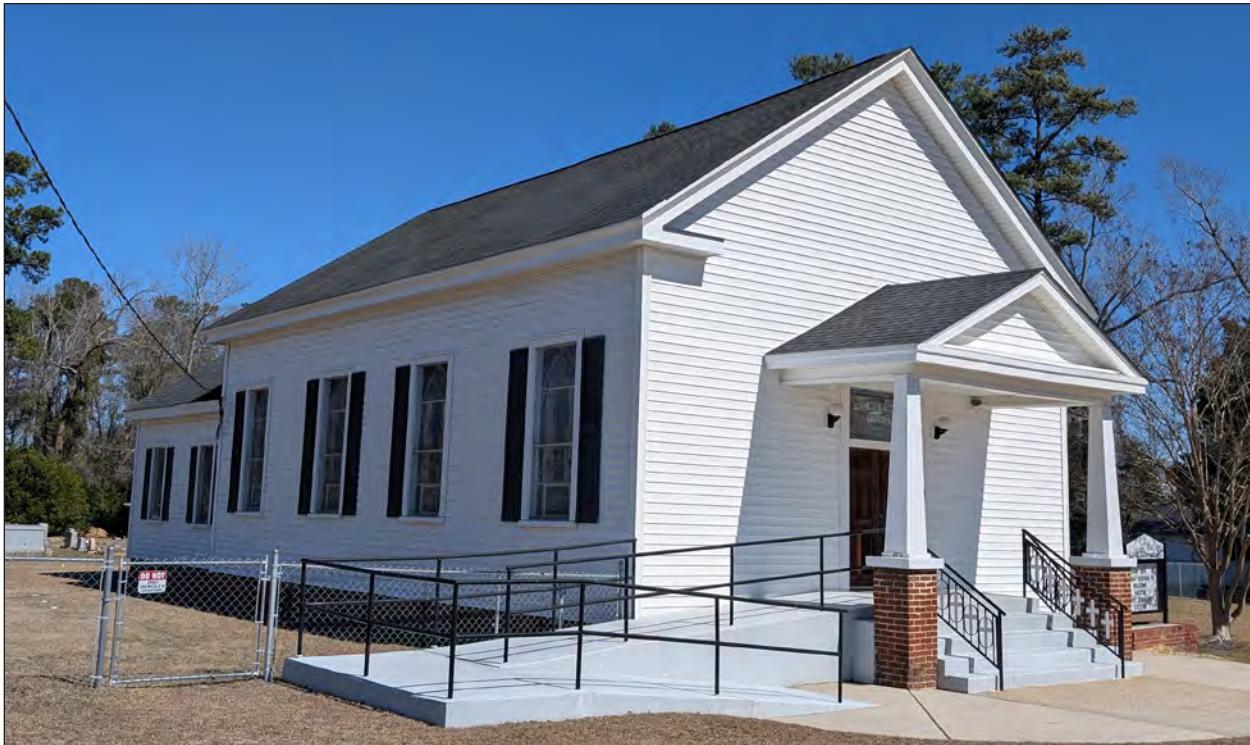
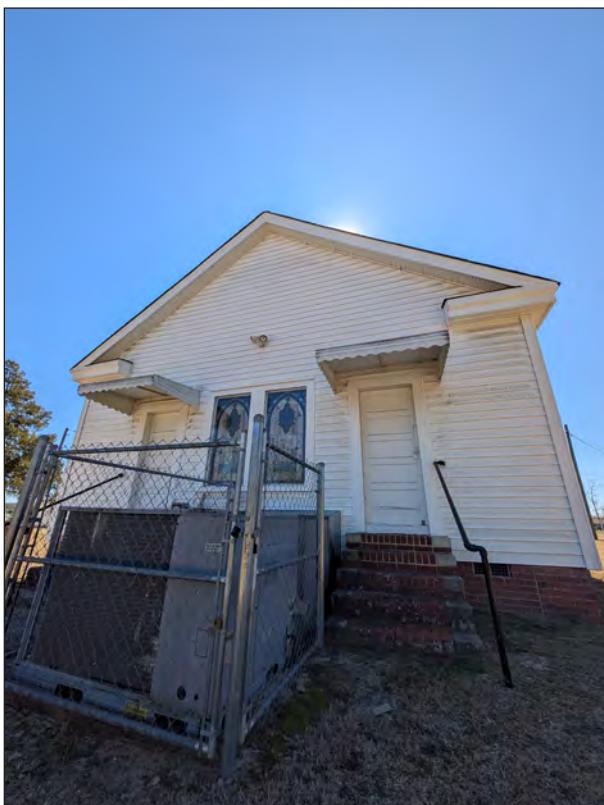
Figure 7.14.  
SHPO Site Number 0028 (White House United Methodist Church), 1 of 2

A. Oblique, Looking Northeast

B. Rear Elevation, Looking South

SHPO Site Number 0028 was listed in the NRHP in 1974 in the areas of religion and architecture, and the current survey concurs with that determination (Brabham and Gramling 1974). Despite alterations since that time that include the concrete entry steps and ramp and the addition of vinyl cladding, the church retains integrity and continues to serve the Methodist congregation of the Four Holes Community in life and the hereafter. Although briefly mentioned in the 1974 nomination and assumed to be included within the designated four-ac. NRHP boundary, the White House United Methodist Church Cemetery had not previously been assigned its own SHPO Site Number. However, based on its direct historical origins and continued connection with the church and congregation that has served the Four Holes Community for nearly two centuries, SHPO Site Number 0028.01 should be explicitly recognized as a contributing resource to the NRHP-listed church property.

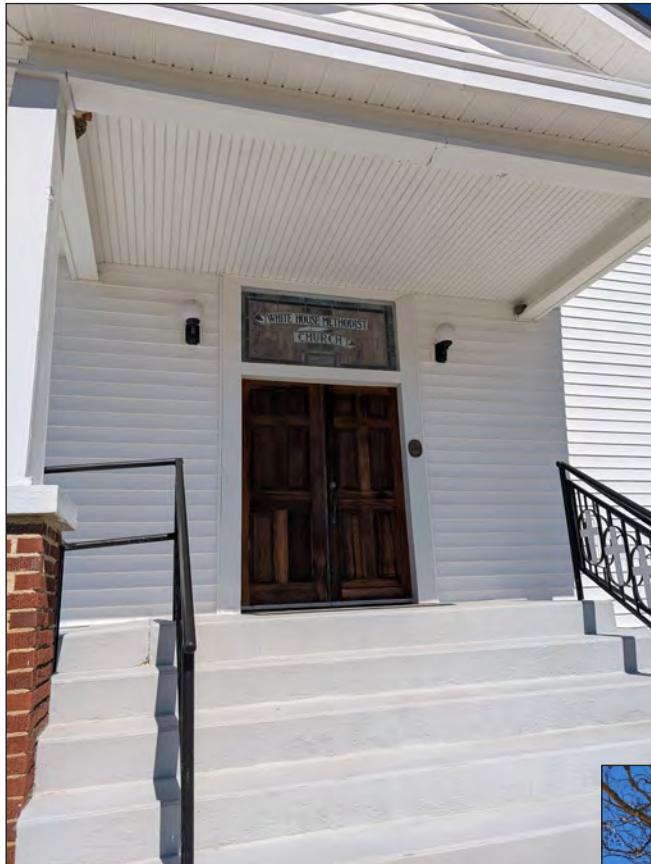
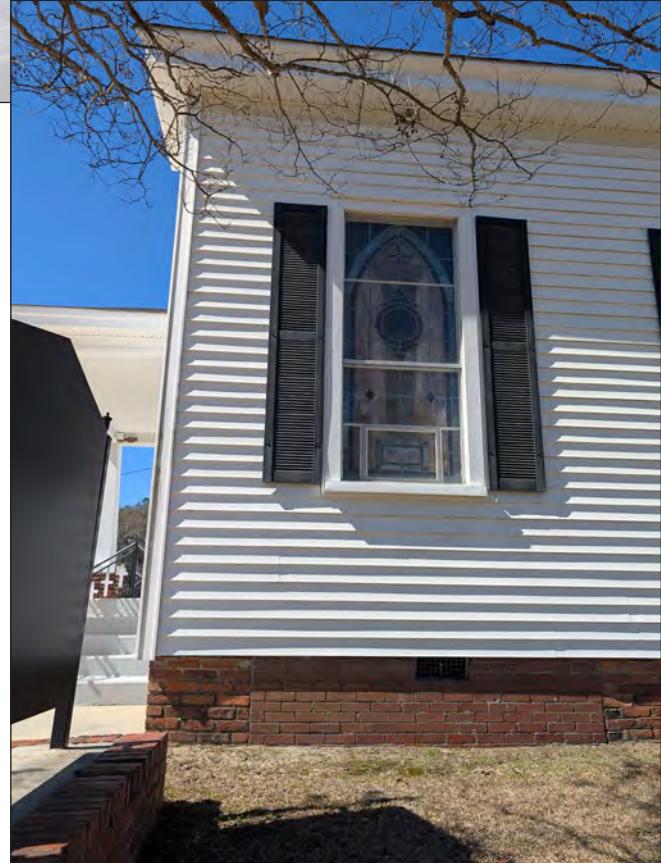
Figure 7.15.  
SHPO Site Number 0028 (White House United Methodist Church), 2 of 2

A. Façade/Entry Detail, Looking North

B. Stained-Glass Window Detail,  
Looking West

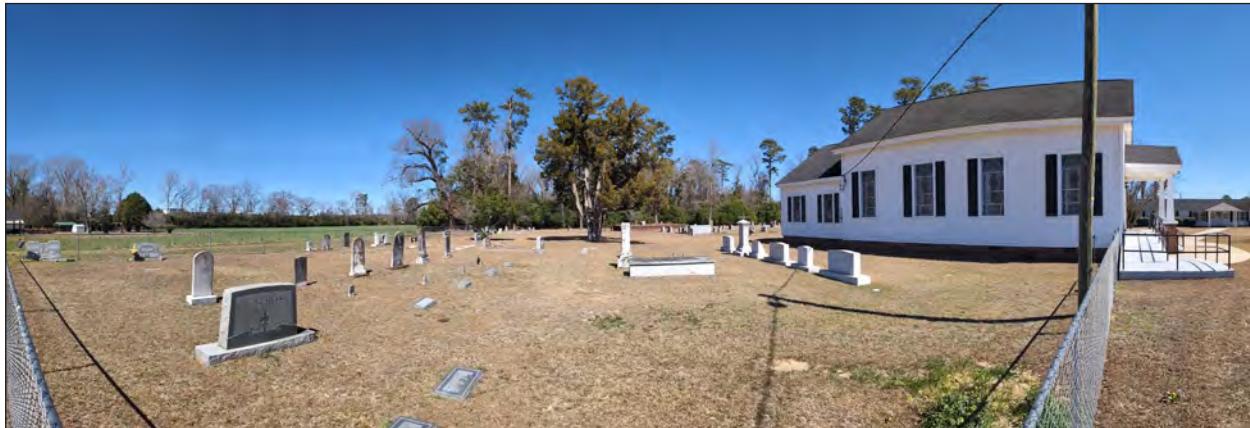
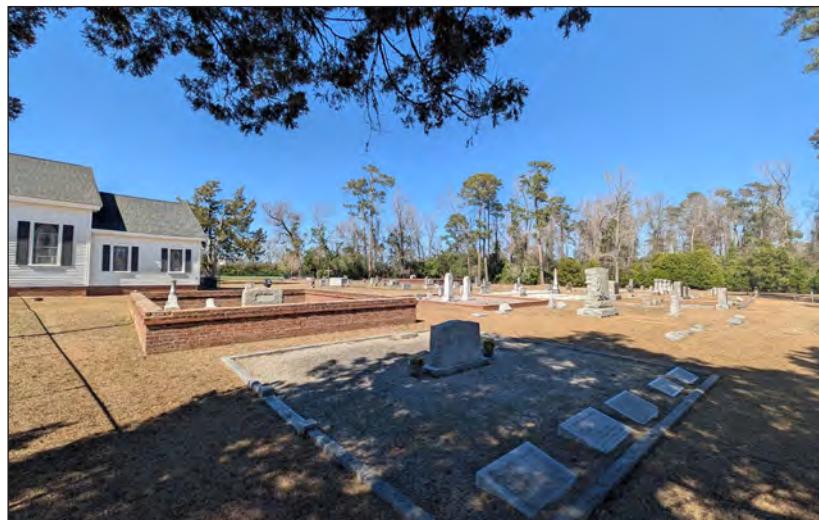
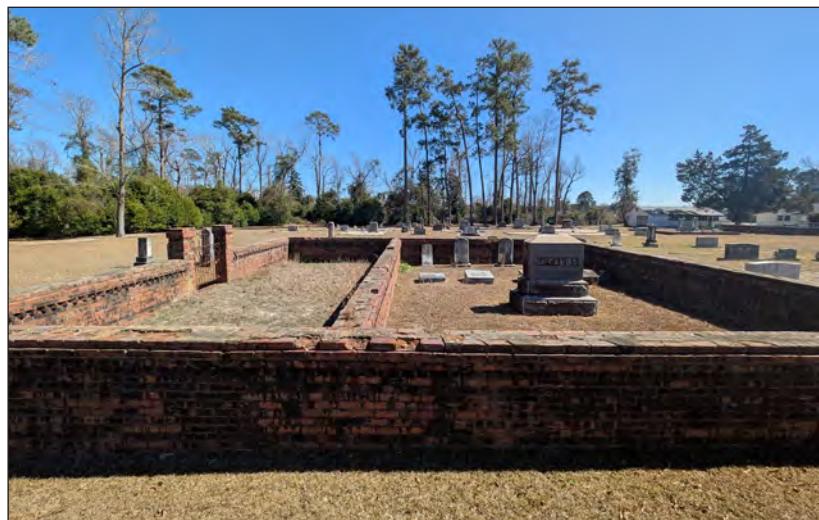
Figure 7.16.  
SHPO Site Number 0028.01 (White House United Methodist Church Cemetery), 1 of 2

Graves are generally clustered in family groupings, some of which are enclosed within masonry walls or iron fencing, or else surrounded by stone curbing. Markers generally face east, although some have family names or inscriptions on the opposite side, and some are four-sided. Although historic markers appear to dominate, at least 40 graves date to the twenty-first century, with the most recent interment having taken place in July 2024 (Find A Grave 2004). Moreover, modern graves are often found adjacent to or in the same row as graves of family members who died decades or a century earlier. There are a variety of obelisk or obelisk-like markers and many dozens of flat or crowned (arched or rounded) tablets, but there are also other types of designed markers, both historic and modern. There are markers that contain symbology for organizations ranging from the Masons to the Woodmen of the World to the military. There are a few ledger graves and flush tablets, but most are upright markers with or without a footstone. Grave goods are few and are mostly limited to flowers. There are several shared graves, but single burials are the dominant type.

A. Cemetery Overview with Church Building from Southwest Corner, Looking Northeast

B. Cemetery Overview with  
Church Building from Southwest  
Corner, Looking Northwest

C. Example of a Walled Burial  
Plot for the McCants Family,  
Looking East

Family names that appear in abundance include Arant, Bookhardt, Bozard, Connor, Dantzler, Edwards, Funchess, Gramling, McCants, Shuler, Stroman, and Zeigler. Landscaping is minimal, consisting of essentially just a few cedar trees scattered throughout the grassy graveyard (Figures 7.16 and 7.17).

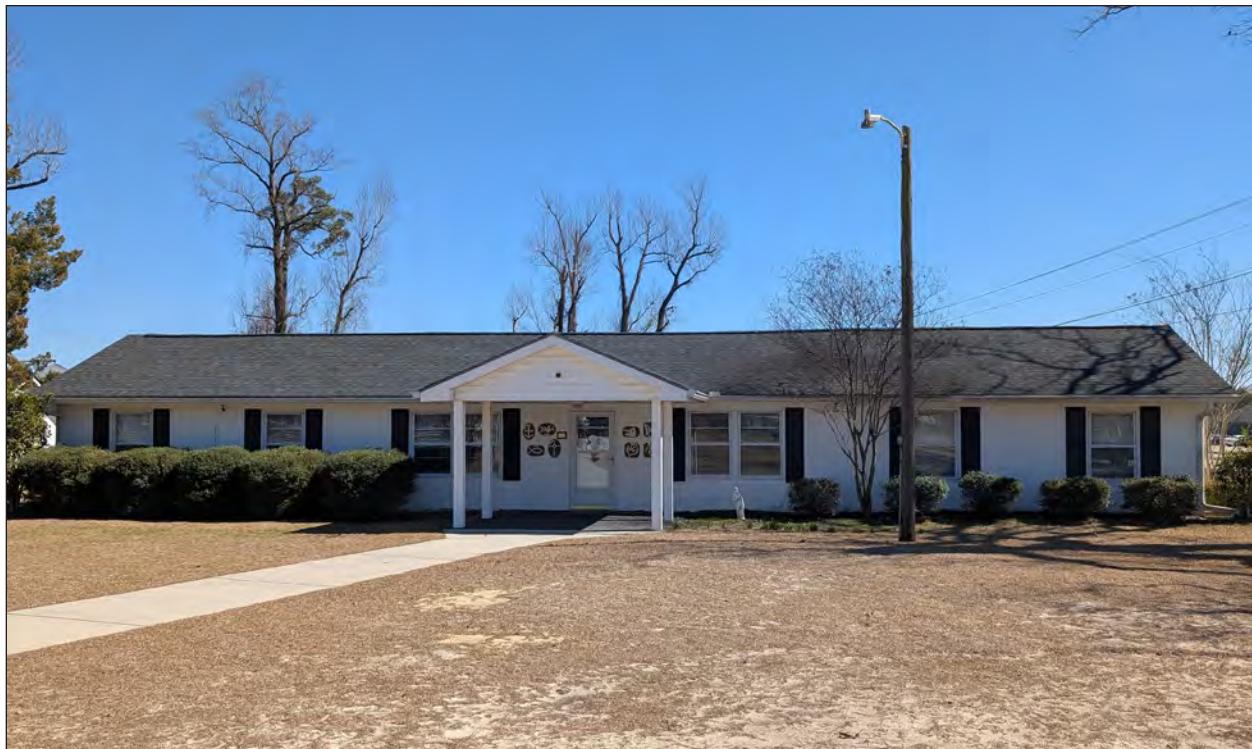
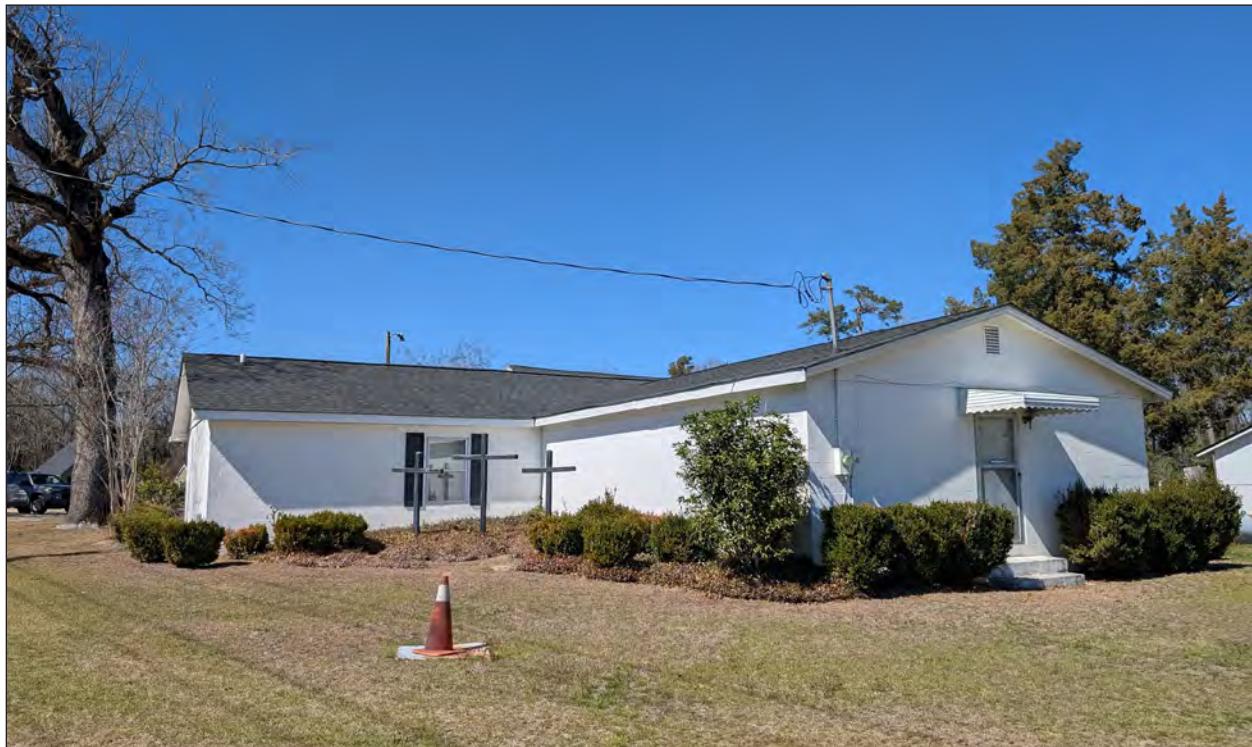
Figure 7.18.  
SHPO Site Number 0028.02

A. Facade, Looking East

B. Rear Oblique, Looking Northwest

Despite its association with the church and location within the NRHP boundary, SHPO Site Number 0028.02 is not considered a contributing resource. Used as an office, a gathering space, and an overflow space for the church, the resource is not known to be associated with significant past events or people. Moreover, its mid-twentieth-century construction date places it outside of the period of significance for the church and cemetery (also not explicitly stated in the NRHP nomination but assumed to be circa 1850s). The rectory was evaluated for significance in the area of architecture, but the Linear Ranch-style building is not a distinctive or noteworthy example of this common South Carolina house type. The additions, moreover, negatively impact its integrity, so the resource is not recommended as a contributing resource to the NRHP-listed church property.

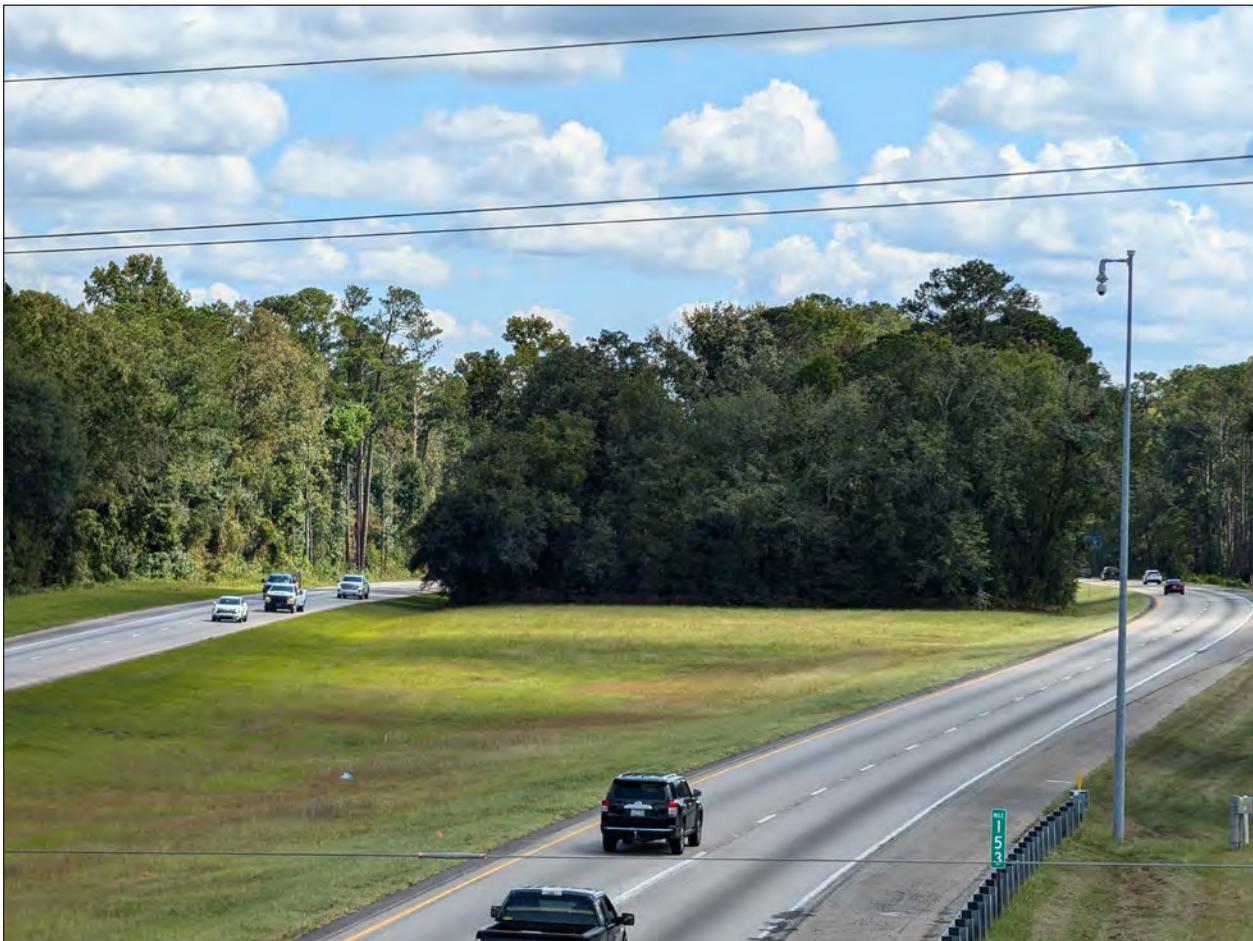
Figure 7.21.

The SCDOT survey found that the "unmarked cemetery" contains "at least two dozen unmarked graves, based on surface depressions," but notes that it "lacks markers/monuments of any kind" (Martin and Jurgelski 2019). Mrs. Stroman, likewise, stated that her son and nephew had explored the site in recent years but observed no markers or monuments. SCDOT's site form notes that the "site boundaries were drawn based on the limits of the earthen berm and ditch that surround the cemetery," but the naturally flat topography in the area suggests that these features are most likely associated with the interstate construction (Figure 7.21).

The Brantley Cemetery (SHPO Site Number 0349) in October 2024 as Viewed from the Four Chop Road Overpass Above I-26, Looking South

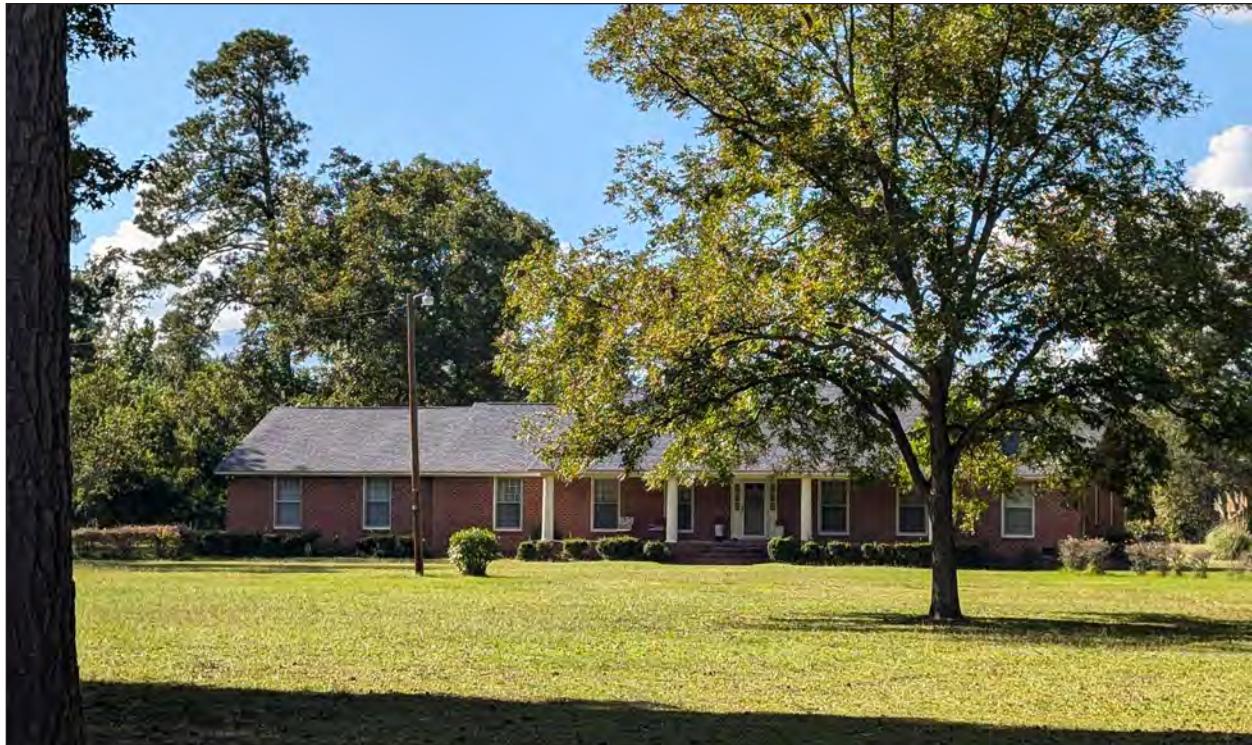
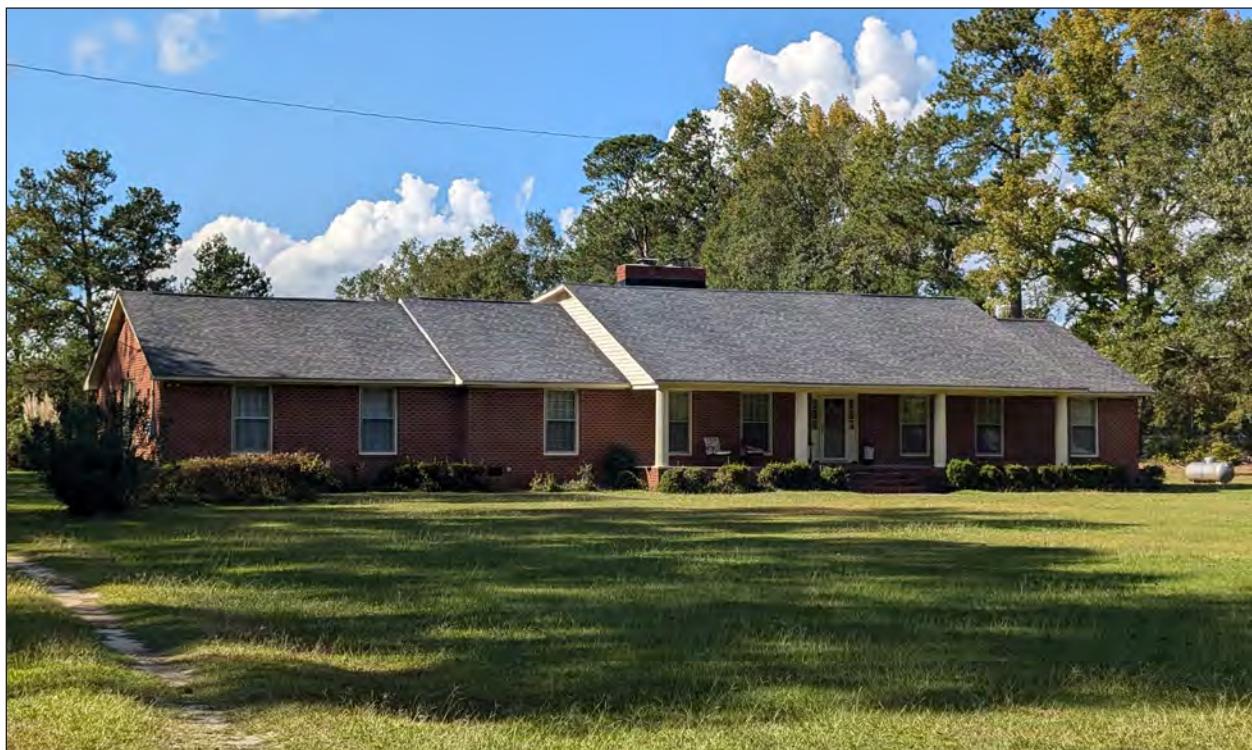
Figure 7.23.  
SHPO Site Number 0511

SHPO Site Number 0511 faces east from its site on Rugby Road. The Orangeburg County Tax Assessor records indicate this Linear Ranch House was built in 1967, but it is not visible in February 1973 aerial photography, so it is assumed to have been built circa 1974. The house has a rectangular footprint with a laterally gabled roof clad in composition shingles. The frame house has a brick veneer exterior that conceals the foundation (Figure 7.23). The observable windows throughout are 12-over-12 sash, most likely wood. The house has a five-bay central core that is flanked on both ends by single-bay wings. The central core is sheltered beneath a raised and engaged porch with round wooden columns. The center bay contains a glazed-and-wood-paneled door flanked by half-glazed and wood-paneled sidelights, while the other façade bays, including the unsheltered wings, each contain single windows. A laterally gabled addition at the south end has two façade windows and central doorway in the south elevation. Only the south and east elevations are visible from the ROW. The central core roof stands about two feet above the wing roofs, and the addition roof is slightly stepped down from the south wing. A wide double-flue brick chimney is located in the rear slope, and the eaves and central core gable ends are clad with aluminum or vinyl.

A. Façade, Looking West

B. Oblique, Looking Northwest

SHPO Site Number 0511 is situated on a trapezoidal 7.02-acre lot that is bisected by Rugby Road at its southwest corner. The house has a setback of approximately 250 feet and a large front lawn lined with trees at the road. There is an agricultural field and woodlands to the rear (west) of the house.

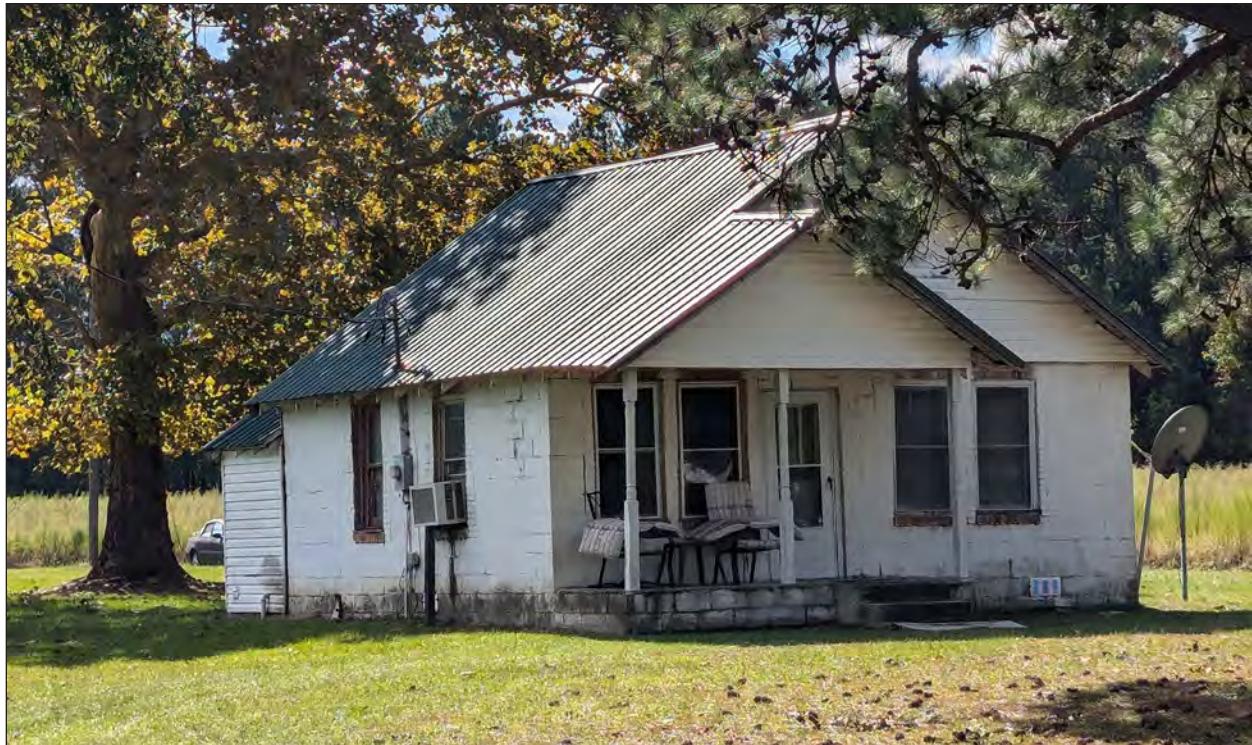
Figure 7.24.  
SHPO Site Number 0512

SHPO Site Number 0512 faces north from its site on Monticello Road. The Orangeburg County Tax Assessor records indicate this front-gabled bungalow was built in 1940. However, it is not represented on the 1946 St. Matthews quadrangle topographic map but is visible in 1958 aerial imagery, so the house is assumed to have been built circa 1950. The one-story concrete-block house has a front-gabled porch across the eastern half of the façade. Both the porch and main gable ends are clad with vinyl siding, while both roof structures are clad with standing-seam metal (Figure 7.24). The main roof's gable end has a central (replacement) nine-light octagonal window, and the western half of the façade contains a set of paired six-over-six sash windows. The raised porch contains a paired set of one-over-one sash windows and the wood-paneled and half-glazed door with three vertical lights. Both side elevations have two windows of different types (one-over-one wood or metal sash), and all visible windows are brick-framed. The porch roof is supported on turned wood posts, and the lateral eaves have exposed rafter tails. A gabled addition with vinyl siding and standing-seam metal roofing is appended to the rear elevation. SHPO Site Number 0512 is situated on an essentially rectangular 1.02-acre lot. The house has a setback of approximately 100 feet and a large lawn with a few mature trees.

A. Oblique, Looking Southwest

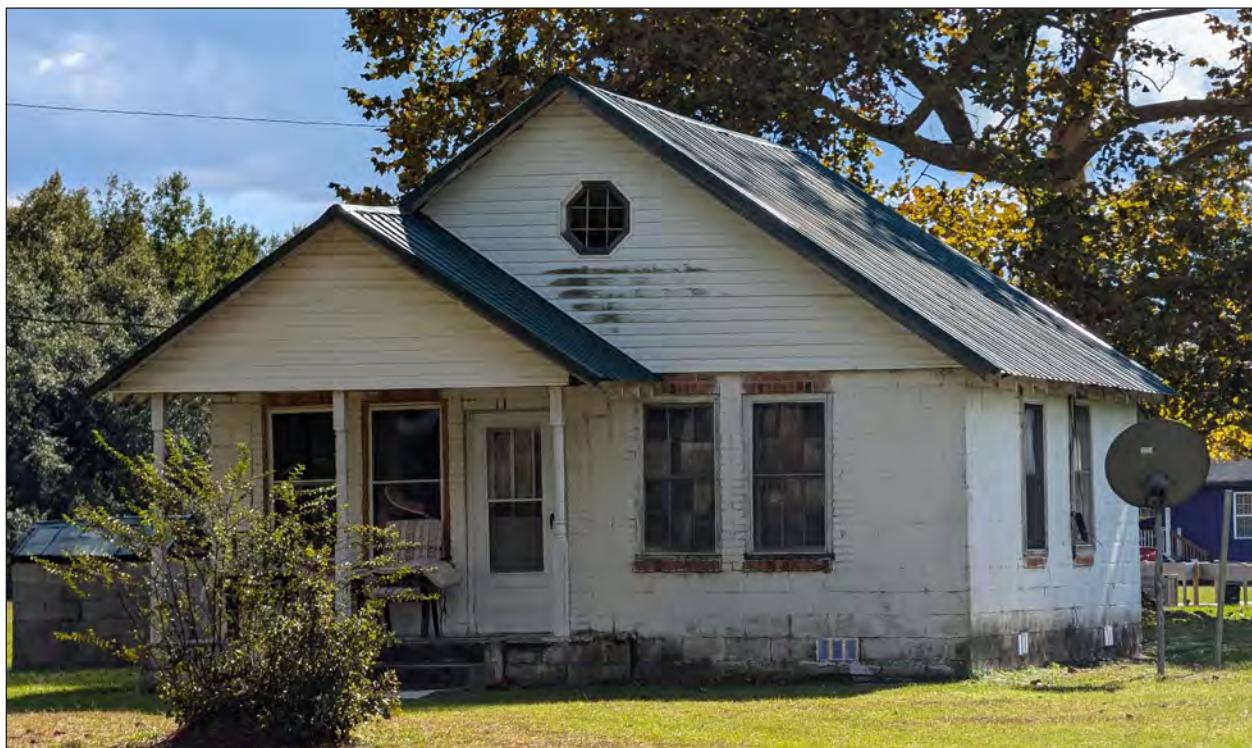
B. Oblique with SHPO Site Number 0512.01 at Left, Looking Southeast

SHPO Site Number 0512.01 is a well house located approximately 10 feet southeast of the rear (southwest) corner of the house. It does not appear in 1958 aerial imagery, and 1980s aerial imagery is inconclusive, but it is assumed to have been built around 1980. This small rectangular concrete block building has a wood-frame gable roof structure with a standing seam metal roof covering and an opening on the south side that lacks a door. A portion of the west well appears to be missing, and the foundation is not visible (Figure 7.24b).

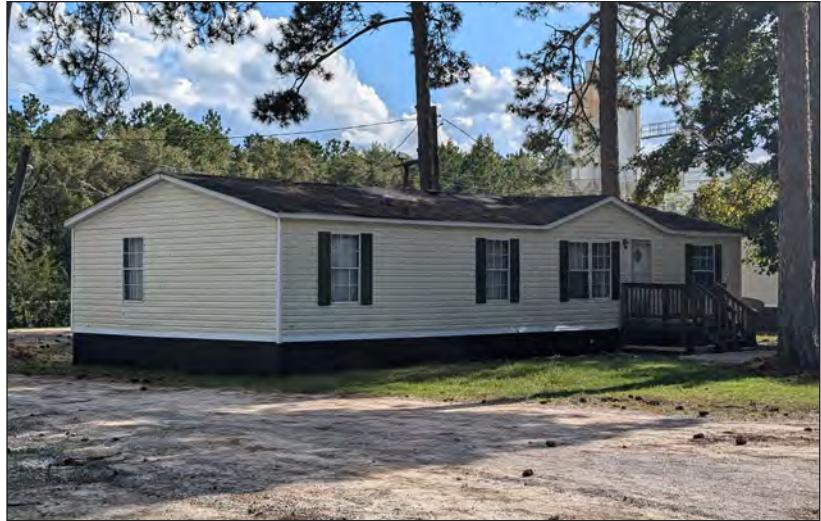
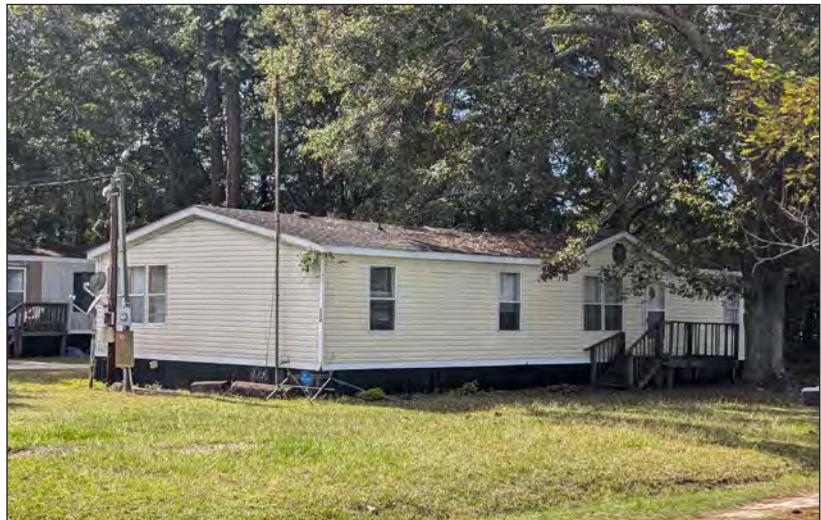
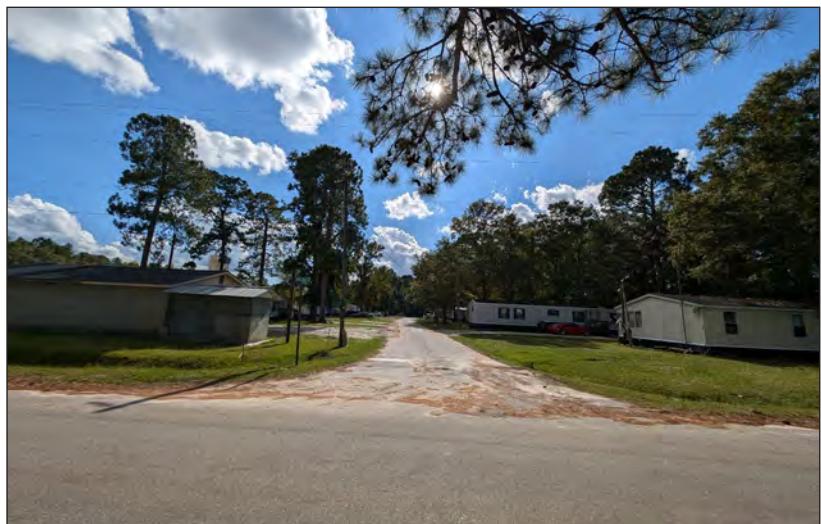
Figure 7.25.  
SHPO Site Numbers 0513-0513.02

six vinyl sash windows, while SHPO Site Number 0513.02 has one-over-one vinyl or metal sash. Some homes have plywood siding or metal roof cladding, but most are similar to SHPO Site Numbers 0513.01 and 0513.02 (Figure 7.25).

A. SHPO Site Number 0513.01,  
Looking Southeast

B. SHPO Site Number 0513.02,  
Looking Southwest

C. SHPO Site Number 0513  
Overview, Looking Northeast

SHPO Site Numbers 0513-0513.02 were evaluated for the NRHP under Criteria A, B, and C. Background research did not indicate that the park or any of the individual homes are associated with any historically significant events or persons. Therefore, the resources are recommended ineligible under Criteria A and B. Under Criterion C, mobile homes and mobile home parks are very common in South Carolina, and no individual resource within the Cumberland Court Mobile Home Park was found to embody the distinctive characteristics of a type, period, or method of construction. Many of the individual resources also appear to have been altered with replacement materials, additions, and other modifications. Therefore, the resources are recommended not eligible for the NRHP under Criterion C.
