# **D-1: PHASE I CULTURAL RESOURCES SURVEY**

***RE: Phase I Cultural Resources Survey for the Proposed Widening of I-26 from Mile Marker 145-172, Orangeburg and Dorchester Counties, South Carolina and Phase I Cultural Resources Survey for the Proposed Widening of I-26 from Mile Marker 145 to 172 - ADDENDUM***

***SCDOT Project #: P041967 and 42454***

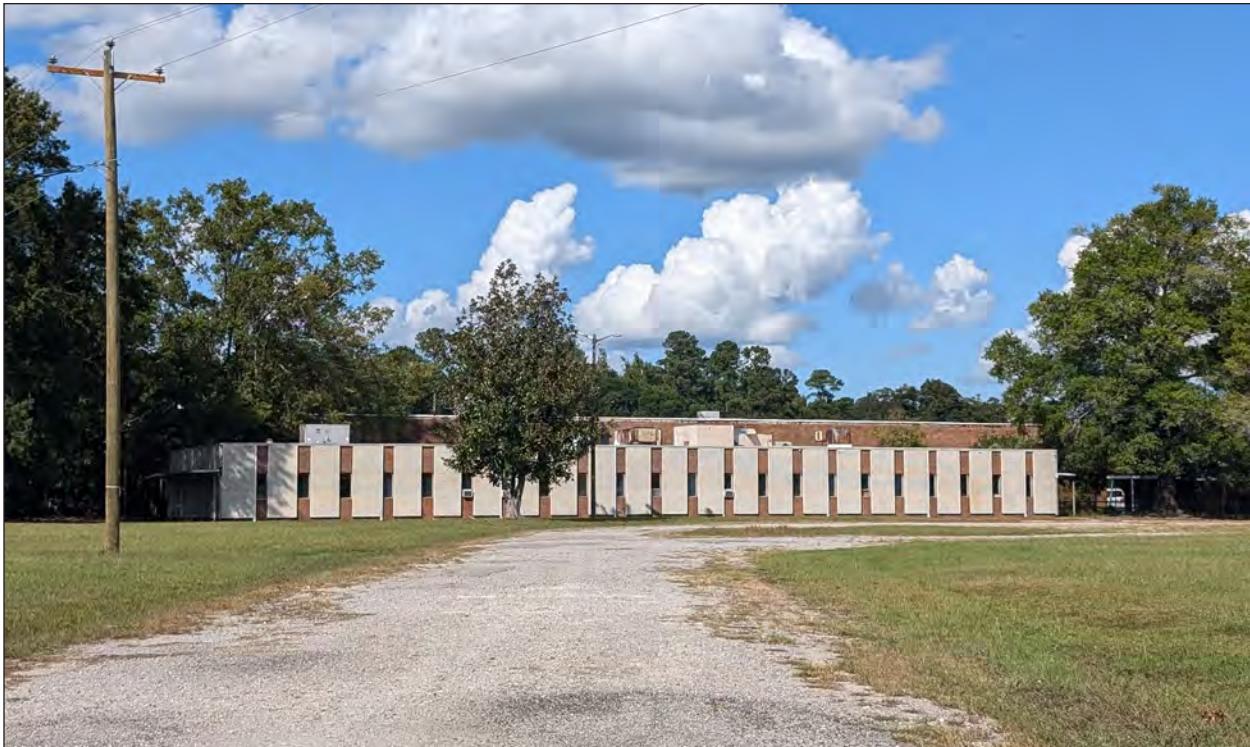
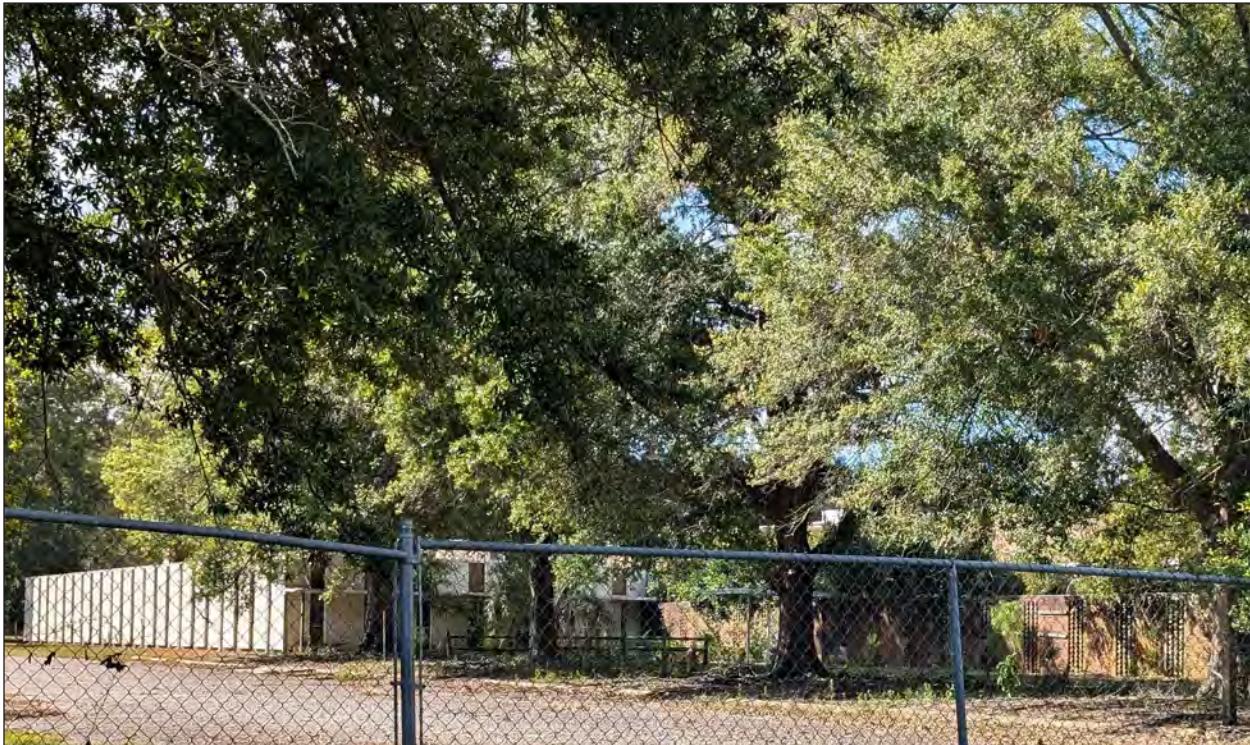
Figure 7.27.  
SHPO Site Number 0514, 1 of 2

A. Façade, Looking North

B. Oblique, Looking Northwest

A three-bay garage/loading dock is attached to the south elevation about 100 feet west of the entry wing. The entry wing and added garage are both standard-height one-story building sections, while the industrial building (core and additions) is one oversized story tall. The remainder of this elevation is unfenestrated, though it does contain an architectural detail wherein the downspouts (spaced approximately every 40 feet) are flanked by vertical rows of protruding stretcher bricks. This detail is also visible on the east and north (rear) elevations, though the downspouts on those sides of the building have been removed; while it may be present on the core's west elevation, that side is not visible from the ROW.

SHPO Site Number 0514 was evaluated for the NRHP under Criteria A, B, and C. Background research did not indicate that the property is associated with historically significant events or persons. The constant change of tenants meant that no particular person or company has had a lasting association with the building. In the present day, the former employee parking lot is overgrown, and only a small portion of the building appears to be occupied and used by BRN Sleep Products. Additionally, an effort designed to draw industry to the area led by the Orangeburg Industrial Development Co. in the late 1950s and early 1960s resulted in the construction of more than a dozen large industrial operations in Orangeburg County. As such, SHPO Site Number 0514 was not the sole result of those efforts, nor did it become a notable economic driver for the area (The Times and Democrat 1962, 1963). Therefore, the resource is recommended not eligible for the NRHP under Criteria A or B.

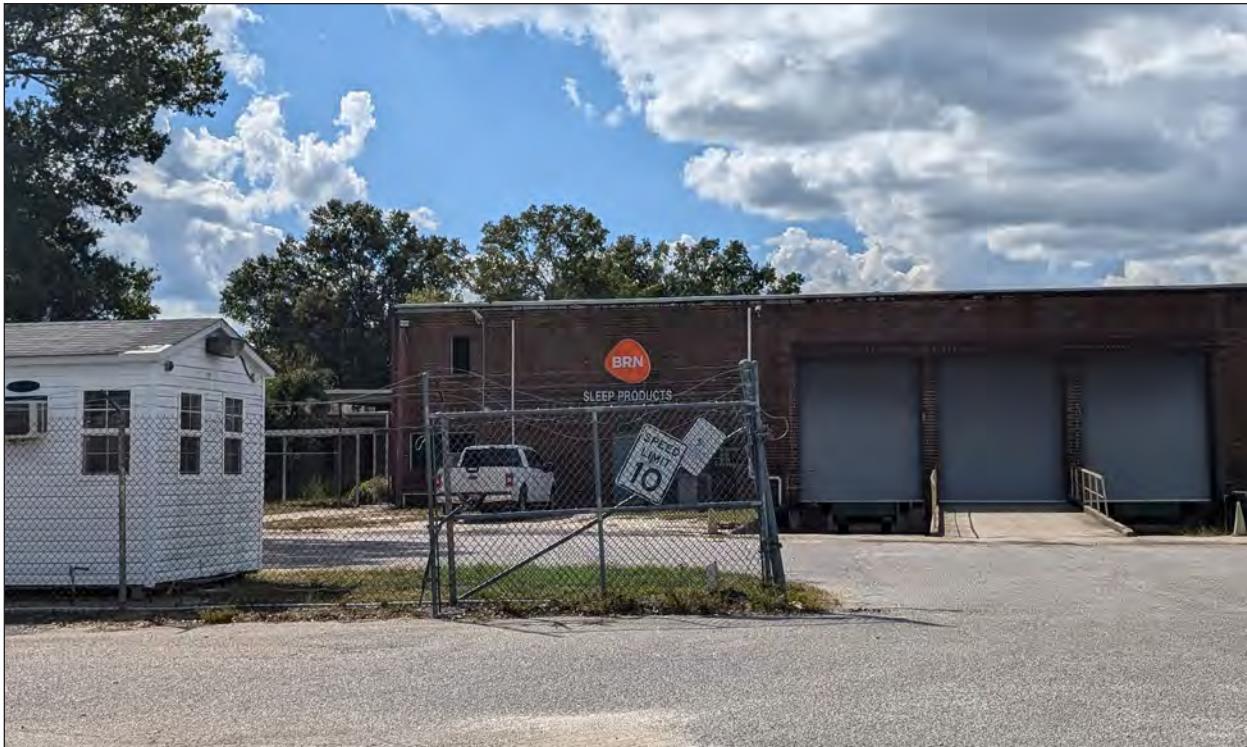
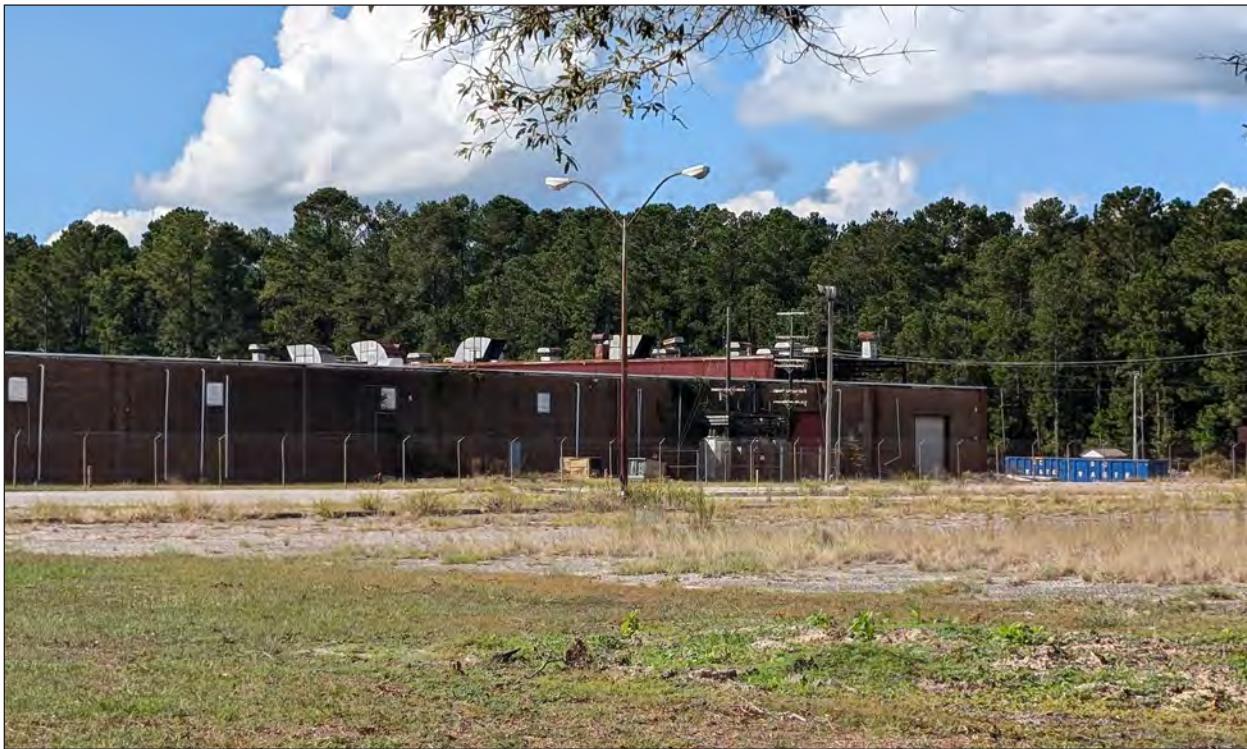
Figure 7.28.  
SHPO Site Number 0514, 2 of 2

A. East Elevation, Looking West

B. East Elevation, Looking Northwest

Under Criterion C, the building was evaluated for its significance in the area of architecture. Despite an original design that was meant for expansion, the level of alteration to the building makes it difficult to tell which portions are original. The building's original Modernist design elements, moreover, are impacted by the non-original portions of the building, such that the original, central orientation of the entry wing to the industrial building portion, visible in 1963 aerial imagery, and the courtyard's symmetrical landscaping that was visible in 1973 aerial imagery are unreadable. Although it retains integrity of location, setting, and association, these changes significantly affect integrity of design, materials, workmanship, and, to a lesser extent, feeling. Therefore, SHPO Site Number 0514 is recommended not eligible for the NRHP under Criterion C.

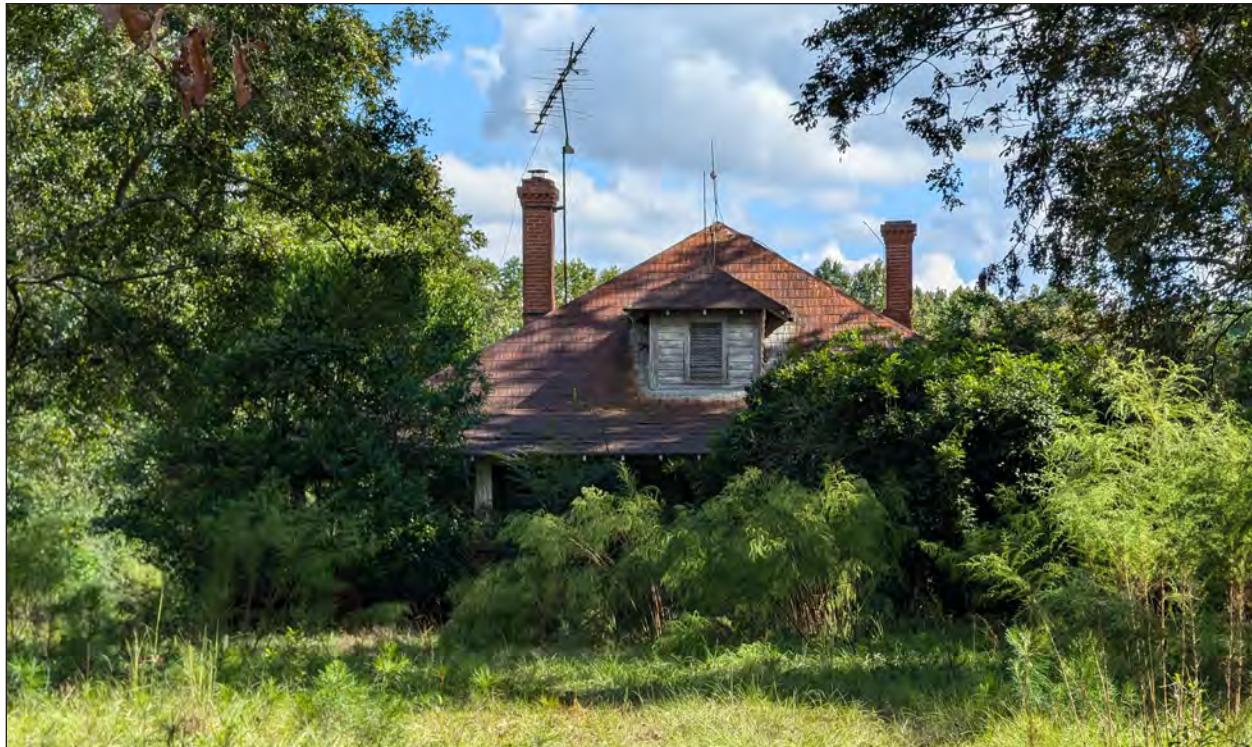
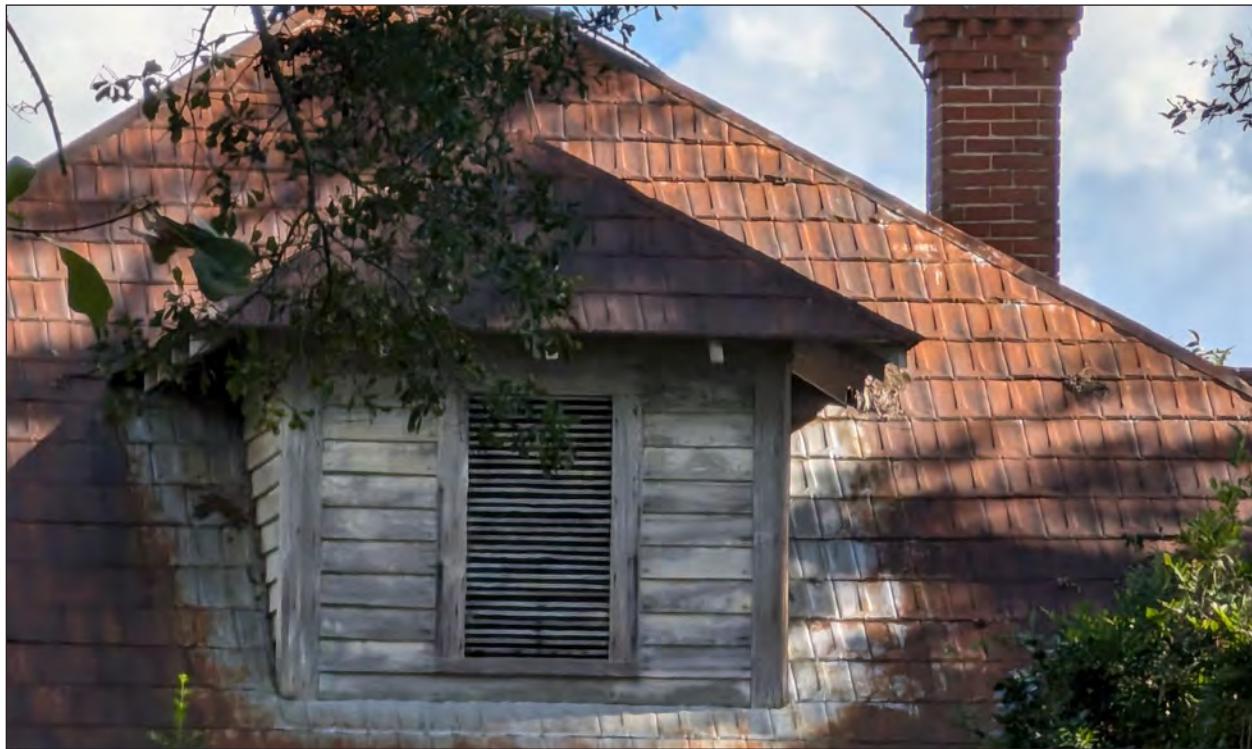
Figure 7.29.  
SHPO Site Number 0515

SHPO Site Number 0515, the Gramling Place House, is a modified pyramidal cottage that faces north from its site on Legendary Road at its intersection with Holbrook Street. The house seems to appear on the 1913 Orangeburg County Soil Survey Map, so based on this, as well as on its form and materials, it is assumed to have been built circa 1900. The house has a pyramidal core roof that extends as a hipped roof above the rear addition, as well as a wraparound hipped porch (both sides), and the continuous roof structure is clad with pressed metal shingles. The foliage surrounding the one-story rectangular house is so dense that the exterior siding type is difficult to discern, but a hipped dormer centered in the front slope has weatherboard siding, so that is likely the material on the rest of the house. The dormer also contains a central rectangular wooden louvre vent, and exposed rafter tails are visible on both the dormer and porch roofs. The porch roof has Craftsman-style supports with paneled and tapered wood columns resting on brick piers, but foliage obscures the actual façade details. Corbelled brick chimneys rise from both side slopes, with the eastern chimney standing several feet above its counterpart (Figure 7.29).

A. Façade, Looking South

B. Façade Detail, Looking South

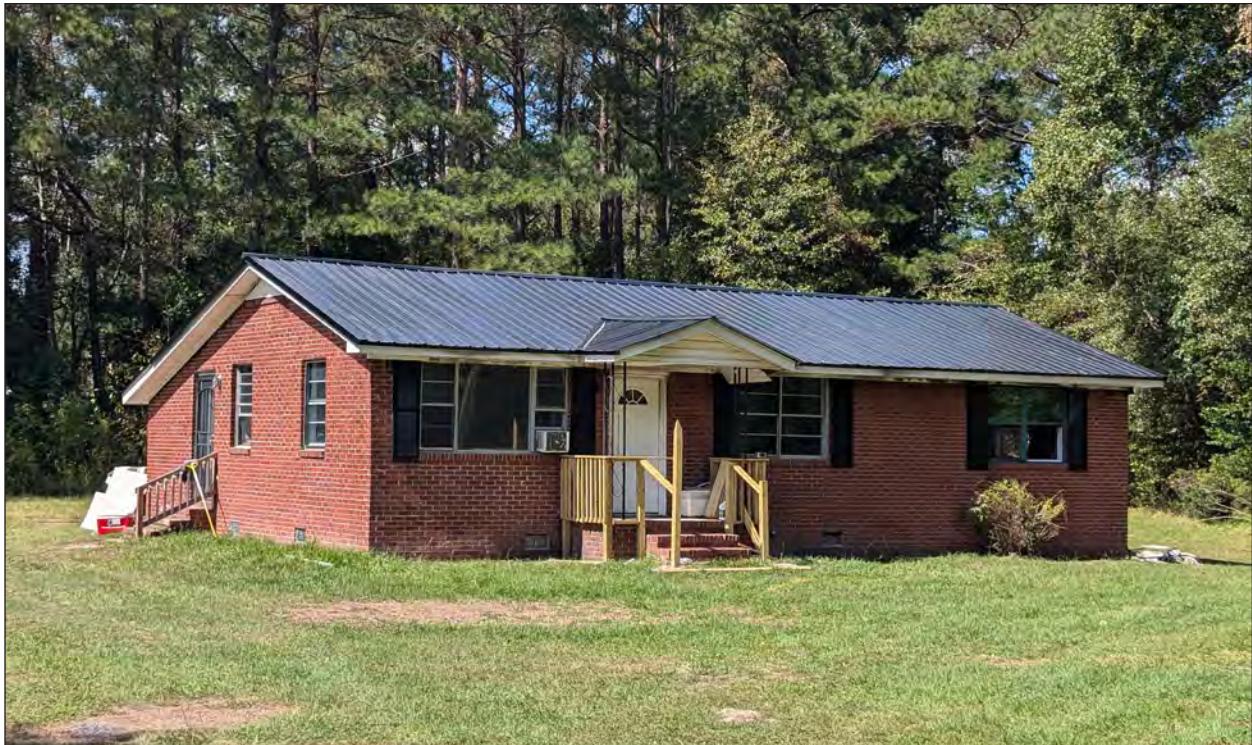
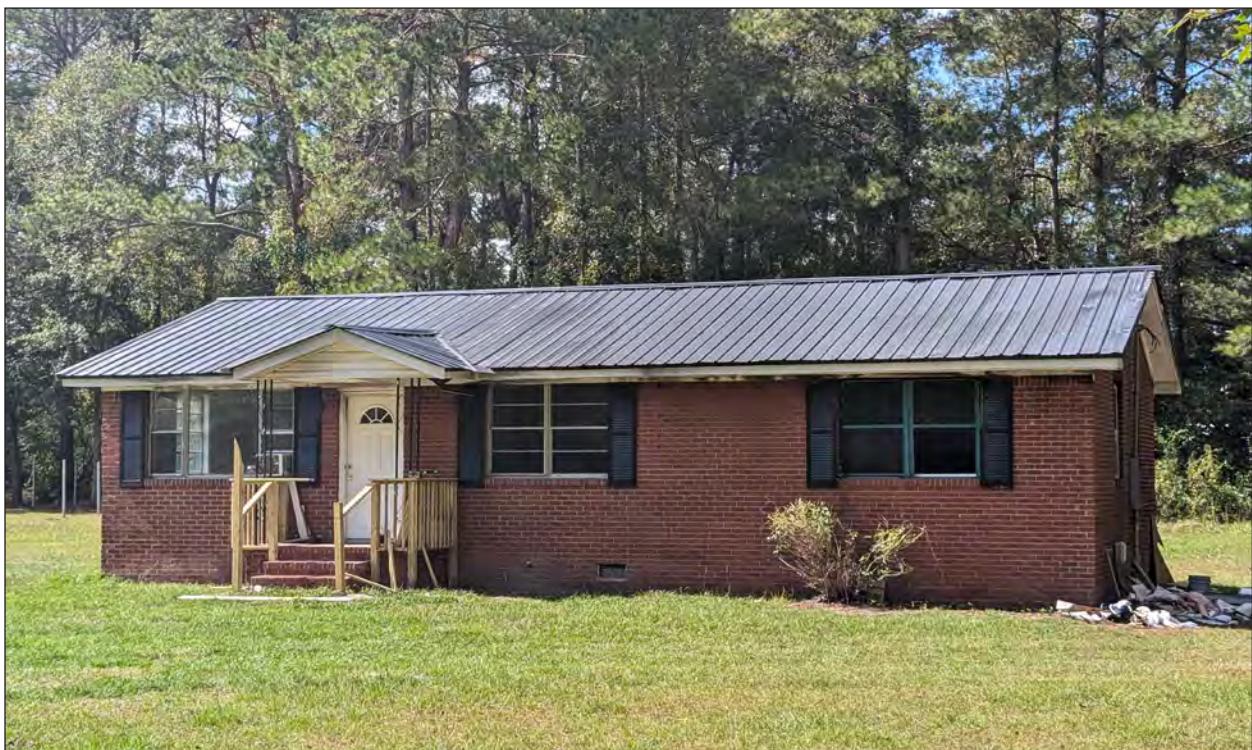
Figure 7.30.  
SHPO Site Number 0516

A. Oblique, Looking Northwest

B. Oblique, Looking Southwest

SHPO Site Number 0516 was evaluated for the NRHP under Criteria A, B, and C. Under Criteria A and B, the resource is not known to be associated with events or persons significant in the past. Under Criterion C, Site Number 0516 was evaluated for significance in the area of architecture. SHPO Site Number 0516 is a Compact Ranch House, but it is not a distinctive or noteworthy example of this house type, which is common in South Carolina. It was not found to embody the distinctive characteristics of a period or method of construction and does not possess significance for its engineering or materials. It does not retain integrity due to alterations that include the added synthetic cladding and replacement doors and windows. Therefore, the resource is recommended not eligible for the NRHP under Criteria A, B, or C.

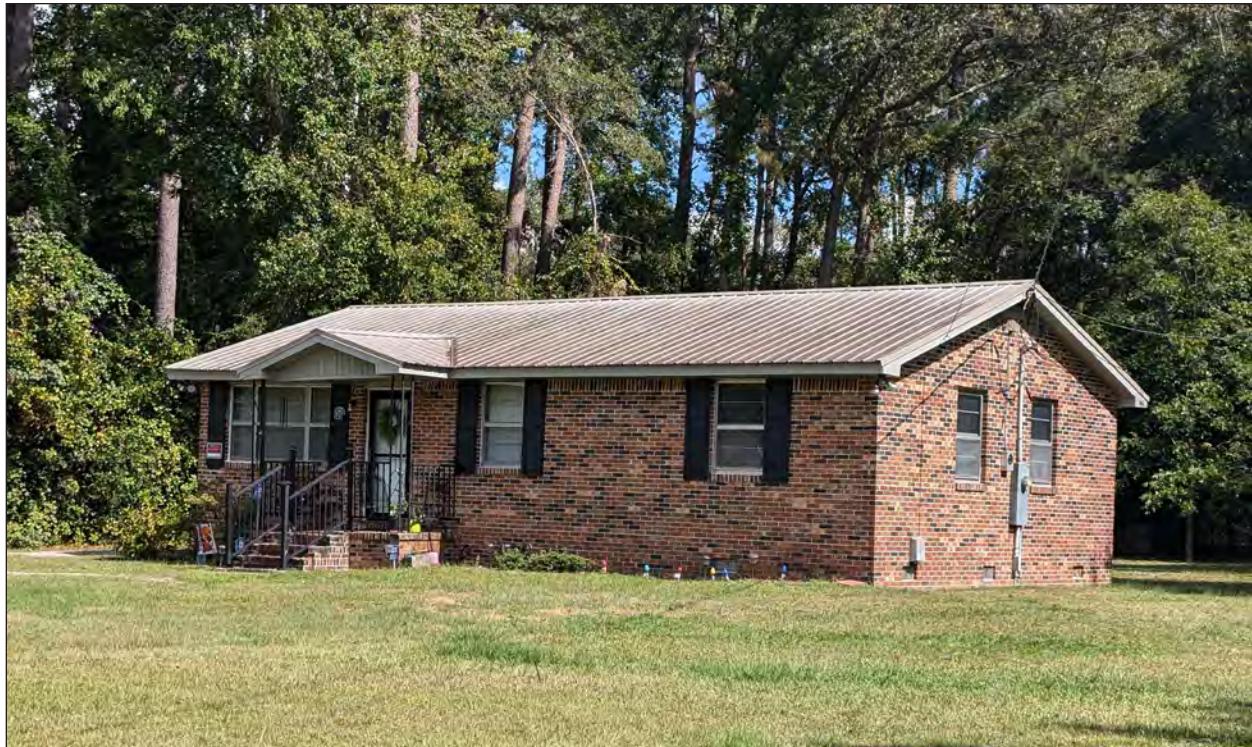
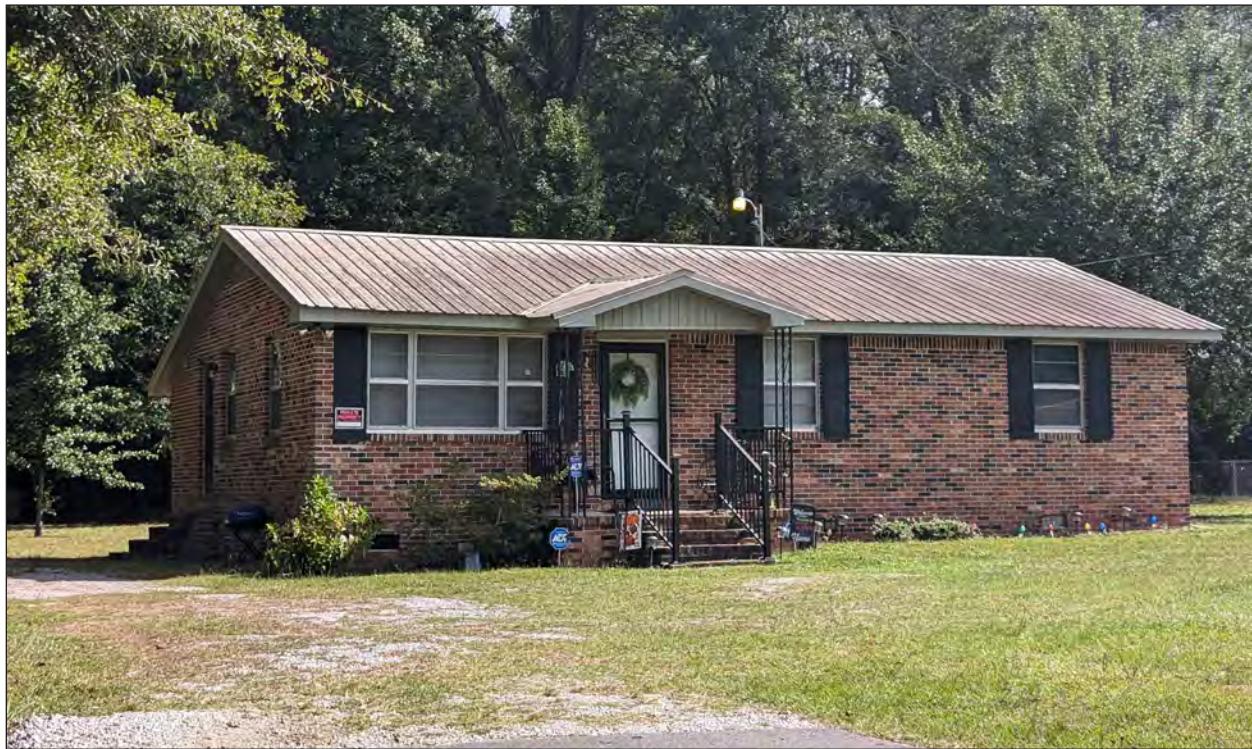
Figure 7.31.  
SHPO Site Number 0517

SHPO Site Number 0517 faces west from its site on Devine Court. The Orangeburg County Tax Assessor records indicate this Compact Ranch House was built in 1974, and, though a 1973 aerial image appears to show a clearing in the woods in the location of this resource, the image does not appear to show a house, so it is assumed to have been built circa 1974. The house has a rectangular footprint with a laterally gabled roof clad in PBR metal panels, and its brick veneer exterior conceals the foundation (Figure 7.31). Observable windows, including the picture window flanked by sash windows located in the northernmost façade bay, are horizontal two-over-two double-hung sash, most likely wood. The raised entrance-bay-only front porch is sheltered by a small gabled roof, and there is an unsheltered side entrance on the north elevation. This elevation has two single windows, while the south elevation has one. The front door is non-historic, and the eaves and porch roof gable end are clad with vinyl and aluminum. SHPO Site Number 0517 is situated on a rectangular 0.52-acre lot. The house has a setback of approximately 65 feet and a large front and rear lawn with a few small trees at the rear.

A. Oblique, Looking Northeast

B. Oblique, Looking Southeast

SHPO Site Number 0517 was evaluated for the NRHP under Criteria A, B, and C. Under Criteria A and B, the resource is not known to be associated with events or persons significant in the past. Under Criterion C, Site Number 0517 was evaluated for significance in the area of architecture. SHPO Site Number 0517 is a Compact Ranch House, but it is not a distinctive or noteworthy example of this house type, which is common in South Carolina. It was not found to embody the distinctive characteristics of a period or method of construction and does not possess significance for its engineering or materials. Therefore, the resource is recommended not eligible for the NRHP under Criteria A, B, or C.

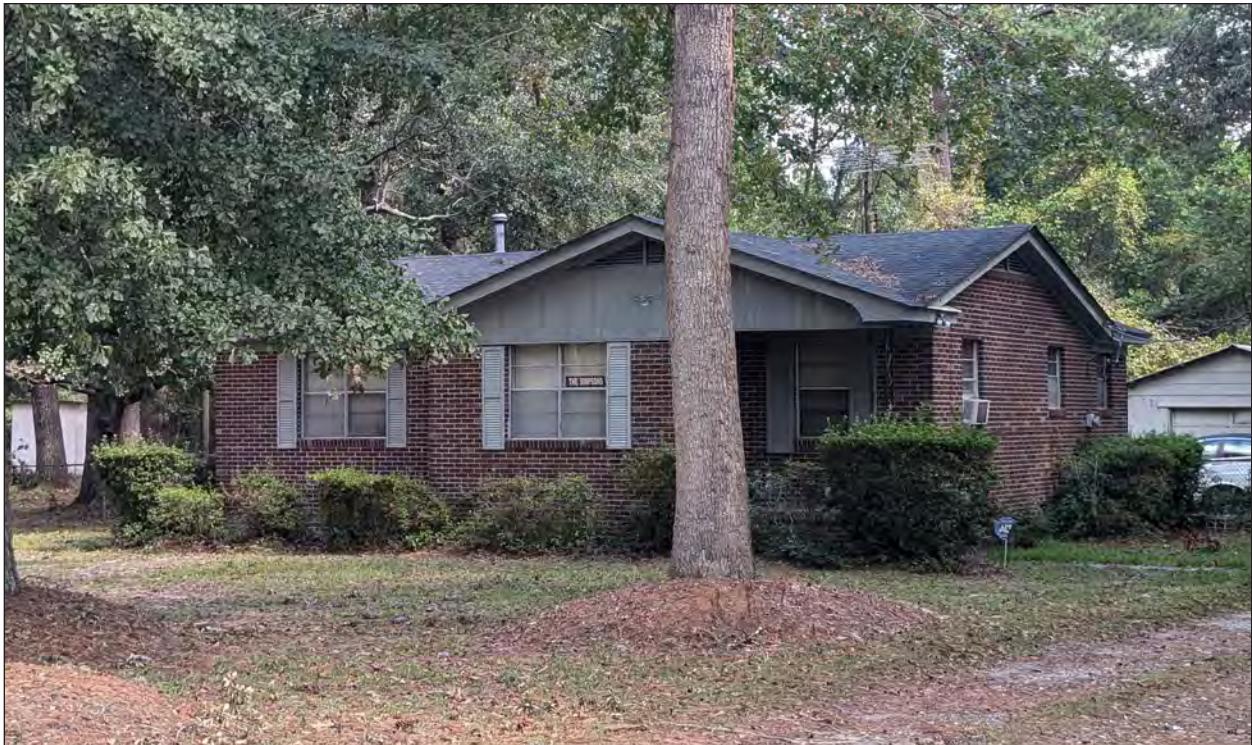
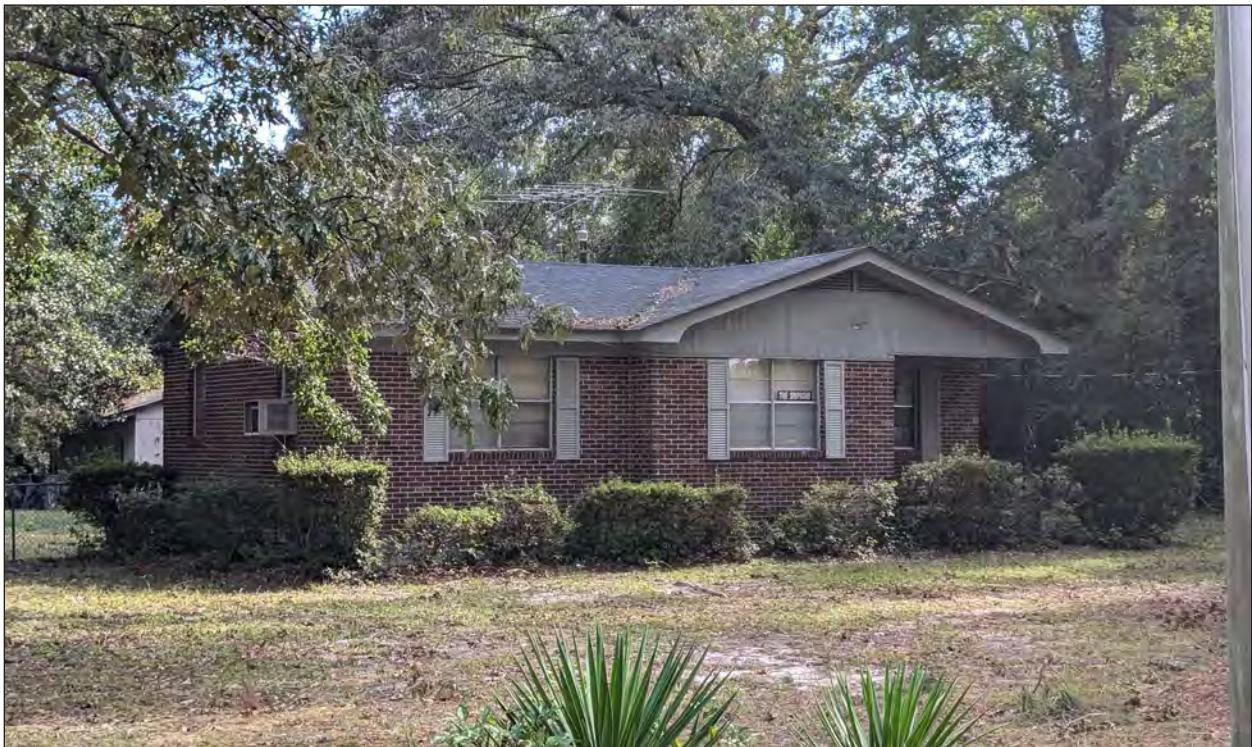
Figure 7.32.  
SHPO Site Number 0518

SHPO Site Number 0518 faces west from its site on Devine Court. The Orangeburg County Tax Assessor records indicate this Compact Ranch House was built in 1965. Aerial imagery from the 1970s is inconclusive, due to tree cover, but the house and its outbuildings are assumed to have been built circa 1965. The house has an irregular T-shaped footprint with a laterally gabled roof that is clad in composition shingles and that has cross-gabled wings on both the front and rear elevations. The area below the front gable is divided between interior space and a small porch that contains a street-facing window and the main entrance that is perpendicularly oriented to the road, such that the door is obscured from the ROW. The raised porch roof is supported at the outer corner by a scrolled metal column, and the face of the front gable is clad in T1-11 plywood. Observable windows throughout the house are horizontal two-over-two double-hung sash, most likely wood, and the façade outside of the porch has two paired sets, while the side elevation windows are all single. The frame house has boxed wood eaves and a brick veneer exterior that conceals the foundation (Figure 7.32).

A. Oblique, Looking Northeast

B. Oblique, Looking Southeast

SHPO Site Numbers 0518–0518.02 were evaluated for the NRHP under Criteria A, B, and C. Under Criteria A and B, the resources are not known to be associated with events or persons significant in the past. Under Criterion C, the resources were evaluated for significance in the area of architecture. Although SHPO Site Number 0518 is a Compact Ranch House, it is not a distinctive or noteworthy example of this house type, which is common in South Carolina. It was not found to embody the distinctive characteristics of a period or method of construction and does not possess significance for its engineering or materials. SHPO Site Number 0518.01 is a garage of no distinct style or type and does not possess significance for its engineering or materials, while SHPO Site Number 0518.02 is a well house of no distinct style or type and does not possess significance for its engineering or materials. Therefore, the resources are recommended not eligible, either individually or collectively, for the NRHP under Criteria A, B, or C.

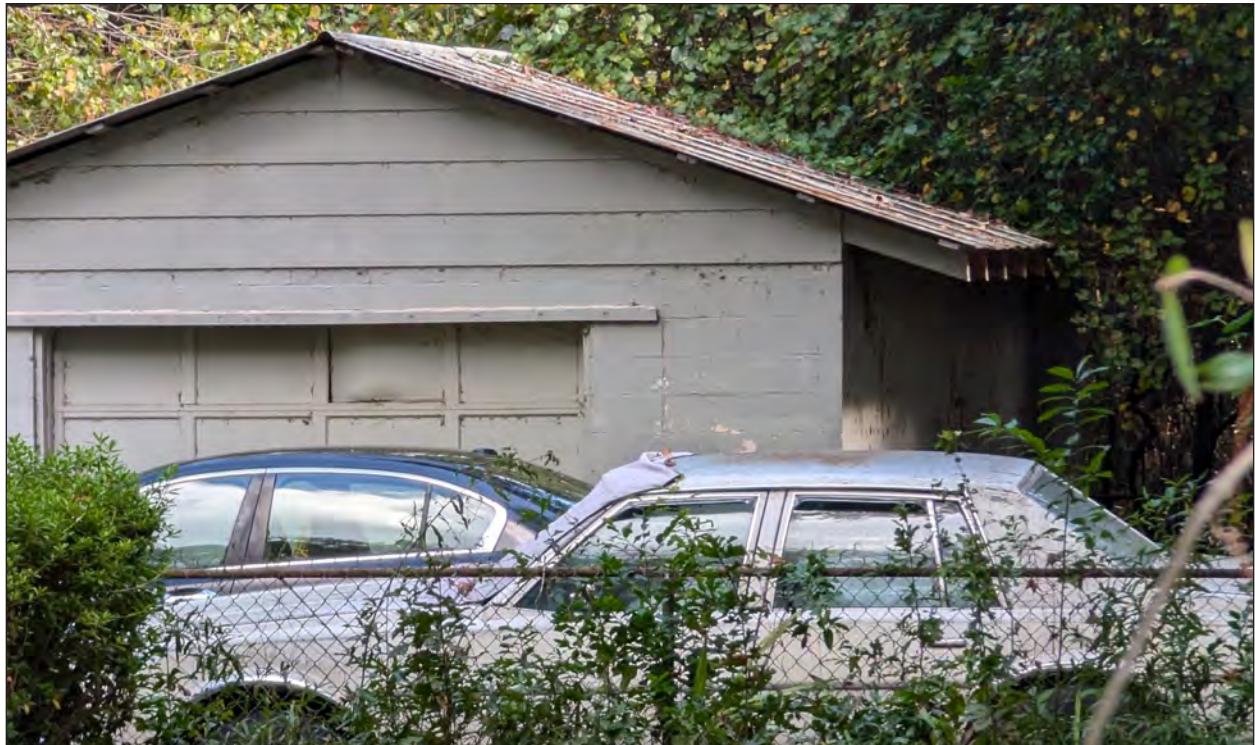
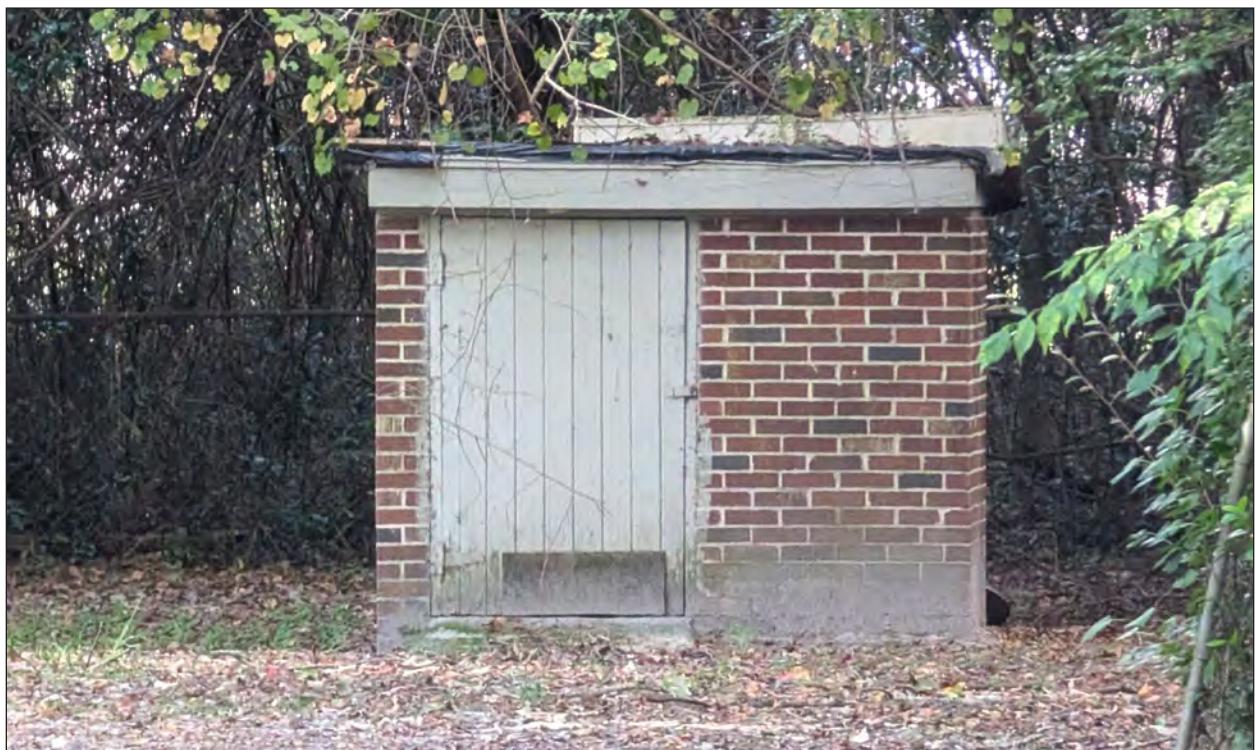
Figure 7.33.  
SHPO Site Numbers 0518.01 and 0518.02

SHPO Site Number 0518.01 is a frame garage that is located approximately 60 feet to the rear of the house. It faces west towards the road, and only the south and west elevations are visible from the public ROW. The concrete-block building is one story tall and rectangular in plan, and it has a front-gabled roof clad in PBR metal panels. A historic wood-paneled garage door is centered in the façade, and the gable end above the door is clad with pressed fiberboard (Masonite) siding. The purlins are visible below the overhanging façade eaves, and exposed rafter tails are visible on the lateral south side. The foundation is not visible, but it is likely on a concrete slab (Figure 7.33a).

SHPO Site Number 0518.02 is a well house located approximately 20 feet south of SHPO Site Number 0518.01. This small, rectangular brick building is consistent in style and materials with the main house. The shed roof slopes to the rear, so the covering is not visible, nor is the foundation, though it is likely on a slab (Figure 7.33b).

A. SHPO Site Number 0518.01, Looking Northeast

B. SHPO Site Number 0518.02, Looking East

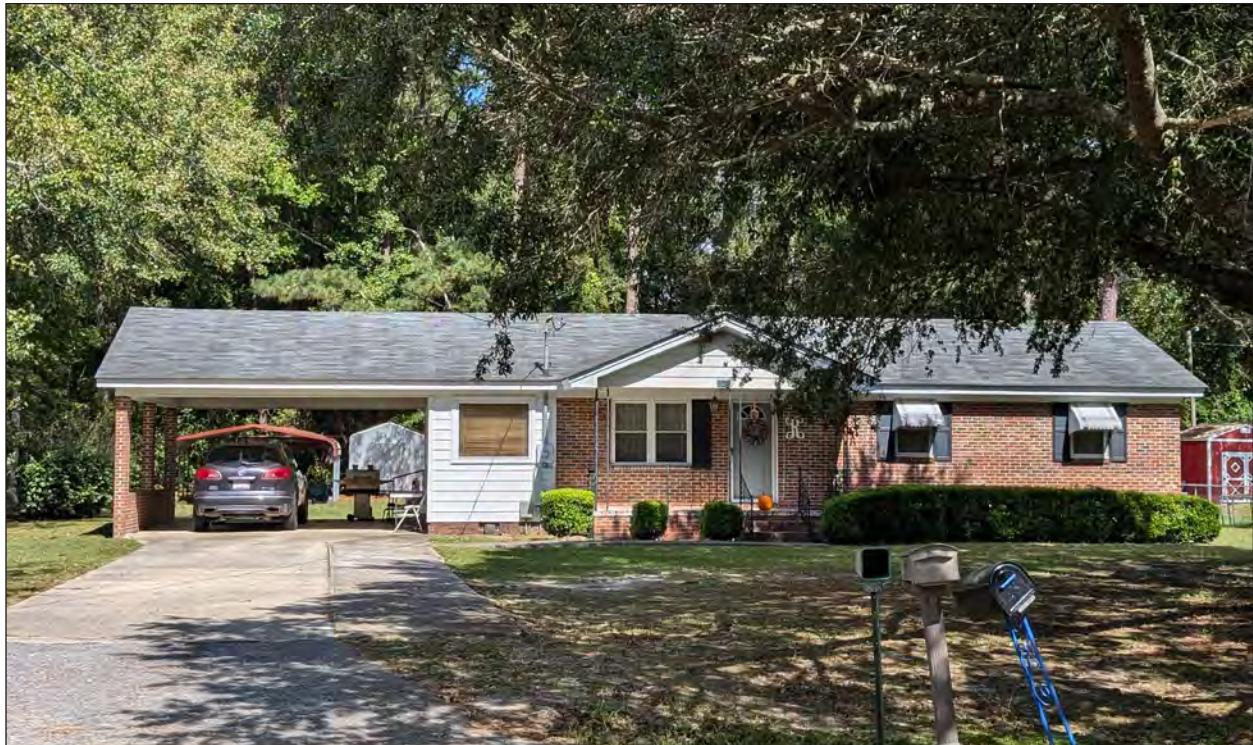
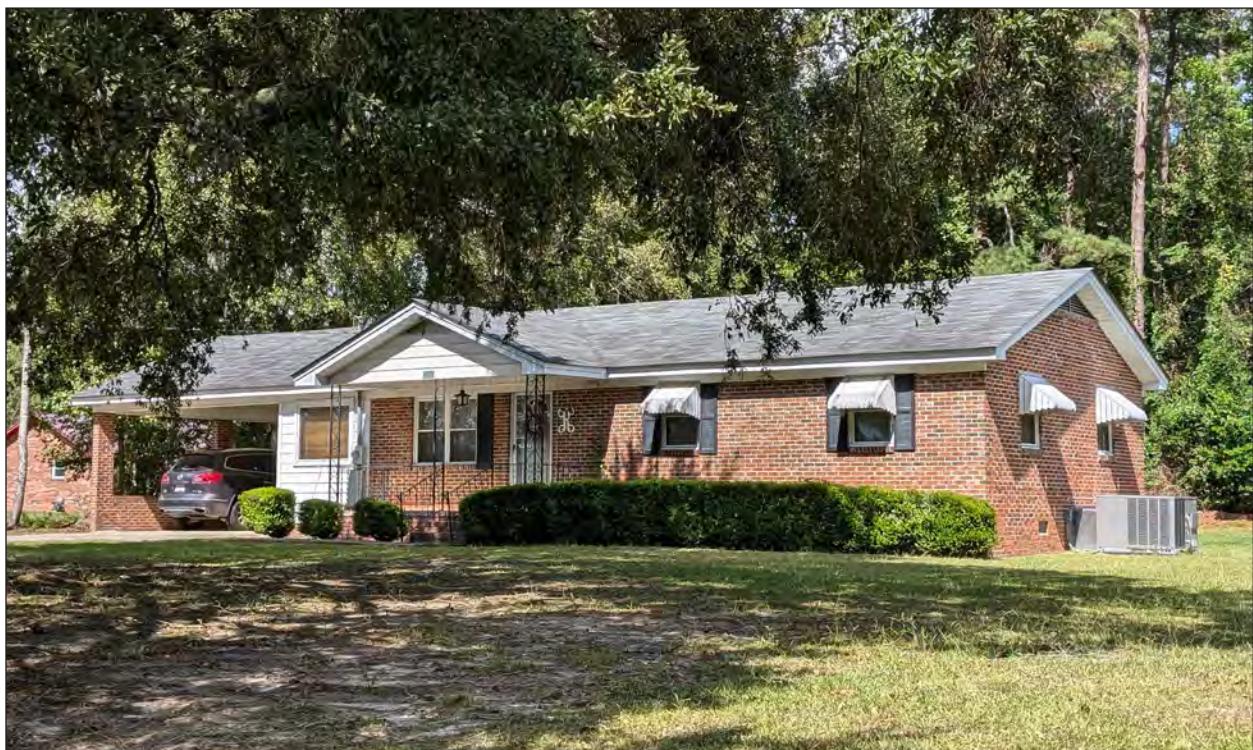
Figure 7.34.  
SHPO Site Number 0519

A. Façade, Looking North

B. Oblique, Looking Northwest

SHPO Site Number 0519 was evaluated for the NRHP under Criteria A, B, and C. Under Criteria A and B, the resource is not known to be associated with events or persons significant in the past. Under Criterion C, Site Number 0519 was evaluated for significance in the area of architecture. Although SHPO Site Number 0519 is a modified Compact Ranch House, it is not a distinctive or noteworthy example of this house type, which is common in South Carolina. As a result, it was not found to embody the distinctive characteristics of a period or method of construction and does not possess significance for its engineering or materials. It does not retain integrity due to alterations that include the addition, replacement windows and doors, and added synthetic cladding. Therefore, the resource is recommended not eligible for the NRHP under Criteria A, B, or C.

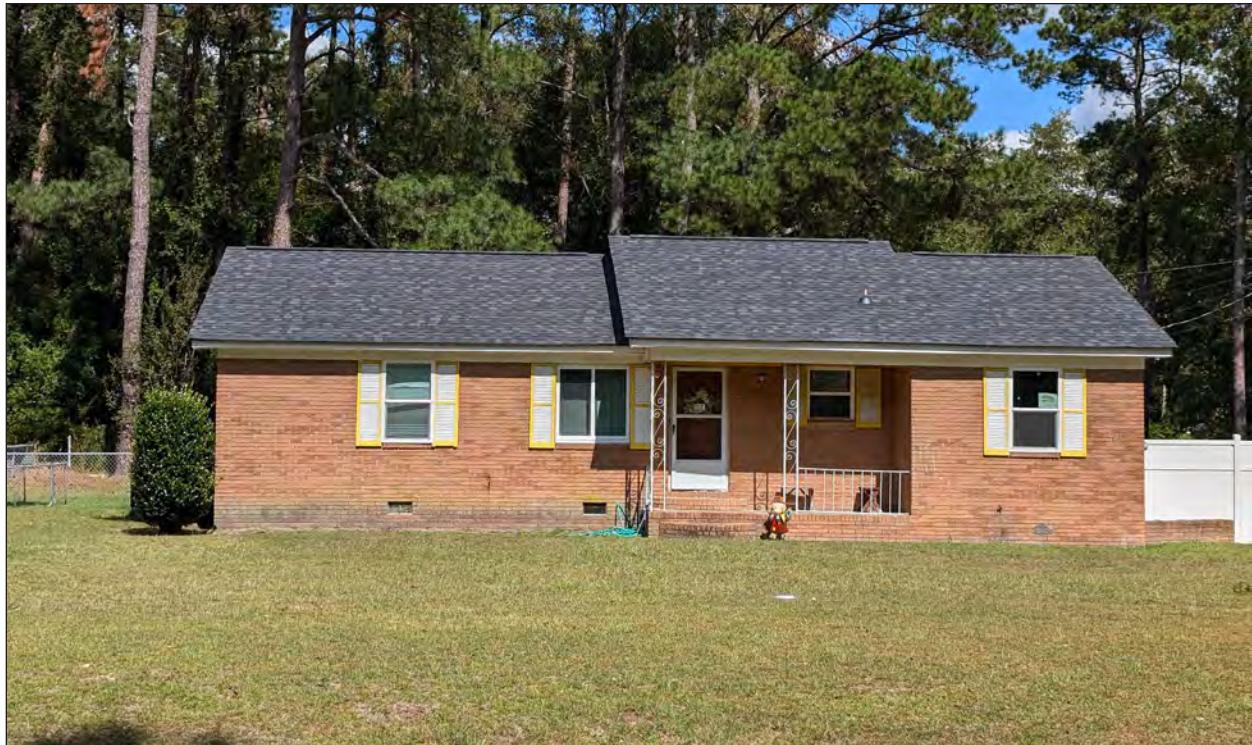
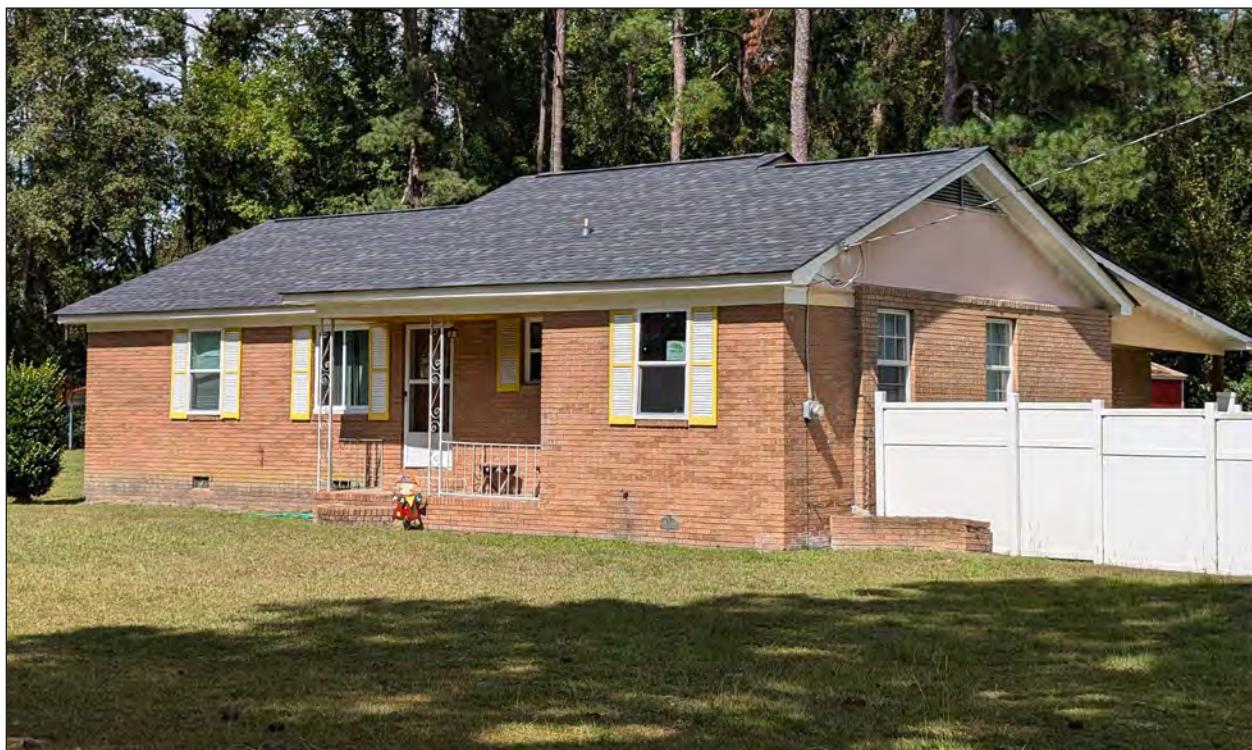
Figure 7.35.  
SHPO Site Number 0520

A. Façade, Looking North

B. Oblique, Looking Northwest

SHPO Site Number 0520 was evaluated for the NRHP under Criteria A, B, and C. Under Criteria A and B, the resource is not known to be associated with events or persons significant in the past. It was evaluated under Criterion C for significance in the area of architecture. Although SHPO Site Number 0520 is a Compact Ranch House, it is not a distinctive or noteworthy example of this house type, nor was it found to embody the distinctive characteristics of a period or method of construction. The house does not possess significance for its engineering or materials, and it does not retain integrity due to alterations that include the addition, replacement windows and doors, and added synthetic cladding. Therefore, the resource is recommended not eligible for the NRHP under Criteria A, B, or C.

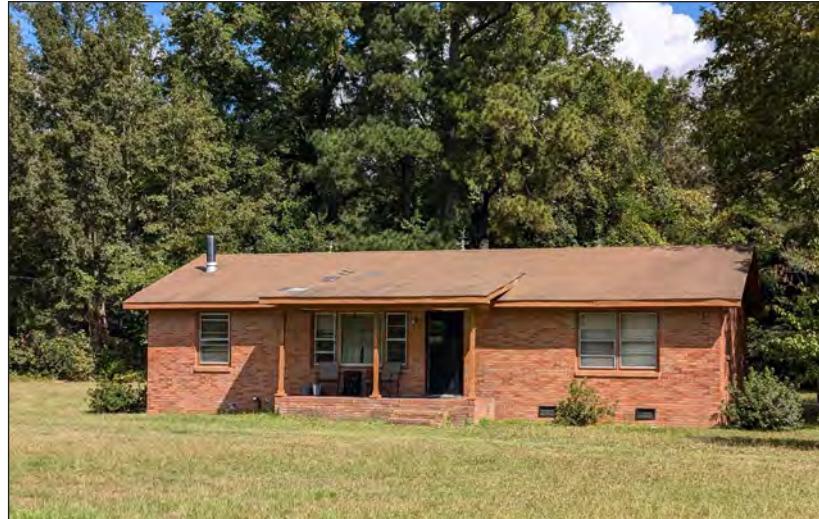
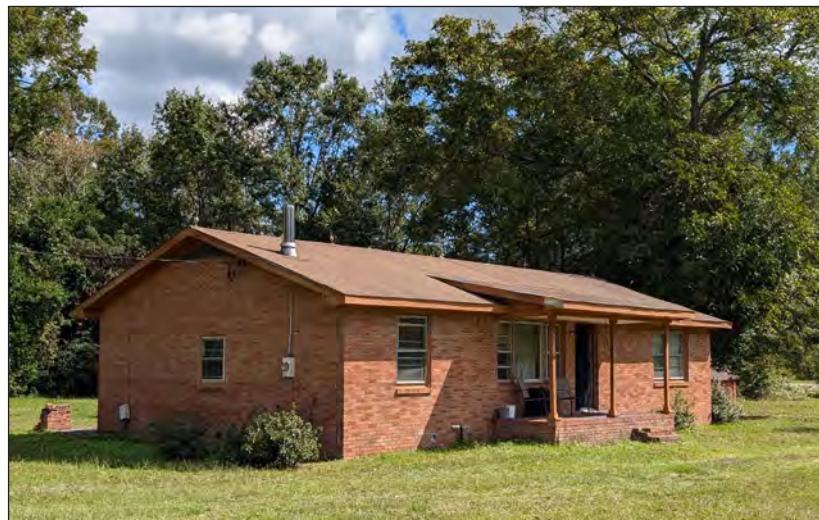
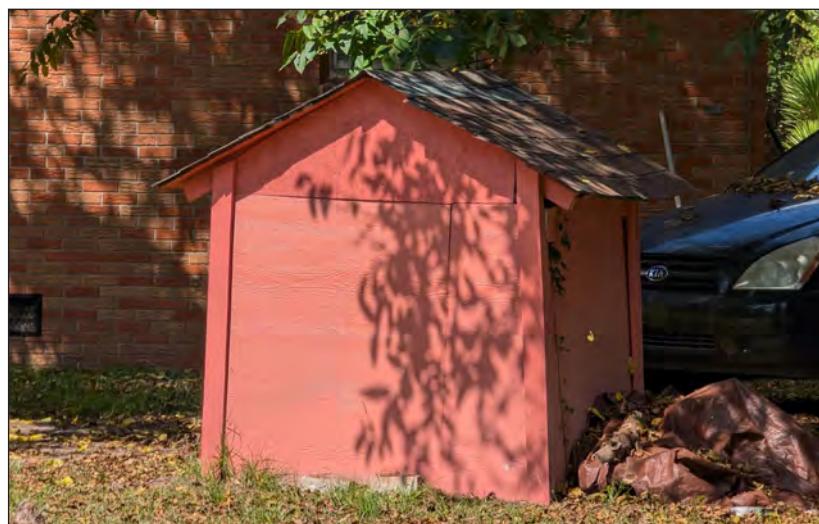
Figure 7.36.  
SHPO Site Numbers 0521 and 0521.01

SHPO Site Number 0521 faces southwest from its site at the intersection of Gramling Road and Devine Court. The Orangeburg County Tax Assessor records indicate this Compact Ranch House was built in 1972, and it is visible in February 1973 aerial photography, so it is assumed to have been built circa 1972. The house is oriented towards the corner rather than towards either street, which is often a common trait for corner houses in Ranch subdivisions, though it is the only diagonally oriented house in this neighborhood. The frame house has a rectangular footprint with a laterally gabled roof clad in composition shingles and a brick veneer exterior that conceals the foundation (Figure 7.36a and b). A shed roof extends from the main roof to cover the raised porch that spans the central bays. The porch contains the main entry (right side) and a single-pane picture window flanked by sash windows. Besides the picture window, observable windows are horizontal two-over-two double-hung sash, most likely wood. The façade outside of the porch has a single and a paired set, while windows on the rear and side elevations are all single. The house has boxed wood eaves, and the porch roof is supported by square wooden posts with trimmed bases. The rear elevation has a ground-level secondary egress that opens onto a small concrete patio.

SHPO Site Number 0521.01 is a well house located approximately 30 feet southeast of the main house. This small frame building has a rectangular footprint and a gabled roof clad in composition shingles, and it has wood corner trim and plywood cladding. The door is presumably on the rear (north elevation), which it is not visible from the ROW. The foundation is not visible (Figure 7.36c).

A. SHPO Site Number 0521,  
Looking North

B. SHPO Site Number 0521,  
Looking East

C. SHPO Site Number 0521.01,  
Looking Northeast

SHPO Site Numbers 0521 and 0521.01 were evaluated for the NRHP under Criteria A, B, and C. Under Criteria A and B, the resources are not known to be associated with events or persons significant in the past. Under Criterion C, the resources were evaluated for significance in the area of architecture. SHPO Site Number 0521 is a Compact Ranch House, but it is not a distinctive or noteworthy example of this house type, which is common in South Carolina. It was not found to embody the distinctive characteristics of a period or method of construction and does not possess significance for its engineering or materials. SHPO Site Number 0521.01 is a well house of no distinct style or type that does not possess significance for its engineering or materials. Therefore, the resources are recommended not eligible, either individually or collectively, for the NRHP under Criteria A, B, or C.
