# **D-1: PHASE I CULTURAL RESOURCES SURVEY**

***RE: Phase I Cultural Resources Survey for the Proposed Widening of I-26 from Mile Marker 145-172, Orangeburg and Dorchester Counties, South Carolina and Phase I Cultural Resources Survey for the Proposed Widening of I-26 from Mile Marker 145 to 172 - ADDENDUM***

***SCDOT Project #: P041967 and 42454***

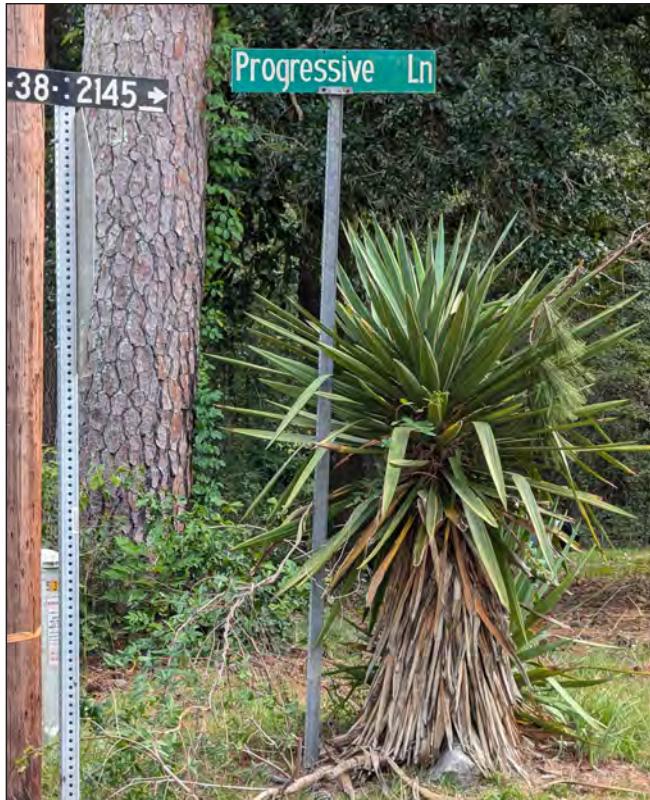
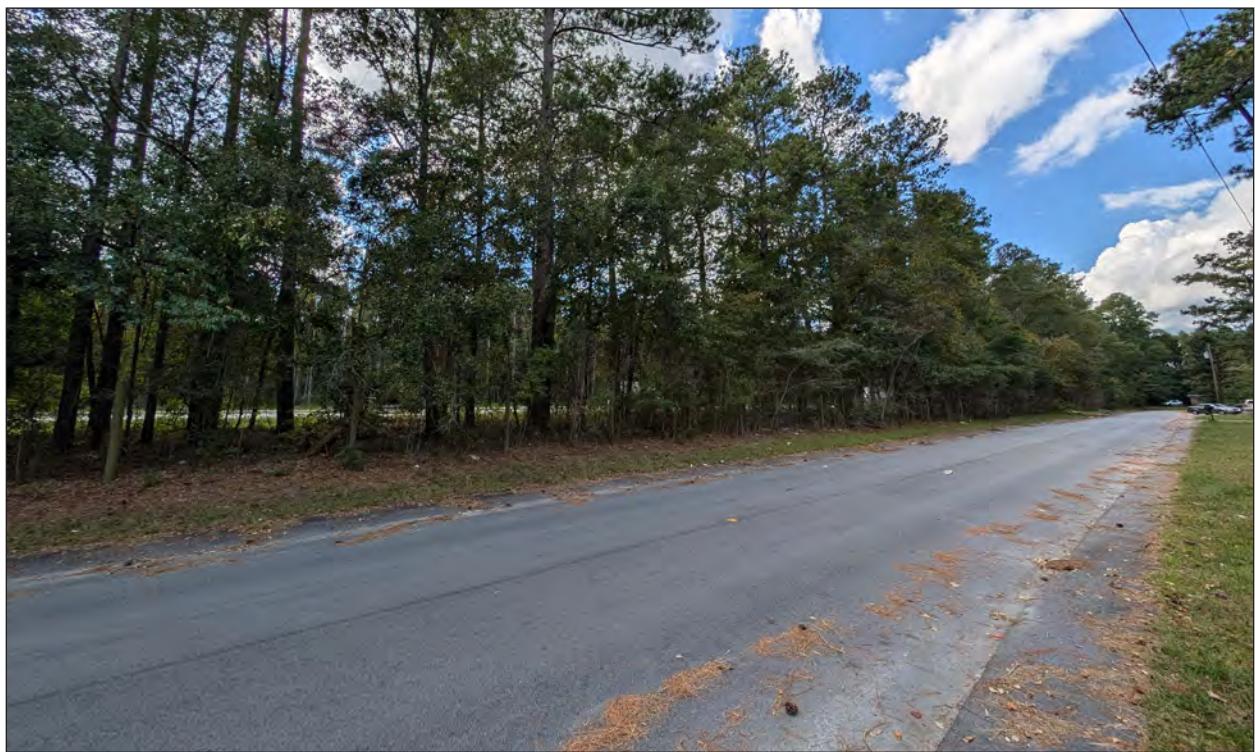
Figure 7.37.  
SHPO Site Number 0522

SHPO Site Number 0522 is the Progressive Lane Subdivision that contains 17 total resources. The subdivision is bounded on the east by Glenzell Road and on the west by I-26, and it includes all of the houses fronting Progressive Lane and the houses on the west side of Glenzell Road between the entrances to Progressive Lane (Figure 7.37). The neighborhood was subdivided and sold to individual buyers by NST Builders beginning in 1970, and 18 houses appear in aerial imagery by 1973, though the house that was across the street from 111 Progressive Lane was demolished between 1983 and 1994 (OCROD 342:255).

A. East Entrance to Progressive Lane  
Subdivision

B. Progressive Lane, Looking West Towards I-26

SHPO Site Numbers 0522-0522.03 were evaluated for the NRHP under Criteria A, B, and C. Background research did not indicate that the subdivision or any of its individual homes are associated with any historically significant events or persons. Therefore, the resources are recommended ineligible under Criteria A and B. Under Criterion C, Ranch house subdivisions are very common in South Carolina, and no individual resource within the Progressive Lane Subdivision was found to embody the distinctive characteristics of a type, period, or method of construction. Many of the individual resources also appear to have been altered with replacement materials, additions, and other modifications. Therefore, the resources are recommended not eligible for the NRHP under Criterion C.

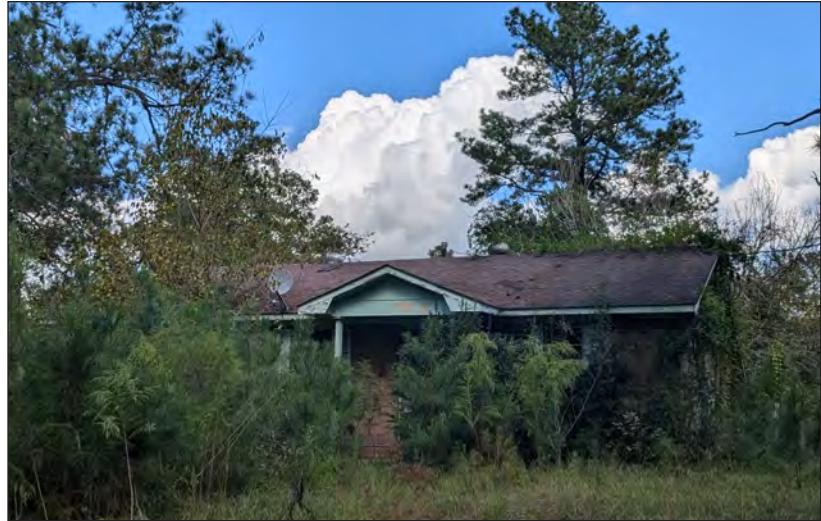
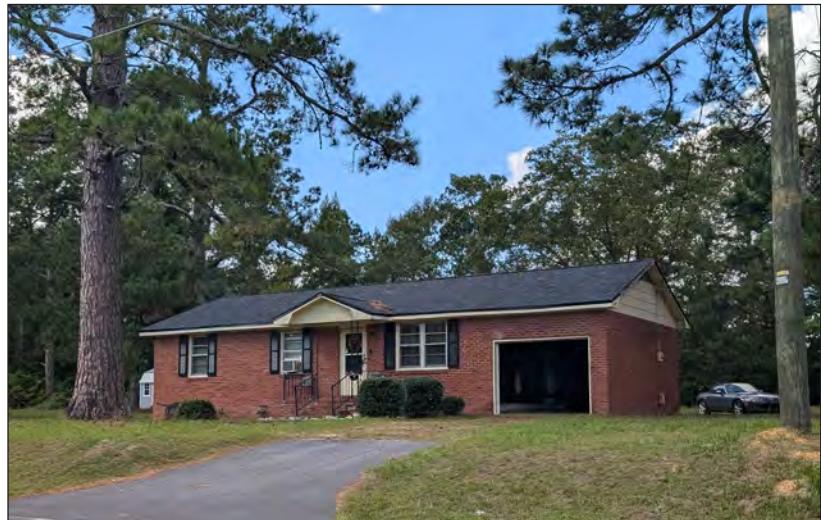
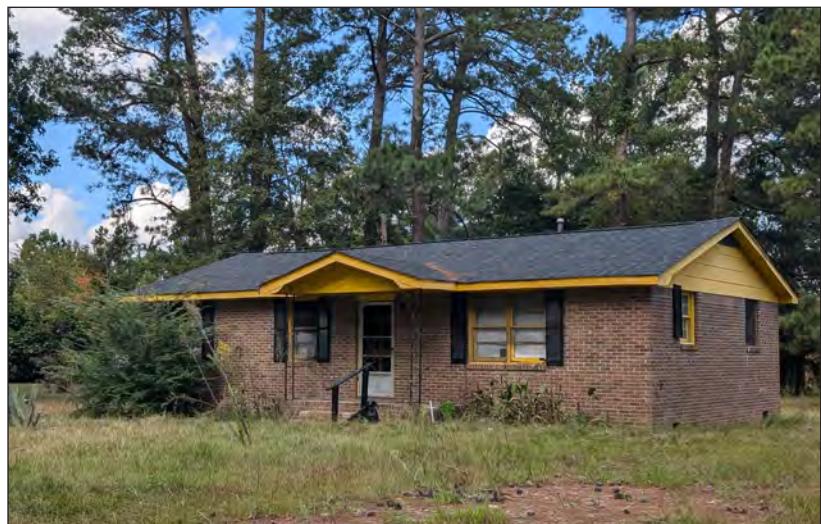
Figure 7.38.  
SHPO Site Numbers 0522.01-0522.03

SHPO Site Number 0522.01 is an example of a house in the Progressive Lane Subdivision without an integral carport/garage that appears to retain most of its original materials (Figure 7.38a). The house retains its original windows, wood eaves, and pressed fiberboard gable-end siding, but it is also one of a few homes that appeared to be vacant during the survey. SHPO Site Number 0522.02 is an example of a house in the Progressive Lane Subdivision with an integral garage that also appears to retain most of its original materials (Figure 7.38b). SHPO Site Number 0522.03 is another example of a house with no garage or carport that appears to retain most of its original materials (Figure 7.38c).

A. SHPO Site Number 0522.01,  
Looking North

B. SHPO Site Number 0522.02,  
Looking West

C. SHPO Site Number 0522.03,  
Looking North

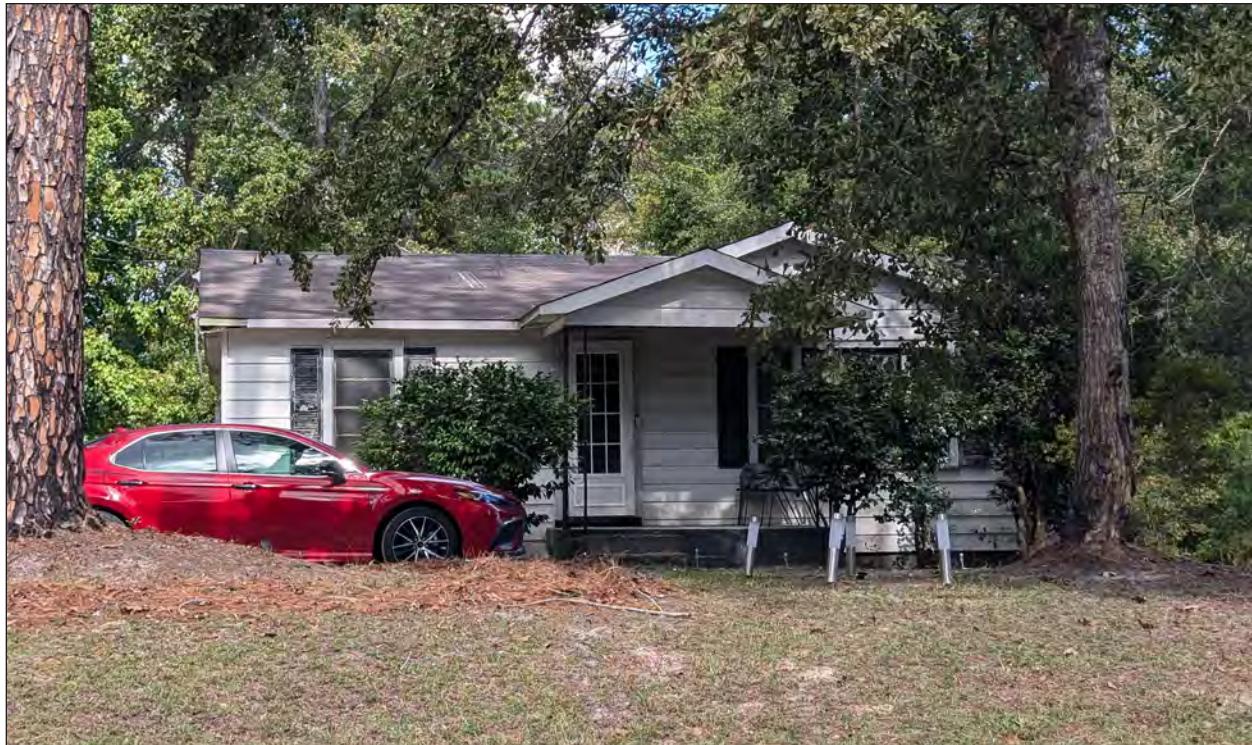
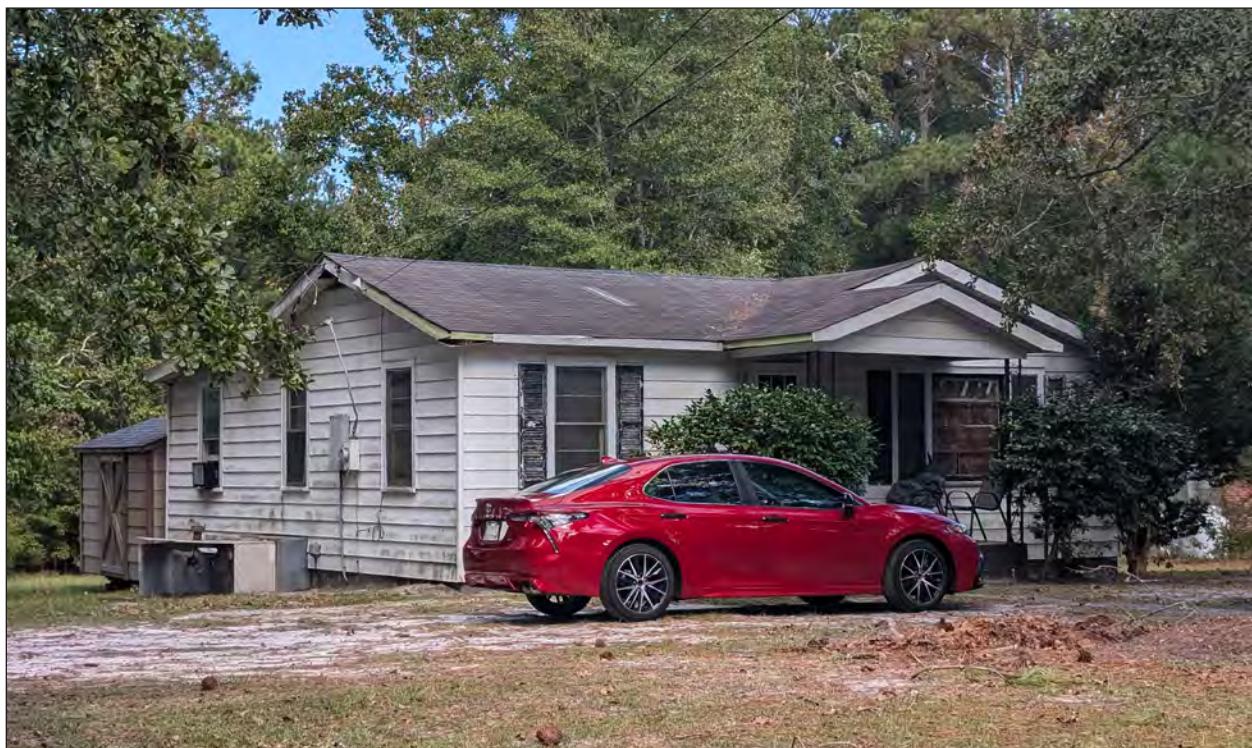
Figure 7.39.  
SHPO Site Number 0523

SHPO Site Number 0523 faces south from its site on Glenzell Road. Orangeburg County Tax Assessor records indicate this Compact Ranch House was built in 1971, and, though a 1973 aerial image is inconclusive, it does seem to appear in 1974 aerial imagery, so it is assumed to have been built circa 1971. The house has a rectangular footprint and a laterally gabled roof clad with composition shingles. Observable windows, including the picture window that is flanked by sash windows, are horizontal two-over-two double-hung wood sash, and the exterior cladding is aluminum, though there is a missing section of siding on the east elevation where the original weatherboard siding is visible. The eaves and window frames are clad in a combination of vinyl and aluminum. The raised front porch is sheltered by a small gabled roof supported on scrolled metal columns, and a cross gable that spans the eastern half of the façade visually pairs with and has the same slope as the porch roof. The picture window is off-center to the right beneath the decorative gable, while the main entry is all the way to the left beneath the porch roof. The front door is obscured by a non-historic storm door, and both the porch and the foundation are concrete block. A single window is situated in the western façade bay, and there are three single windows on the west elevation and two single and one paired set on the east side (Figure 7.39). SHPO Site Number 0523 is situated on a roughly triangular 1.41-acre lot. The house has a setback of approximately 65 feet and front and rear lawns that contain mature trees and camellias, and the deep lot is heavily wooded at the rear.

A. Oblique, Looking Northwest

B. Oblique, Looking Northeast

SHPO Site Number 0523 was evaluated for the NRHP under Criteria A, B, and C. Under Criteria A and B, the resource is not known to be associated with events or persons significant in the past. Under Criterion C, Site Number 0523 was evaluated for significance in the area of architecture. SHPO Site Number 0523 is a Compact Ranch House, but it is not a distinctive or noteworthy example of this house type, which is common in South Carolina. It was not found to embody the distinctive characteristics of a period or method of construction and does not possess significance for its engineering or materials. Therefore, the resource is recommended not eligible for the NRHP under Criteria A, B, or C.

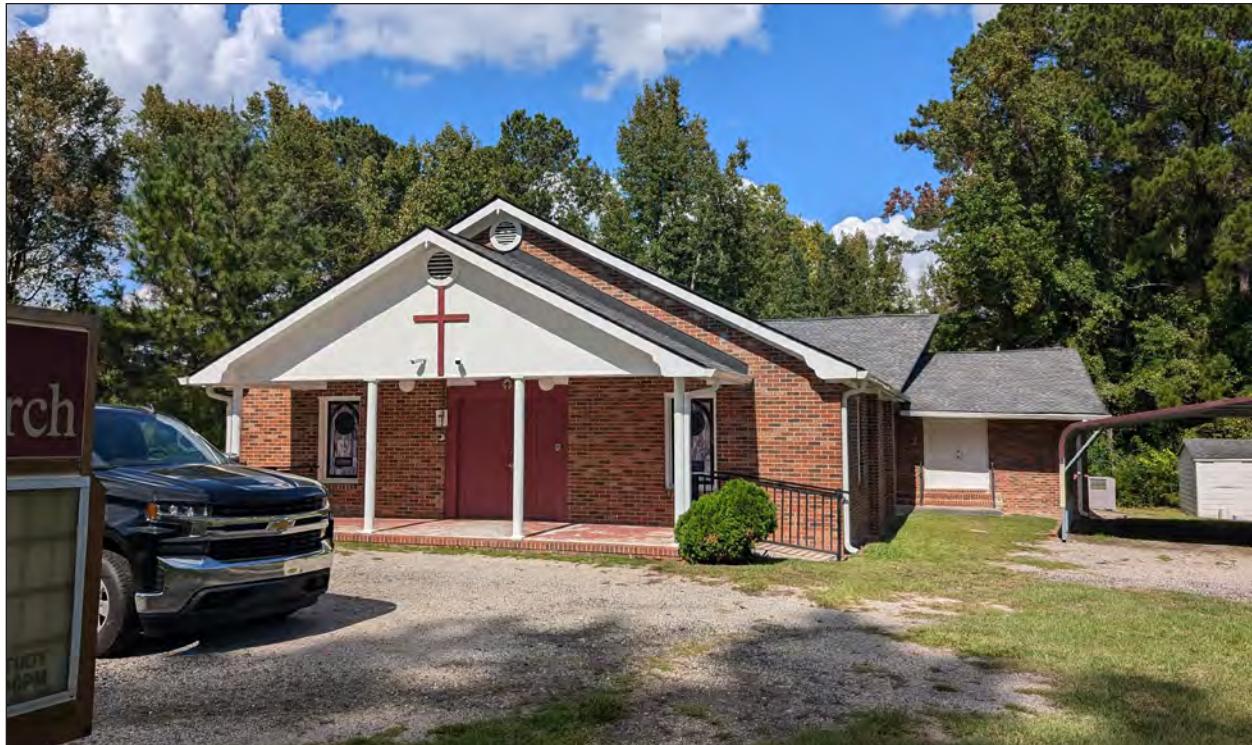
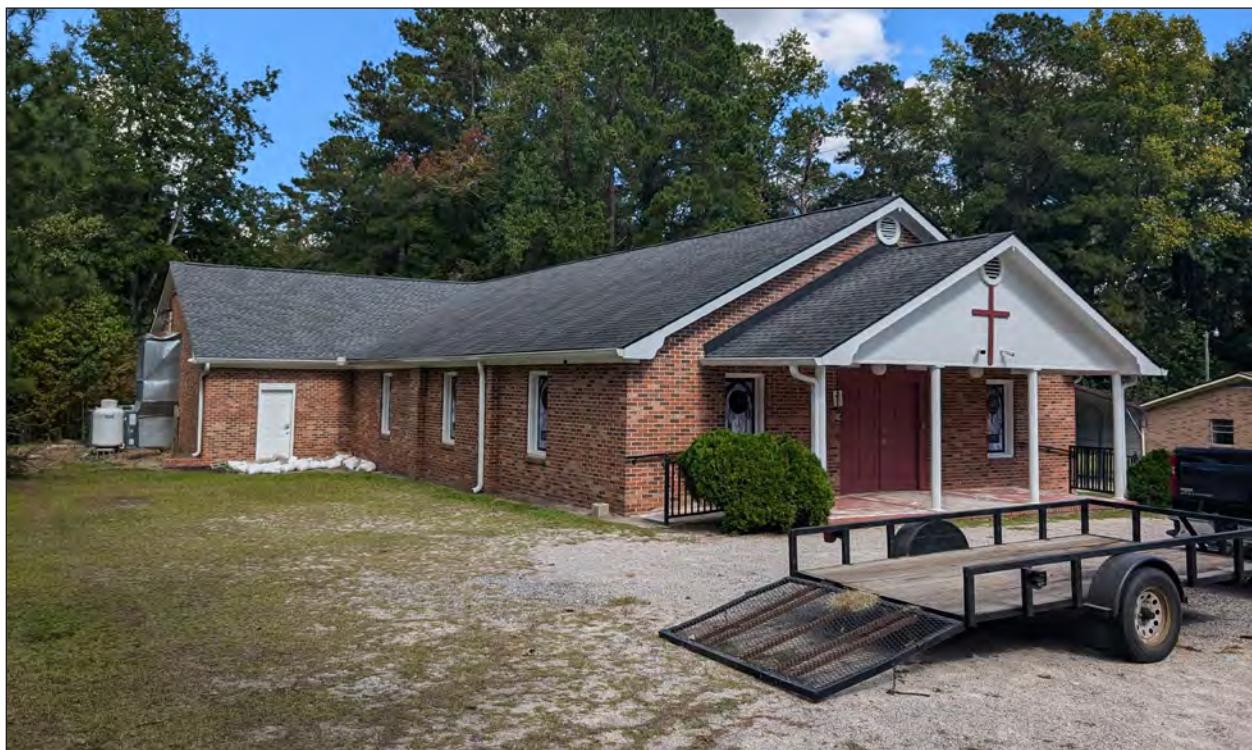
Figure 7.40.  
SHPO Site Number 0524

The one-and-a-half-story T-shaped building has a cross-gabled roof over the main building, a front-gabled porch roof, and an added gabled wing attached to the east elevation of the original core. The building exterior is clad with brick veneer that conceals the foundation, and all three roof structures are clad with composition shingles (Figure 7.40). A central double-leaf wood-paneled door is centered on the façade and is flanked on both sides with rectangular stained-glass windows, and the porch roof gable end is clad in plywood and contains a crucifix with a circular louvered vent above. The porch is slightly raised and has access ramps on both sides, and the roof is supported by fluted vinyl columns. The side elevations of the added cross-gable each have three bays that contain rectangular stained-glass windows, while the façade of the original core contains an entrance with a non-historic door, and the façade of the added east wing contains an entrance with a non-historic double-leaf door. Mechanical equipment is attached to both side elevations. The detached gabled storage building on the east side was constructed sometime after 1983, so it was not assessed (NETRonline 2024).

A. Oblique, Looking Northwest

B. Oblique, Looking Northeast

The church was evaluated under Criterion C for significance in the area of architecture. SHPO Site Number 0524 is not a noteworthy example of a church building, which is a very common building type in South Carolina. It was not found to embody the distinctive characteristics of a period or method of construction and does not possess significance for its engineering or materials, and its integrity is negatively impacted by the 1990s addition on the façade of the original core. Therefore, the resource is recommended not eligible for the NRHP under Criteria A, B, or C.

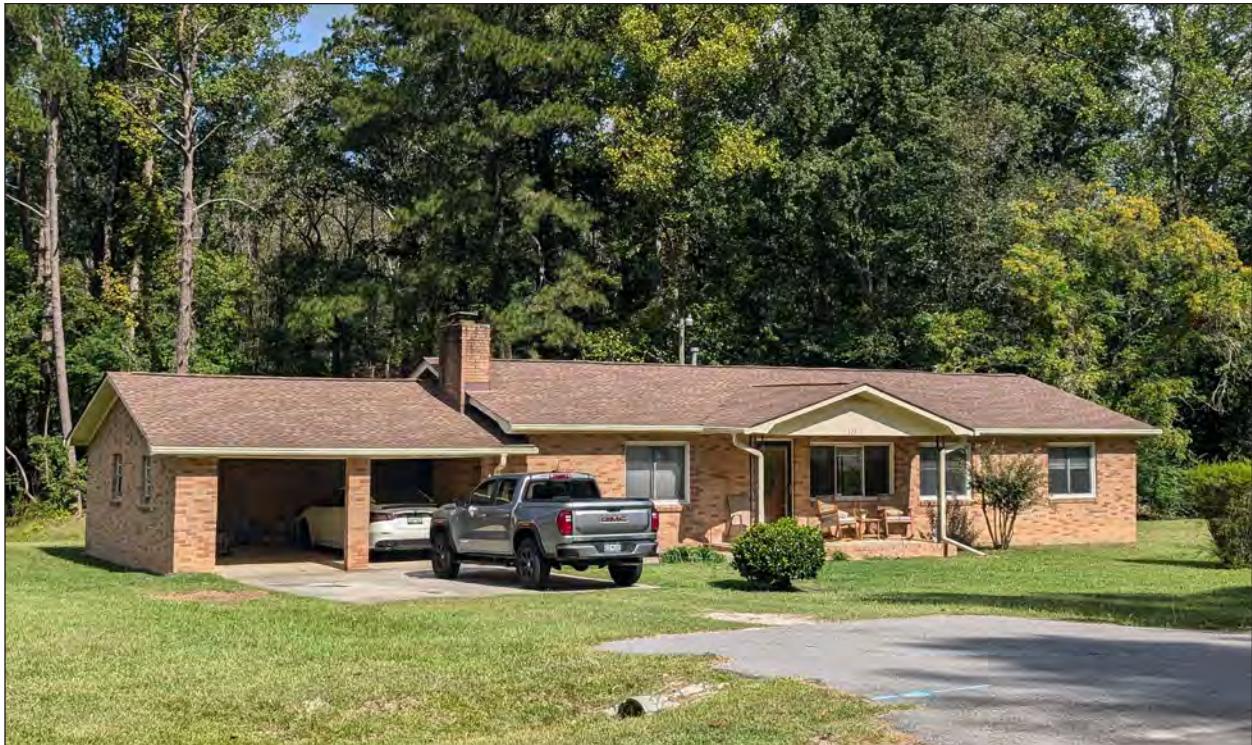
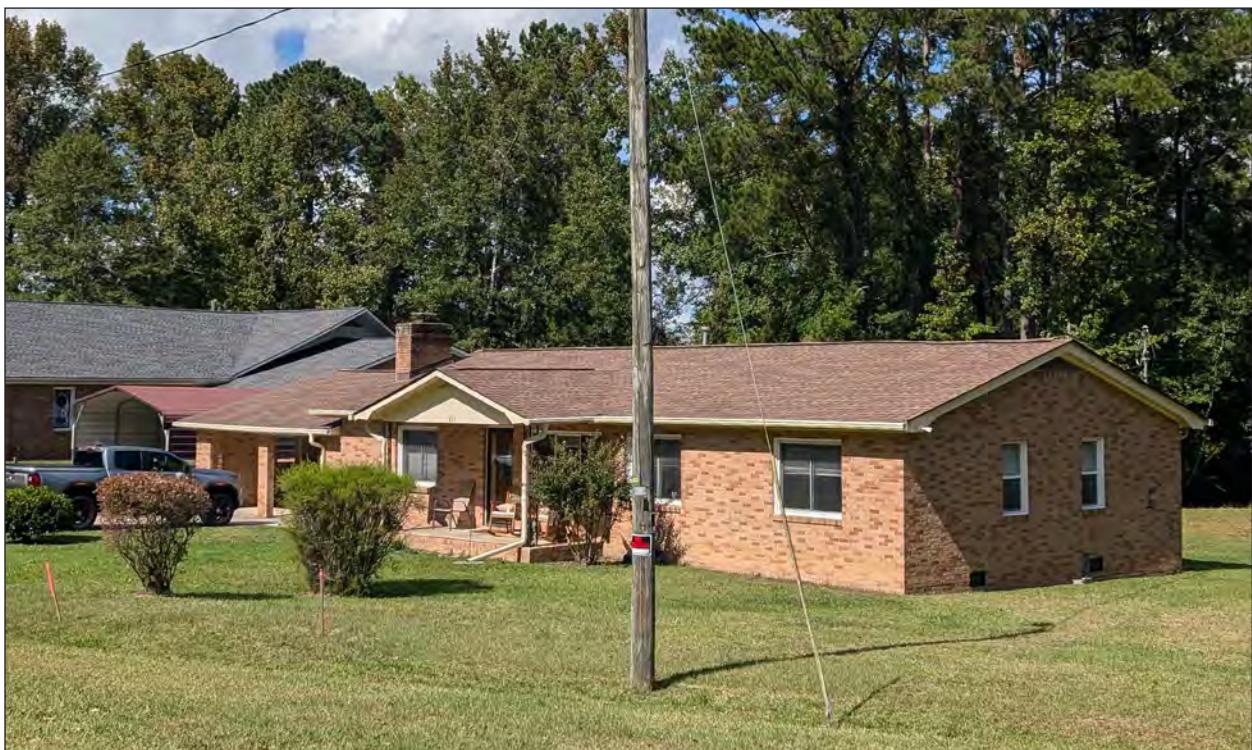
Figure 7.41.  
SHPO Site Number 0525

The frame house has a rectangular footprint with a laterally gabled roof clad in composition shingles and a brick veneer exterior that conceals the foundation (Figure 7.41). A raised porch spans two bays of the five-bay façade and contains the main entry and a triple-pane sliding window. The front porch has a gable roof supported by scrolled metal columns and has T1-11 plywood in the gable end. The other façade bays have two-pane sliding windows, while the east elevation has two single sash windows. The observable windows throughout are non-historic vinyl sashes. The roof over the house stands about a foot above the roof covering the carport. A rectangular brick column divides the carport's two vehicle bays. The carport contains a door into the house and another door into what is most likely a storage room, as well as two sash windows in its exterior (west) wall. An exterior brick chimney at the west end of the original core punctuates both roof structures. SHPO Site Number 0525 is situated on an irregular 1.12-acre lot. The house has a setback of approximately 70 feet, and landscaping includes front and rear lawns and a few scattered shrubs in the front yard.

A. Façade, Looking North

B. Oblique, Looking Northwest

SHPO Site Number 0525 was evaluated for the NRHP under Criteria A, B, and C. Under Criteria A and B, the resource is not known to be associated with events or persons significant in the past. Under Criterion C, SHPO Site Number 0525 was evaluated for significance in the area of architecture. SHPO Site Number 0525 is a modified Linear Ranch House, but it is not a distinctive or noteworthy example of this house type, which is common in South Carolina. It was not found to embody the distinctive characteristics of a period or method of construction and does not possess significance for its engineering or materials, and it does not retain integrity due to alterations that include the carport addition and replacement windows and doors. Therefore, the resource is recommended not eligible for the NRHP under Criteria A, B, or C.

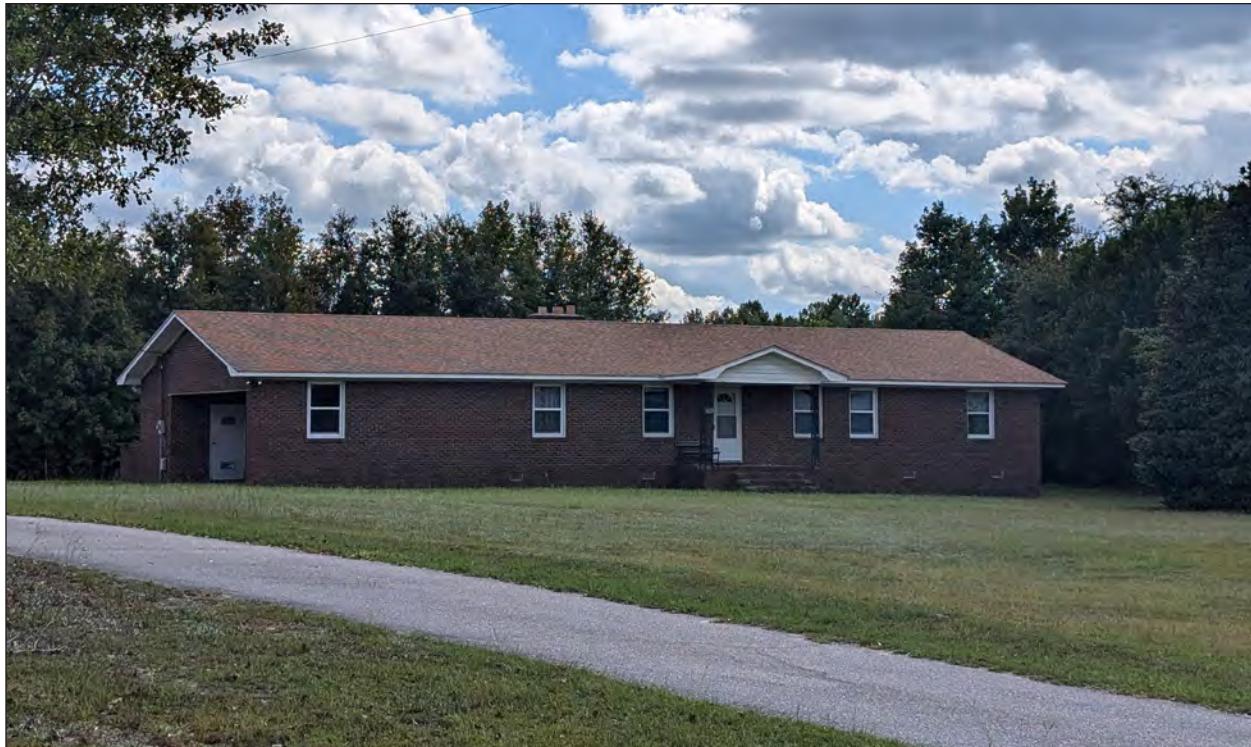
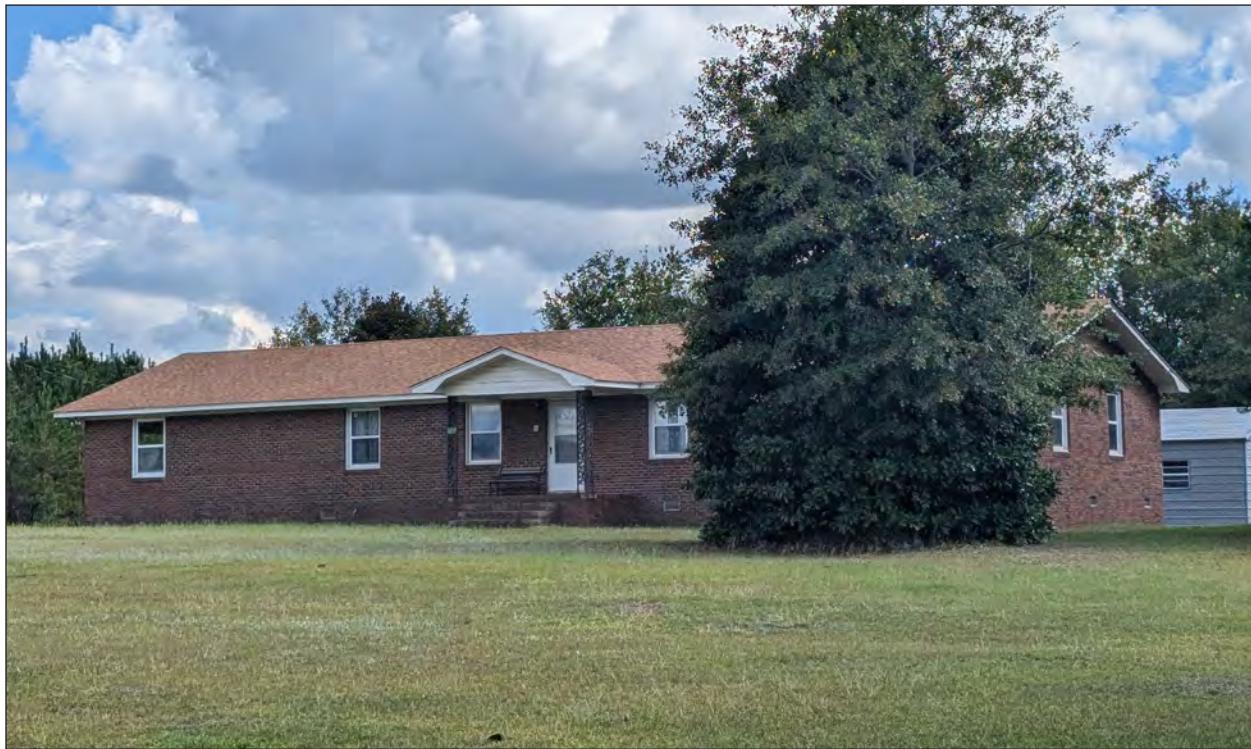
Figure 7.42.  
SHPO Site Number 0526

SHPO Site Number 0526 faces north from its site on Gramling Road, approximately 0.25mile east of its crossing over I-26. Orangeburg County Tax Assessor records indicate this Linear Ranch House was built in 1964, and it is not visible in 1963 aerial photography but is visible in 1973 aerial photography, so it is assumed to have been built circa 1964. SHPO Site Number 0526 is rectangular in plan and is clad in brick veneer that conceals the foundation. The house is topped by a laterally gabled roof clad with composition shingles. The asymmetrical façade has six unevenly spaced windows and an off-center door sheltered by a gabled porch roof. The porch roof is supported by scrolled metal posts, and the door that is off-center to the left within the porch is non-historic, while windows throughout are non-historic vinyl sashes. The eaves are also vinyl clad, and a multiflued brick chimney positioned in the rear slope peeks just above the roofline. The west elevation has two evenly spaced windows, while an integral carport that contains a storage room is located at the east end (Figure 7.42). SHPO Site Number 0526 is situated on a 3.19-acre lot that is wider than it is deep. The house has large front and rear lawns with a few scattered trees, but the eastern third of the parcel contains forest that is contiguous with the silvicultural operation associated with SHPO Site Number 0527.

A. Oblique, Looking Southwest

B. Oblique, Looking Southeast

SHPO Site Number 0526 was evaluated for the NRHP under Criteria A, B, and C. Under Criteria A and B, the resource is not known to be associated with events or persons significant in the past. Under Criterion C, Site Number 0526 was evaluated for significance in the area of architecture. While SHPO Site Number 0526 is a Linear Ranch House, it is not a distinctive or noteworthy example of this common house type. It was not found to embody the distinctive characteristics of a style, period, or method of construction and does not possess significance for its engineering or materials. It does not retain integrity due to alterations that include the replacement windows and added synthetic cladding. Therefore, the resource is recommended not eligible for the NRHP under Criteria A, B, or C.

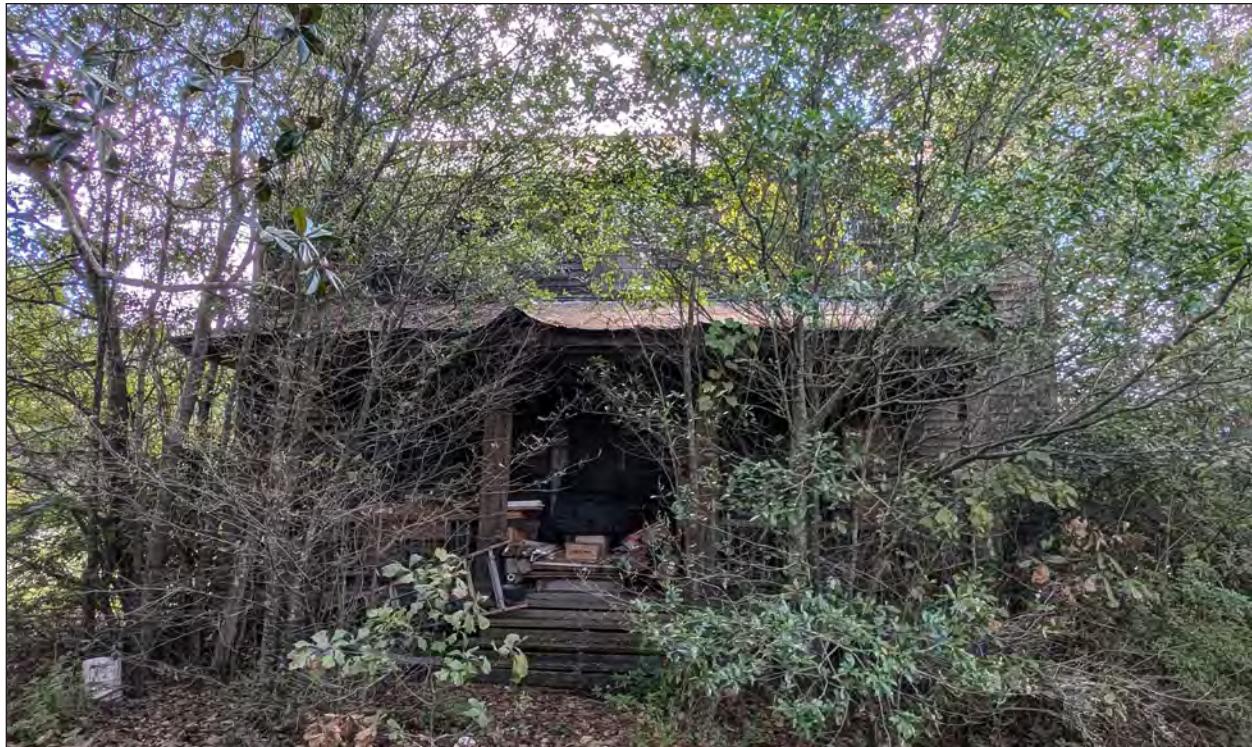
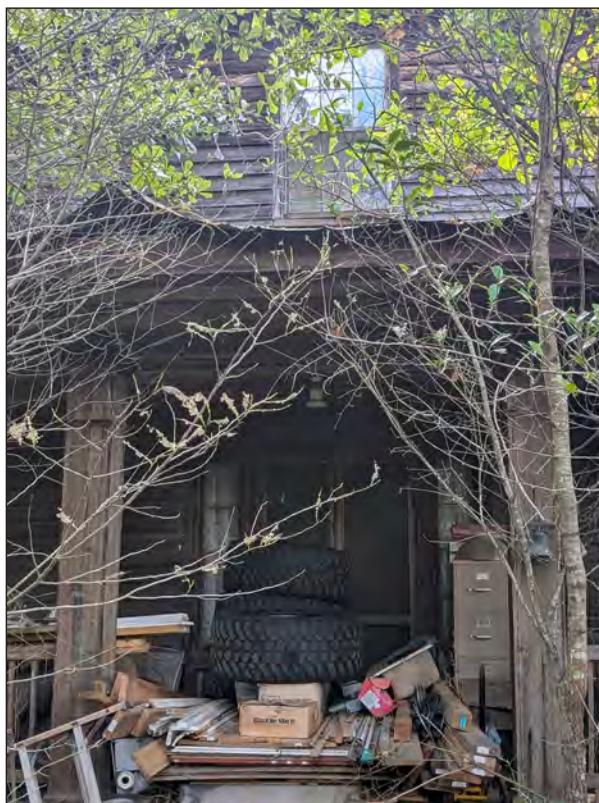
Figure 7.43.  
SHPO Site Number 0527, 1 of 2

The core façade (north elevation) and west elevation are very heavily overgrown with sapling trees, but the three-bay façade is symmetrical and contains single windows in the ground-floor outer bays and all three upper-floor bays, while the central entrance in the ground-floor center bay contains a double-leaf door flanked by half-glazed and wood-paneled sidelights. The sidelights appear to retain the original glazing, and the front doors are obscured by historic wooden screen doors, but they appear to be wood paneled. The window openings are boarded up almost everywhere except on the façade, where a few contain six-over-six wood sash windows. Wood railings line the perimeter of the porch, whose roof is supported on boxed wood posts, and a set of splayed wooden steps ascends to the porch that is congested with furniture, truck tires, and other miscellaneous items (Figure 7.43). The rear (east) and south sides of the addition are also heavily overgrown and obscured, while the porch across the "façade" (east elevation) is similarly stacked with all manner of items, such that the door is not visible. A single window opening that contains a one-over-one wood sash window is visible at the south end of the porch, but no other fenestration is discernible across the addition. The east elevation of the core has two un-boarded window openings: one second-floor opening retains only the wood sash frames but no muntins or glazing, while an opening in the rear block contains a squat six-over-six wood sash window. The foundation is mostly obscured, but at least portions of it are enclosed with concrete block (Figure 7.44).

A. Façade, Looking South

B. Façade Detail, Looking South

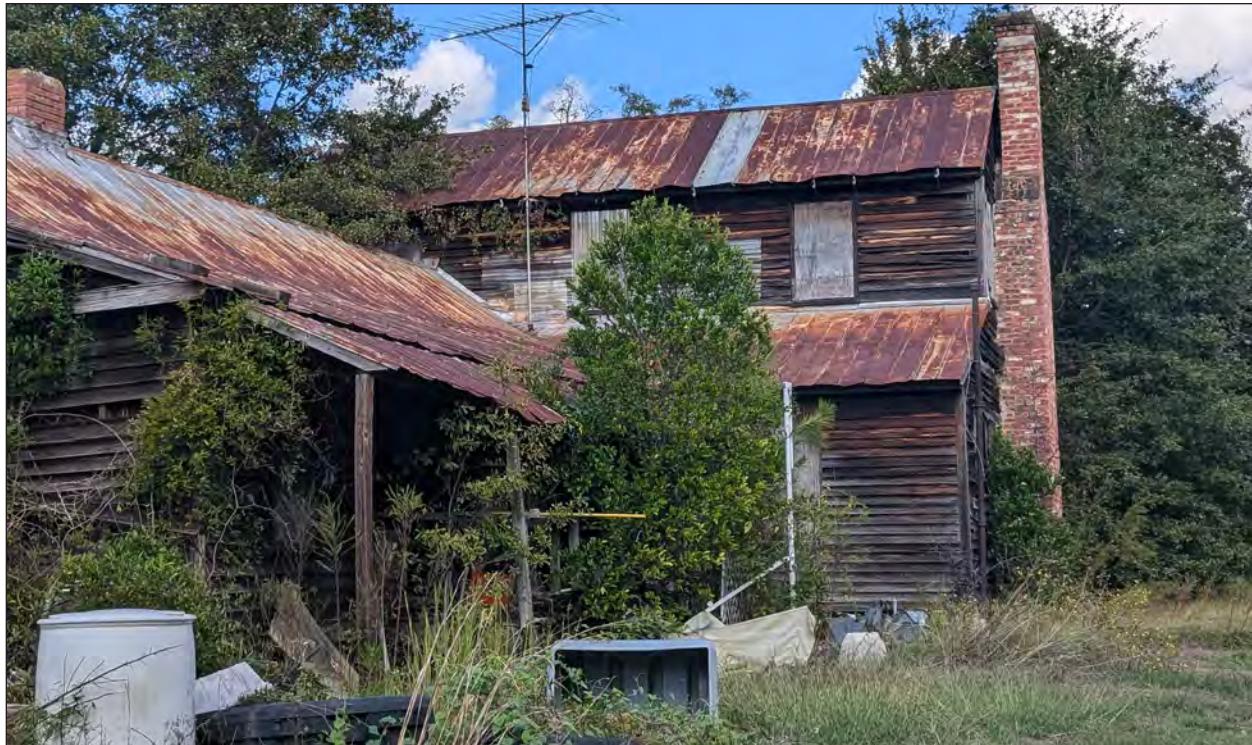
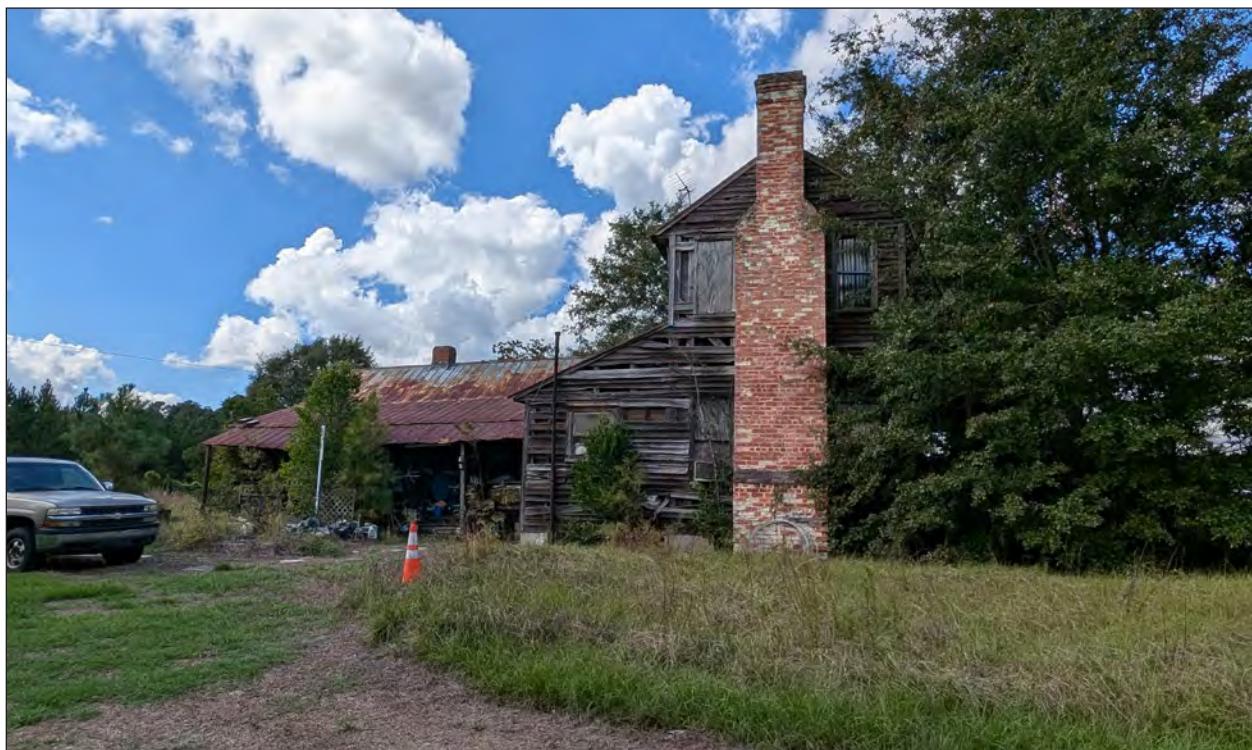
Figure 7.44.  
SHPO Site Number 0527, 2 of 2

A. Rear Oblique, Looking Northwest

B. East Elevation, Looking West

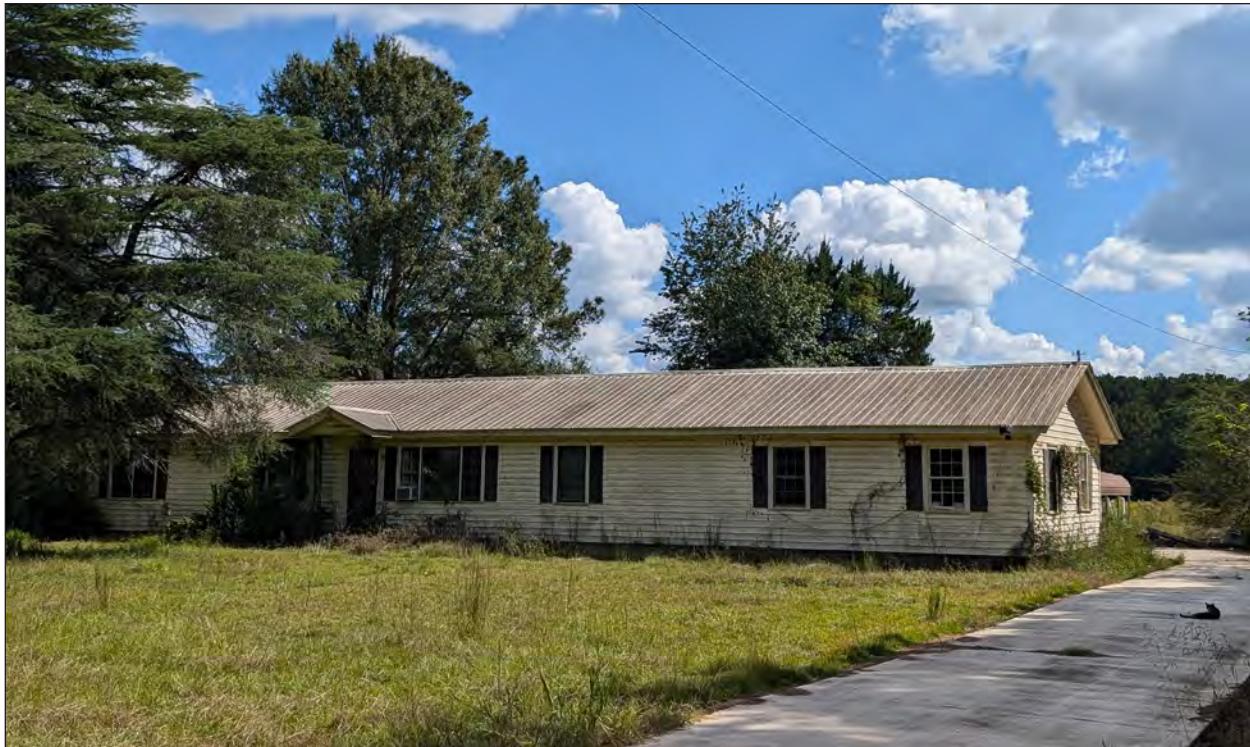
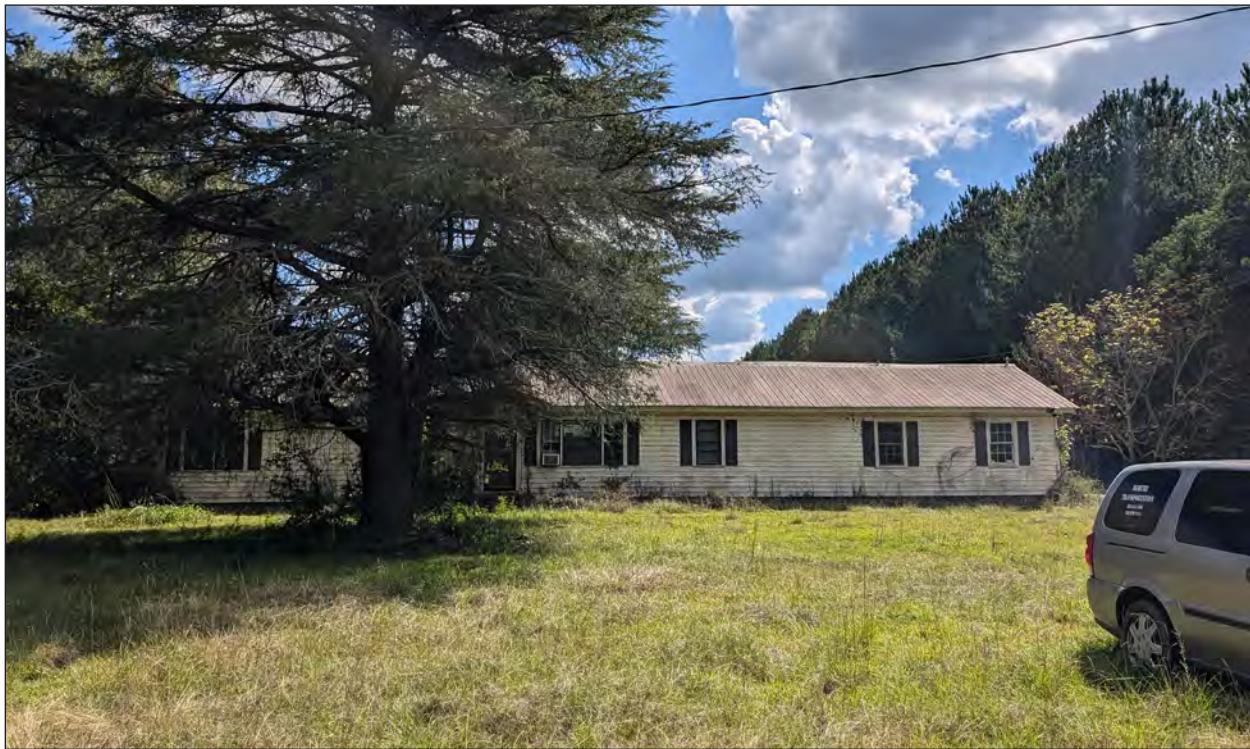
Figure 7.45.  
SHPO Site Number 0528

SHPO Site Number 0528 faces north from its site on Old Elloree Road, approximately 0.25 mile west of its crossing over I-26. The Orangeburg County Tax Assessor records indicate this Linear Ranch House was built in 1955, and it is visible in 1958 aerial imagery, so it is assumed to have been built circa 1955. SHPO Site Number 0528 is rectangular in plan, and the exterior is clad with vinyl siding, and the laterally gabled roof is clad with PBR metal panels. The asymmetrical façade has six unevenly spaced windows or window sets, including one paired set and one single-pane picture flanked by sash windows. The off-center main entry is sheltered by a gabled porch roof. The porch roof is supported by scrolled metal posts, and the door appears to be non-historic, while windows throughout are four-over-four or six-over-six wood sashes. The eaves are vinyl clad, and the foundation appears to be continuous brick (Figure 7.45). SHPO Site Number 0528 is situated on a 1.06-acre lot. The house has large front and rear lawns with a few mature trees, and a U-shaped driveway wraps around the rear of the house, where aerial imagery shows there are outbuildings that are not visible from the ROW.

A. Oblique, Looking Southeast

B. Façade, Looking South

SHPO Site Number 0528 was evaluated for the NRHP under Criteria A, B, and C. Under Criteria A and B, the resource is not known to be associated with events or persons significant in the past. Under Criterion C, Site Number 0528 was evaluated for significance in the area of architecture. While SHPO Site Number 0528 is a Linear Ranch House, it is not a distinctive or noteworthy example of this common house type. It was not found to embody the distinctive characteristics of a style, period, or method of construction and does not possess significance for its engineering or materials. Therefore, the resource is recommended not eligible for the NRHP under Criteria A, B, or C.

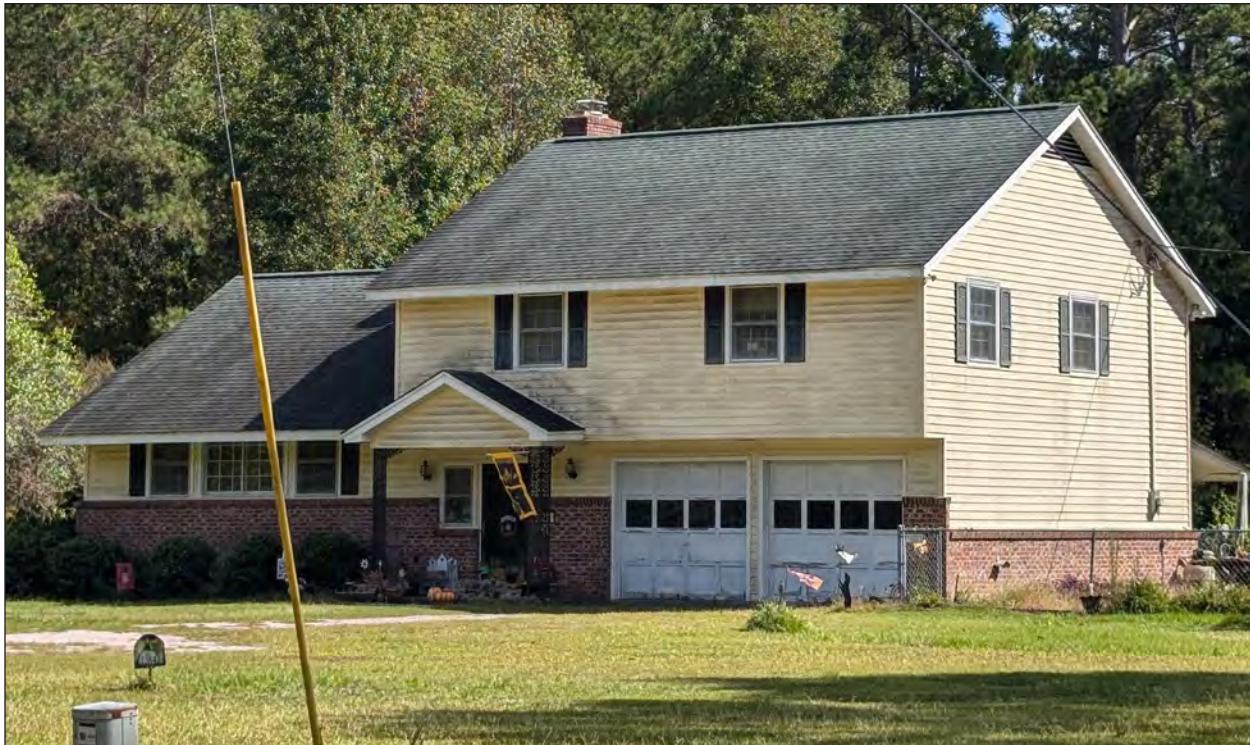
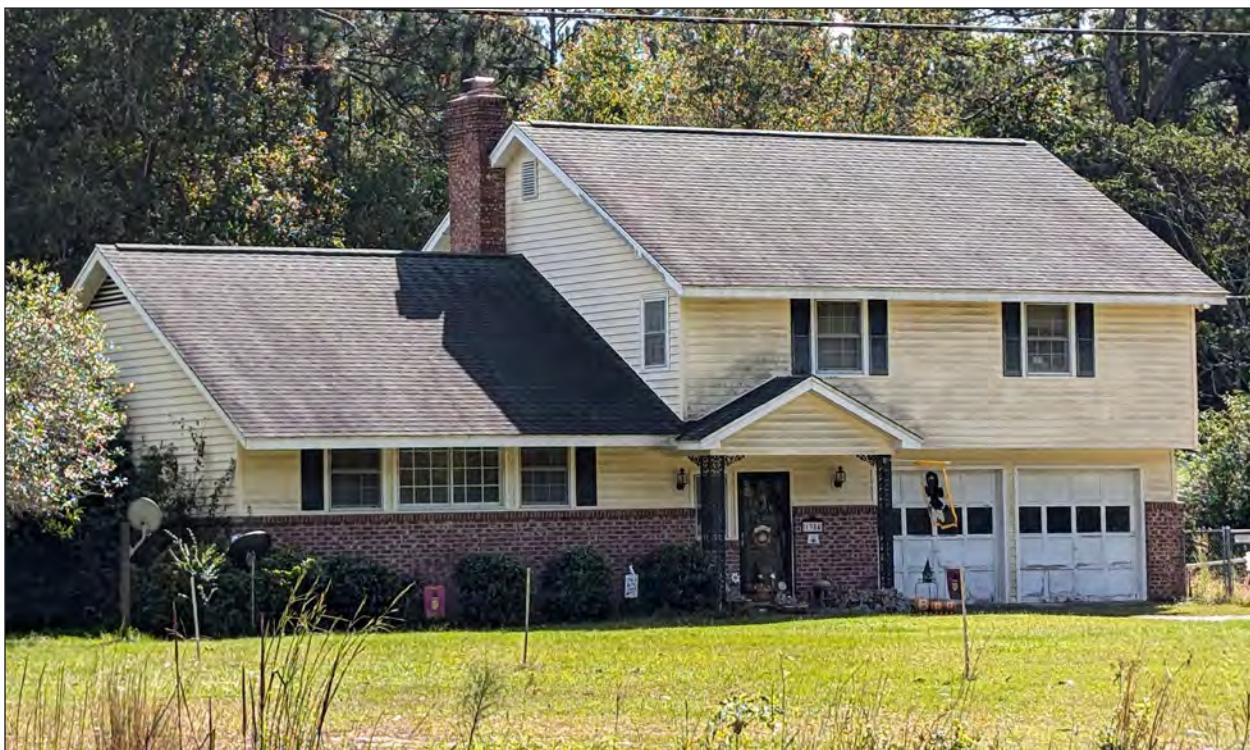
Figure 7.46.  
SHPO Site Number 0529

This split-level house is rectangular in plan, the exterior is primarily clad in vinyl siding with a brick veneer skirt wall that conceals the foundation, and its laterally gabled roof is clad with composition shingles (Figure 7.46). The two-story façade has two windows in the upper level, two garage bays in the west side of the lower level, and the main entry in the east side of the lower level, while the one-story façade has a wide multi-pane picture window flanked by sash windows. The entrance-bay-only front porch is sheltered by a small gabled roof supported by scrolled metal columns. Except for a four-over-four sash window to the left of the paneled wooden front door, visible sash windows are six-over-six. An exterior brick chimney is appended to the east side of the two-story block, and the roof eaves are clad with aluminum or vinyl. SHPO Site Number 0529 is situated on a trapezoidal 20.74-acre lot that is deeper than it is wide. The house has large front and rear lawns with scattered mature trees, and there are more than 15 acres of woodlands at the sides and rear of the house. A gabled metal building (combination garage and barn) located to the east of the house was erected circa 2005, so it was not assessed (Figure 7.46a).

A. Oblique, Looking Southeast

B. Oblique, Looking Southwest

SHPO Site Number 0529 was evaluated for the NRHP under Criteria A, B, and C. Under Criteria A and B, the resource is not known to be associated with events or persons significant in the past. Under Criterion C, Site Number 0529 was evaluated for significance in the area of architecture. While SHPO Site Number 0529 is a split-level house, it is not a distinctive or noteworthy example of this common house type. It was not found to embody the distinctive characteristics of a style, period, or method of construction and does not possess significance for its engineering or materials. Therefore, the resource is recommended not eligible for the NRHP under Criteria A, B, or C.
