# **D-1: PHASE I CULTURAL RESOURCES SURVEY**

***RE: Phase I Cultural Resources Survey for the Proposed Widening of I-26 from Mile Marker 145-172, Orangeburg and Dorchester Counties, South Carolina and Phase I Cultural Resources Survey for the Proposed Widening of I-26 from Mile Marker 145 to 172 - ADDENDUM***

***SCDOT Project #: P041967 and 42454***

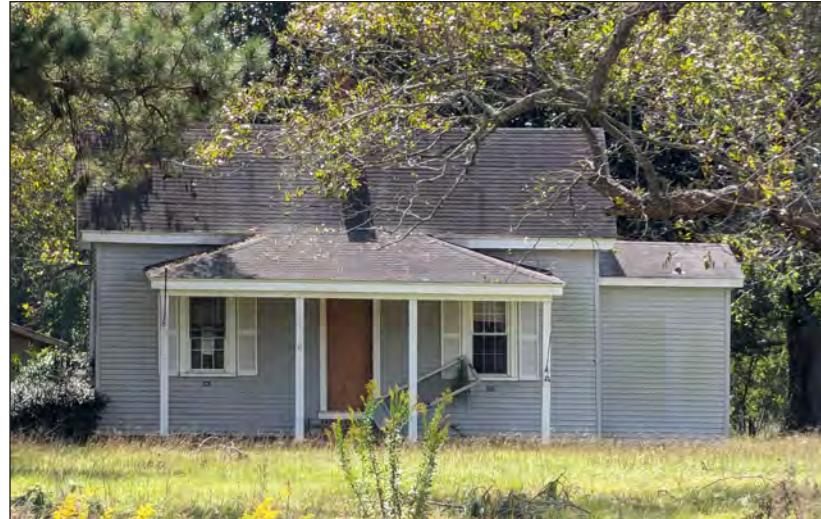
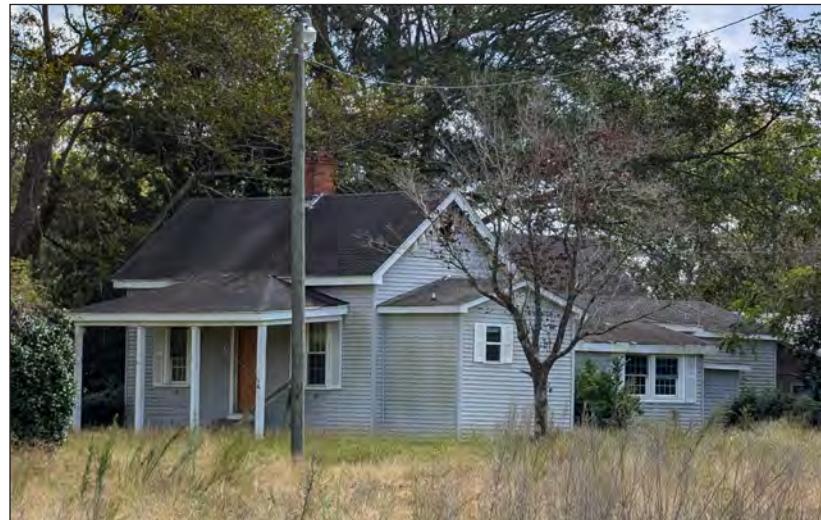
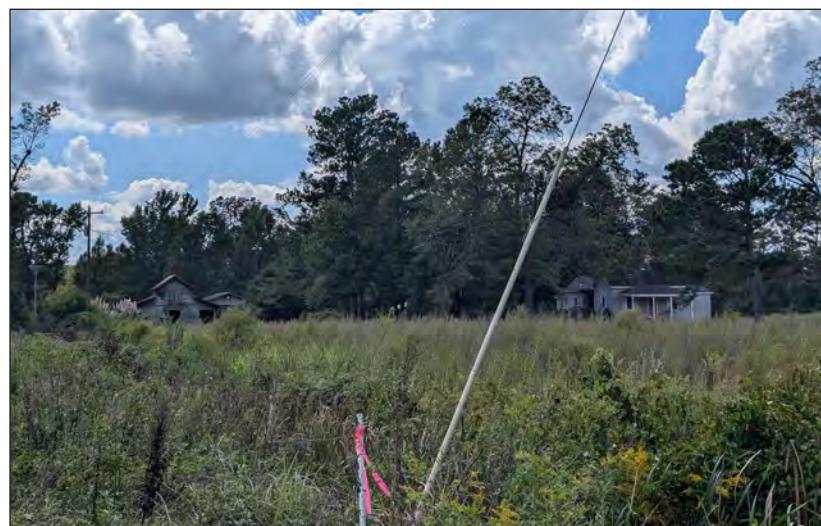
Figure 7.47.  
SHPO Site Number 0530

A. Façade, Looking South

B. Oblique, Looking Southeast

C. Property Overview with SHPO  
Site Number 0530.01 at Left,  
Looking Southwest

SHPO Site Numbers 0530 and 0530.01 are situated on an irregular 113.74-acre lot. The house has a setback of approximately 250 feet, and there are several other barns and outbuildings on the property that are either inaccessible or are less than 50 years old, so they were not assessed. A long driveway lined with mature trees leads to the house, and the parcel contains a pond, several agricultural fields, and a large, wooded section at the rear of the parcel.

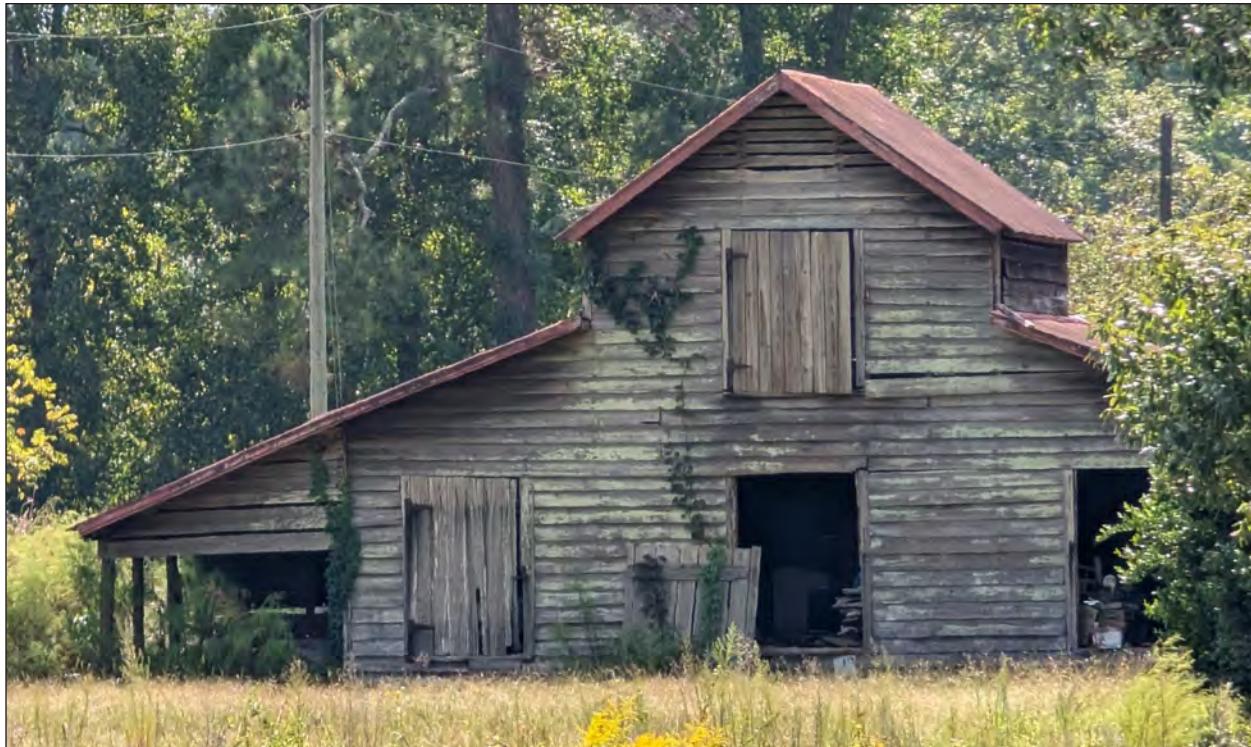
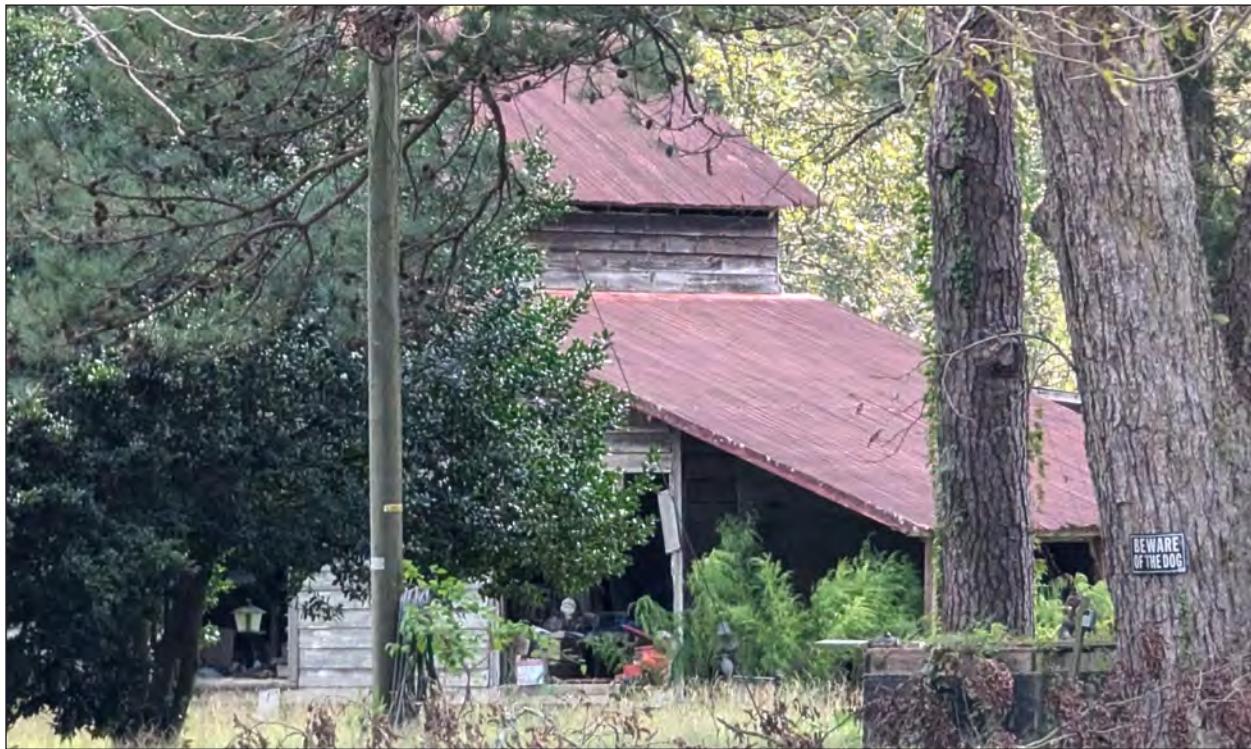
Figure 7.48.  
SHPO Site Number 0530.01

A. Oblique, Looking Southeast

B. Oblique, Looking Southeast

windows across the façade and throughout the house are non-historic vinyl sashes with simulated muntins. The porch ceiling is historic beadboard, but the eaves across the entire house are clad with vinyl or aluminum. The historic core of the house is double-pile, and a large cross-gabled addition is appended to the rear. A vinyl-clad chimney with a concrete block base is appended to the north gable end. The porch and rear addition foundations are continuous concrete block, while the core foundation is brick pier with concrete-block infill (Figure 7.49).

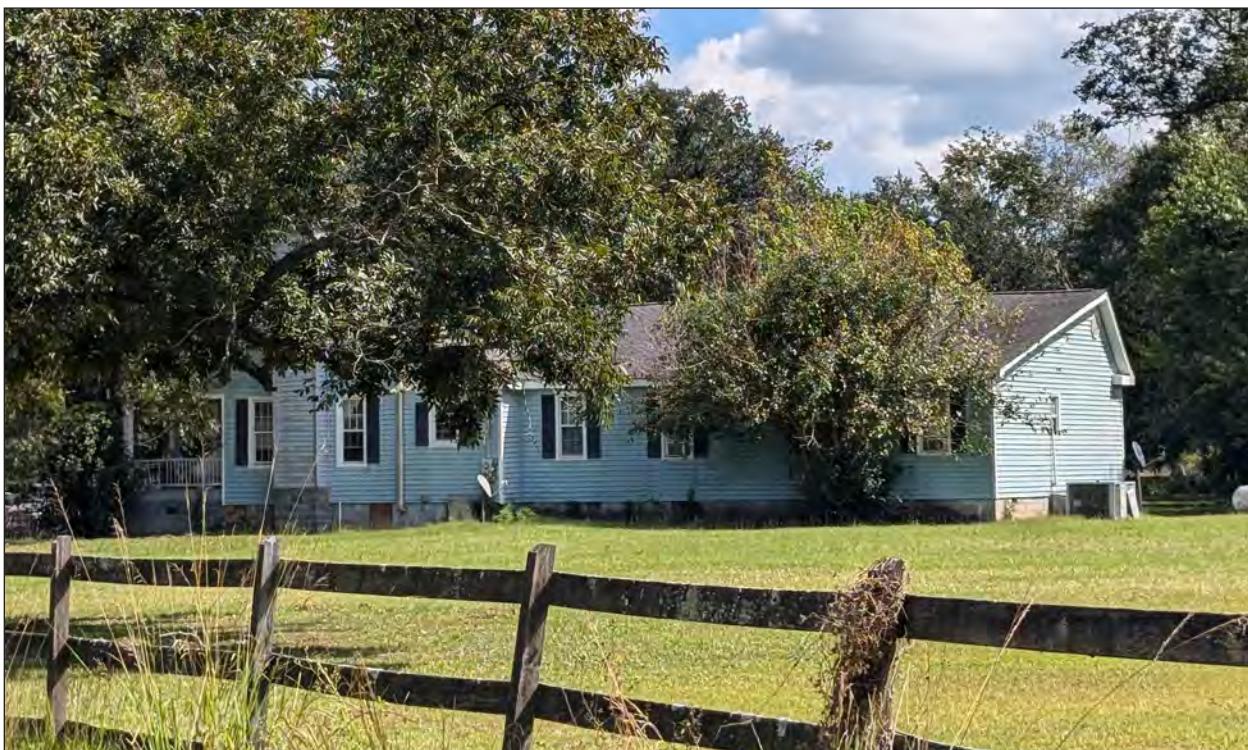
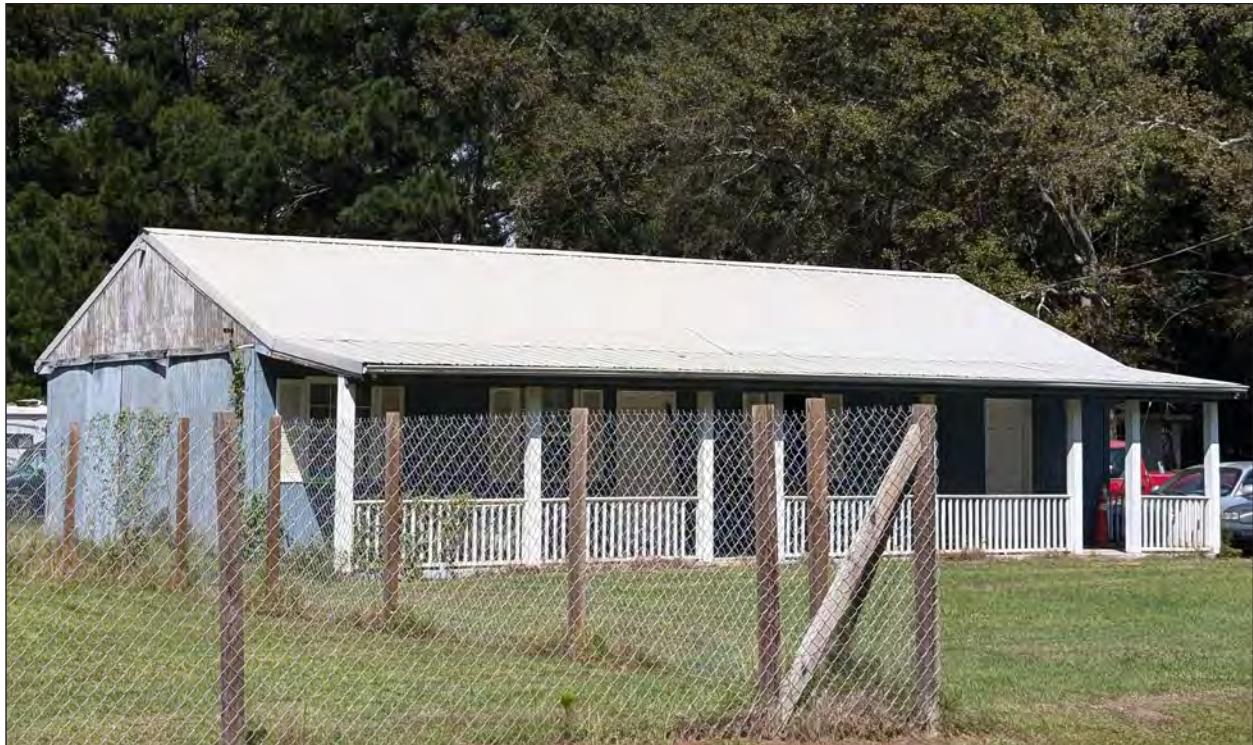
Figure 7.50.  
SHPO Site Number 0532

SHPO Site Number 0532 faces south from its site on Boone Road just north of its intersection with Four Holes Road. This circa 1970 house of no distinct style or type is visible in 1973 aerial photographs, but is not present in 1963 aerial photographs. The concrete-block house is clad in T1-11 plywood siding and has a laterally gabled roof clad in PBR metal panels (Figure 7.50). A ground-level, full-façade front porch spans the house's asymmetrical façade, which contains two entrances and three windows. The porch is sheltered by a shed roof supported by square wooden posts with wooden railings in between. The east elevation has two windows, and windows throughout are non-historic vinyl and metal sashes, and both front doors are non-historic metal types.

A. Oblique, Looking Southeast

B. Rear Oblique, Looking East

A. Oblique, Looking Northeast

The concrete-block building frame is visible on the east elevation, where a section of plywood is missing around one of the windows, and the building appears to rest on a concrete slab foundation. SHPO Site Number 0532 is situated on an irregular 8.1-acre lot that contains a large, non-historic metal warehouse or garage building and a large truck yard with a variety of shipping containers, automobiles, and trucks stored in it.

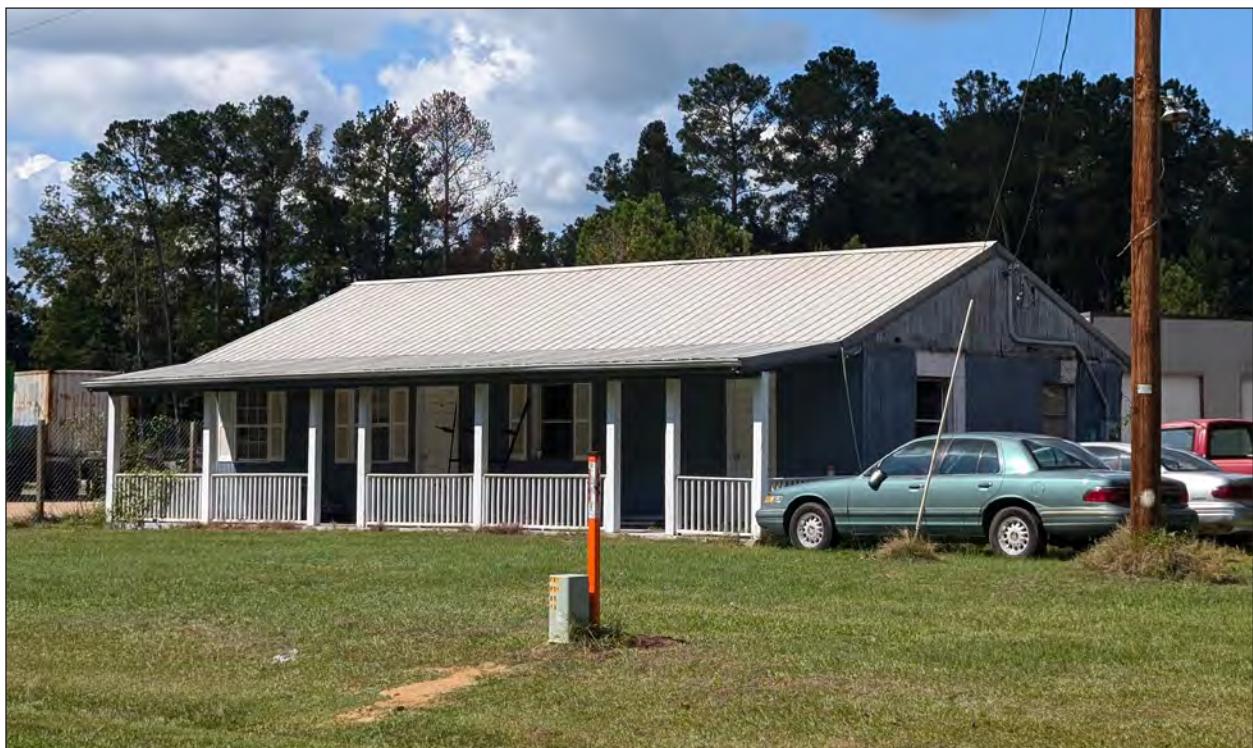
B. Oblique, Looking Northwest

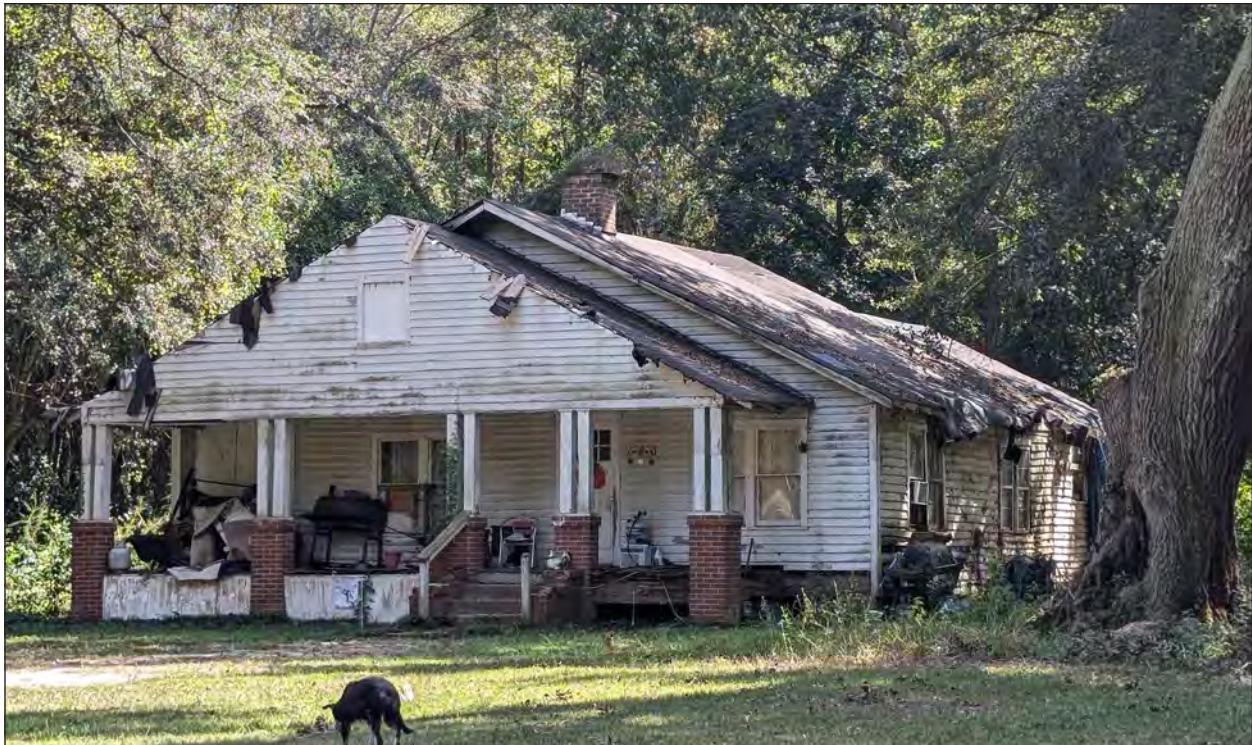
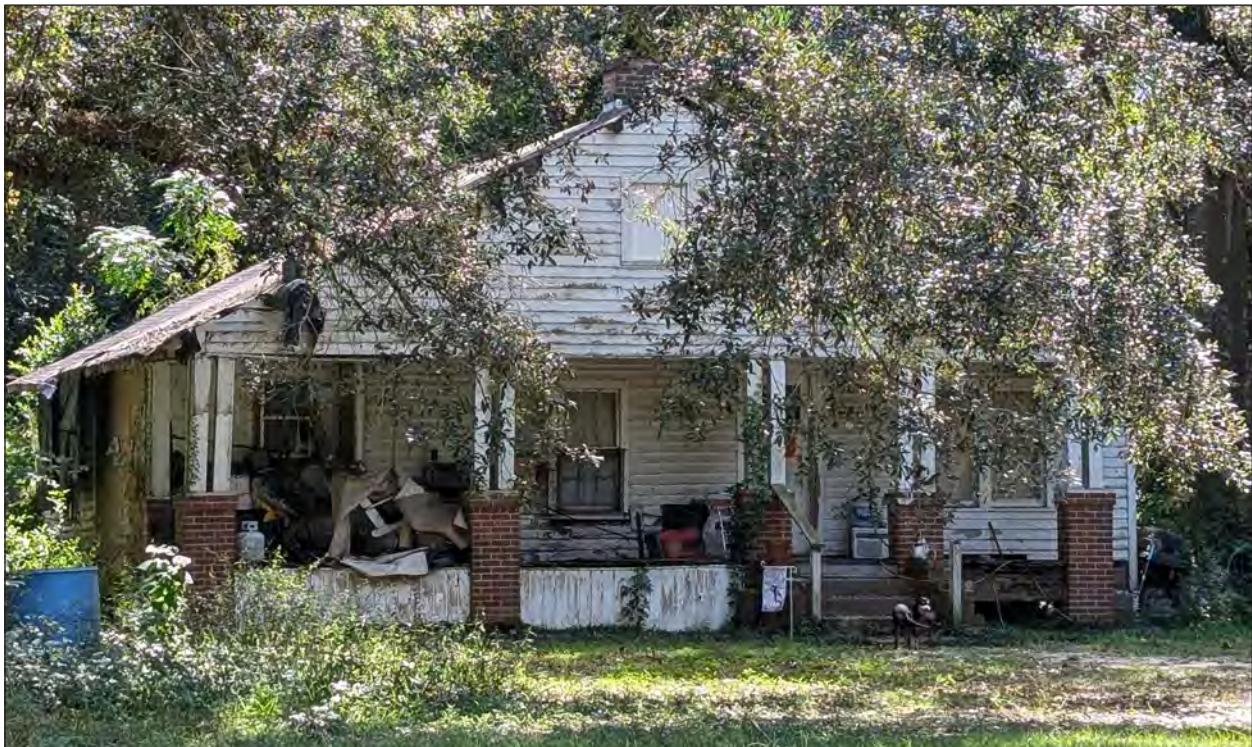
Figure 7.51.  
SHPO Site Number 0533

The one-story house is clad in weatherboard siding and has a front-gable roof and a nearly full-width front porch beneath a nestled gable roof that extends from the façade on its west side but joins with the main roof on the eastern slope. The roof is clad with composition shingles that are in an advanced state of failure, and there are several tarps across the roof covering what are likely holes beneath. The porch roof is supported by Craftsman-style wood, boxed columns that are paired on square brick piers, which extend to the ground below the wood frame porch (Figure 7.51). The façade has two sets of paired windows, with the entrance that contains a six-light wood-paneled door positioned between them.

A. Oblique, Looking Southeast

B. Oblique, Looking Southwest

The porch originally wrapped around on the east side for one or two bays, but that area was framed in and enclosed with plywood and a non-historic vinyl window to create additional interior space. The west elevation has two sets of paired windows as well, and most of the paired windows have mismatched sashes ranging between one-over-one, six-over-six, and vertical three-pane patterns. The house rests on brick piers, and there is a gabled addition appended to the rear, but its details are difficult to see from the ROW.

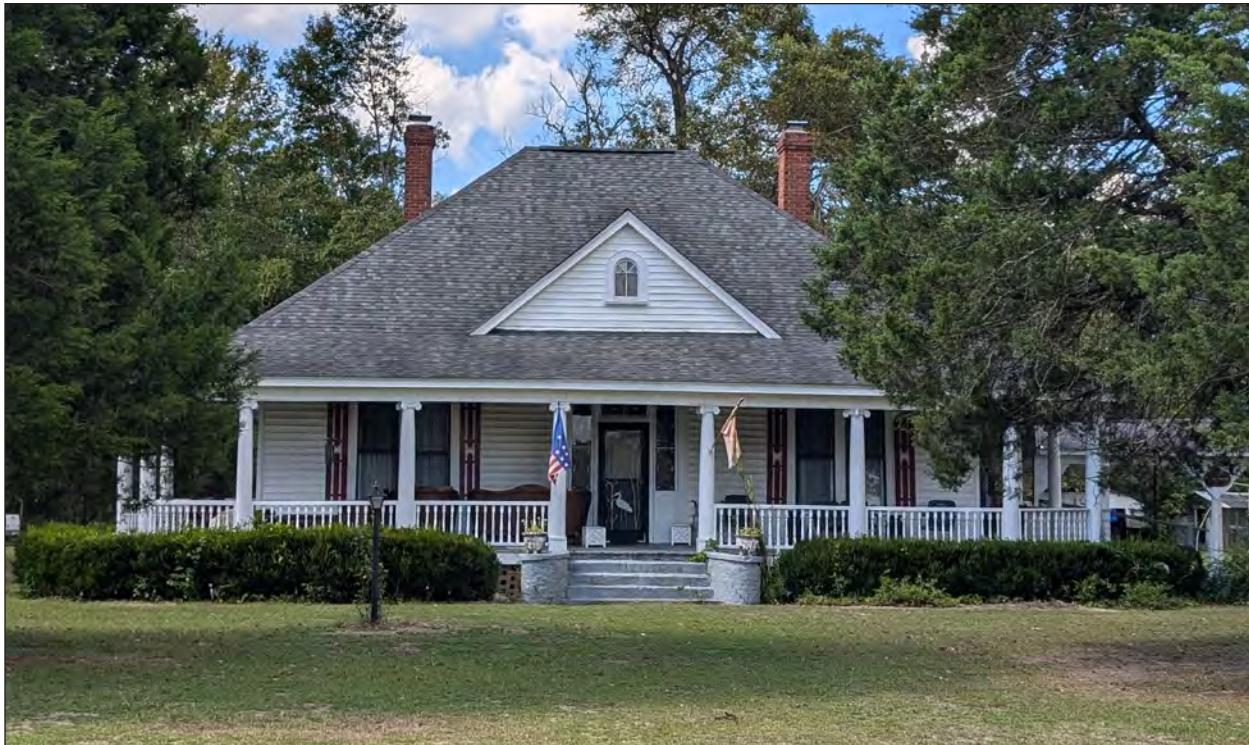
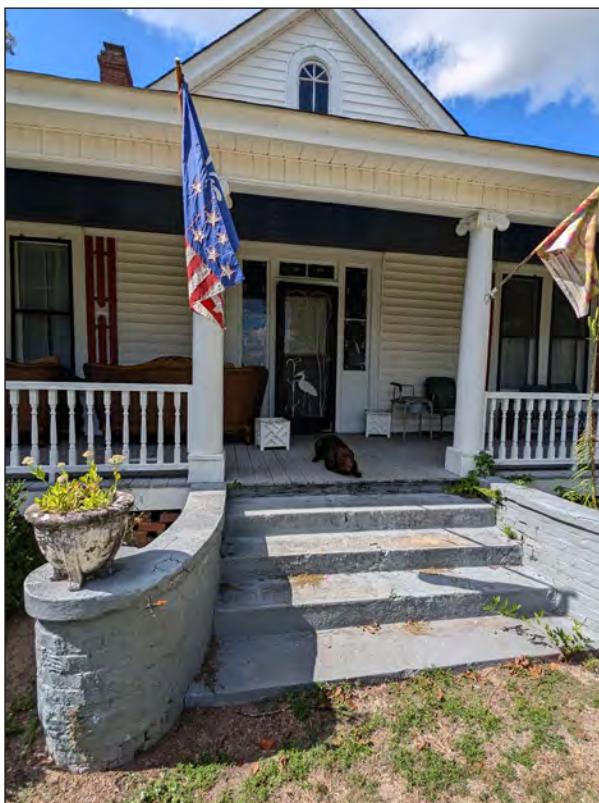
Figure 7.52.  
SHPO Site Number 0534, 1 of 2

have turned wooden balusters and molded handrails in between. The porch is accessed by a set of splayed concrete steps flanked by brick side walls with volute caps, and the porch decking is tongue and groove, while the ceiling is beadboard, though the frieze and eaves are wrapped with vinyl (Figure 7.52). The entrance is centered on the three-bay façade and contains a glazed-and-wood-paneled door topped by a two-light transom and flanked by wood-paneled and half-glazed, two-light sidelights, while the outer bays contain paired windows. Centered above the entrance in the front roof slope is a cross gable that contains an arched multi-light window. There are paired windows within the porch footprint on both side elevations, and there are additional sets further to the rear of the house on both sides, but only the east side has a visible additional entrance.

A. Façade, Looking North

B. Façade Detail, Looking North

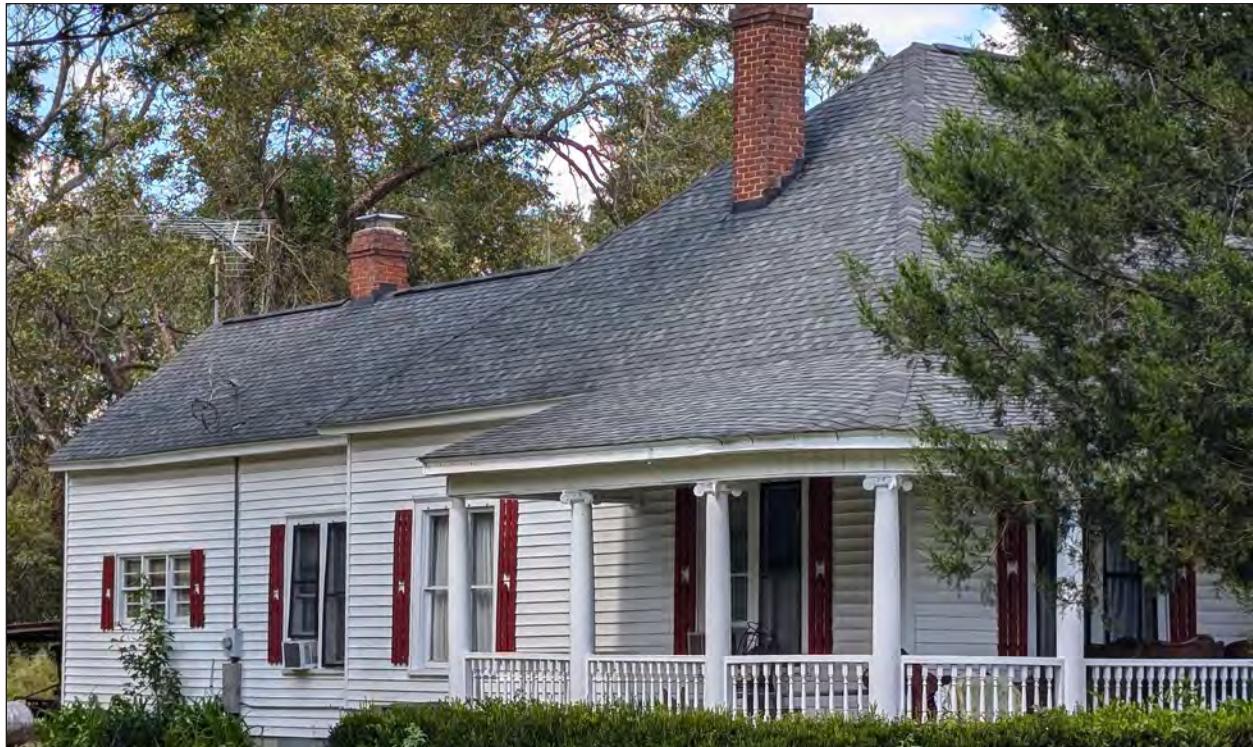
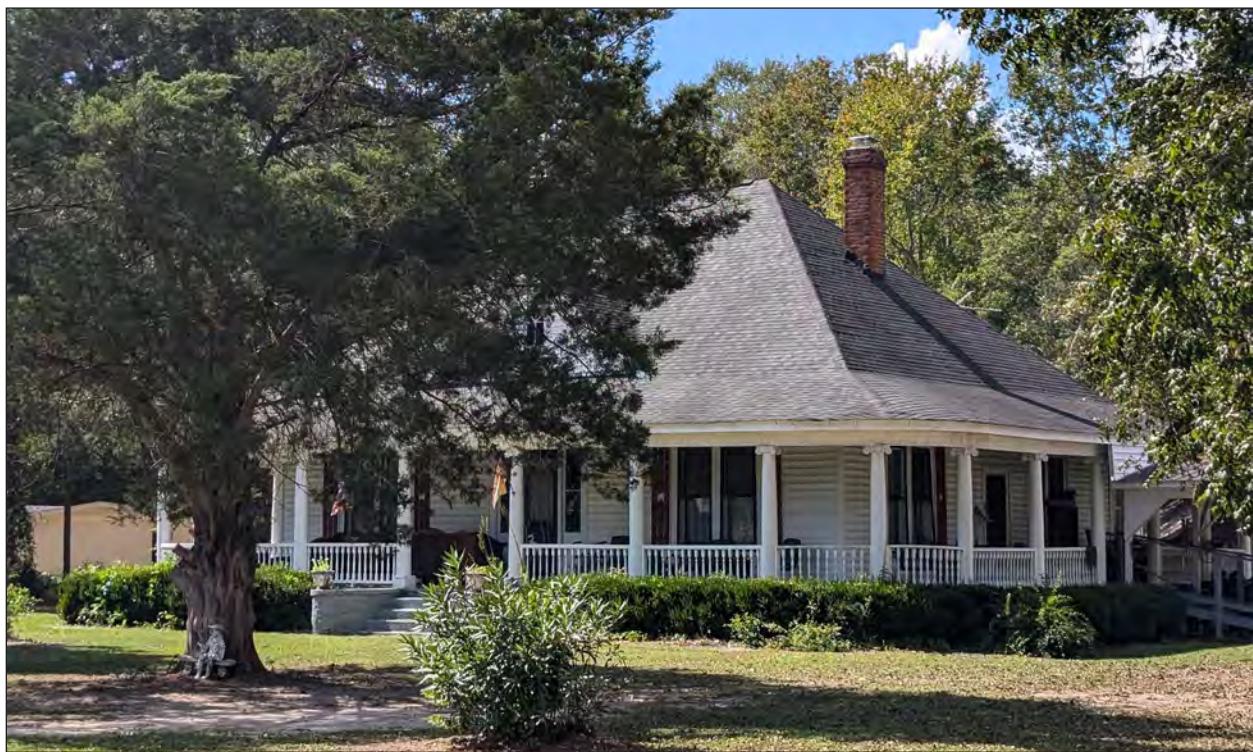
Figure 7.53.  
SHPO Site Number 0534, 2 of 2

There appear to be two generations of rear additions. The older addition on the west side contains paired windows, while the more recent addition has a stout triple set of horizontal two-over-two wood sash windows. All the other windows are one-over-one wood sash, and all of the windows have faux shutters. A chimney rises from the ridgeline at the junction of the two additions. A continuous concrete-block foundation is visible beneath the additions on the west side, but the core foundation is obscured by the porch and the foundation plantings (Figure 7.53).

A. Oblique, Looking Northeast

B. Oblique, Looking Northwest

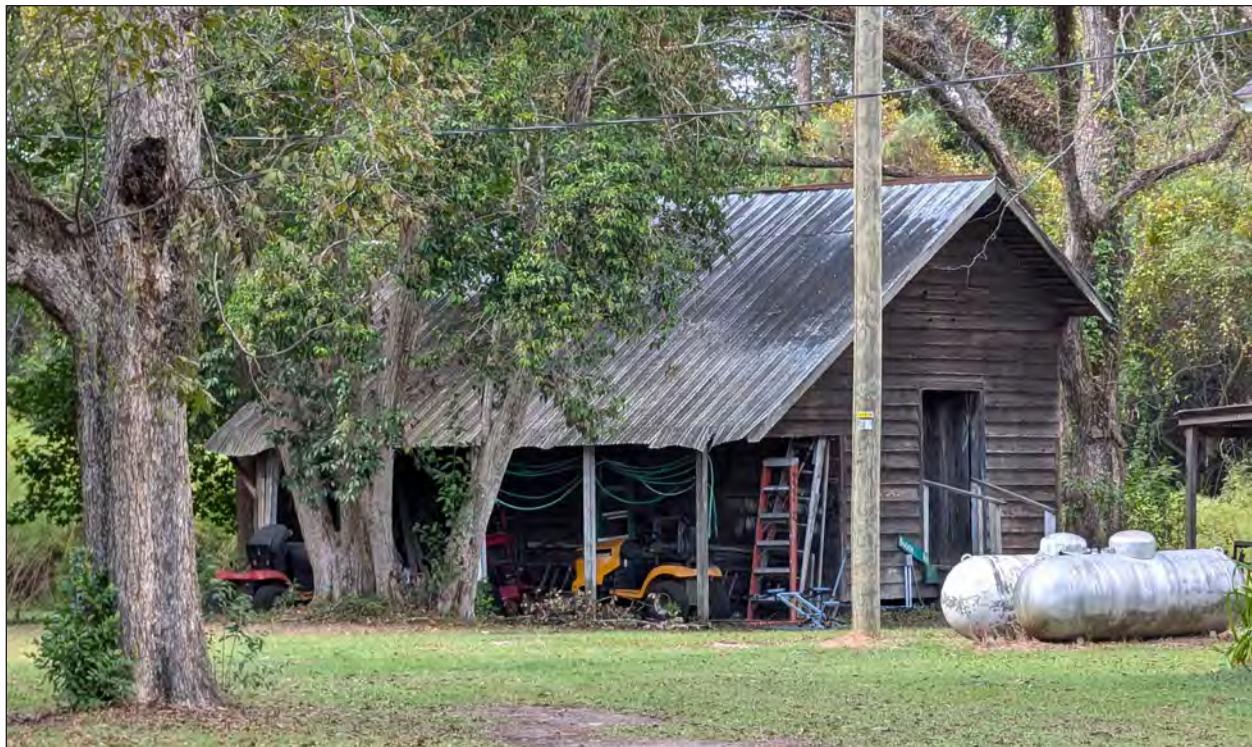
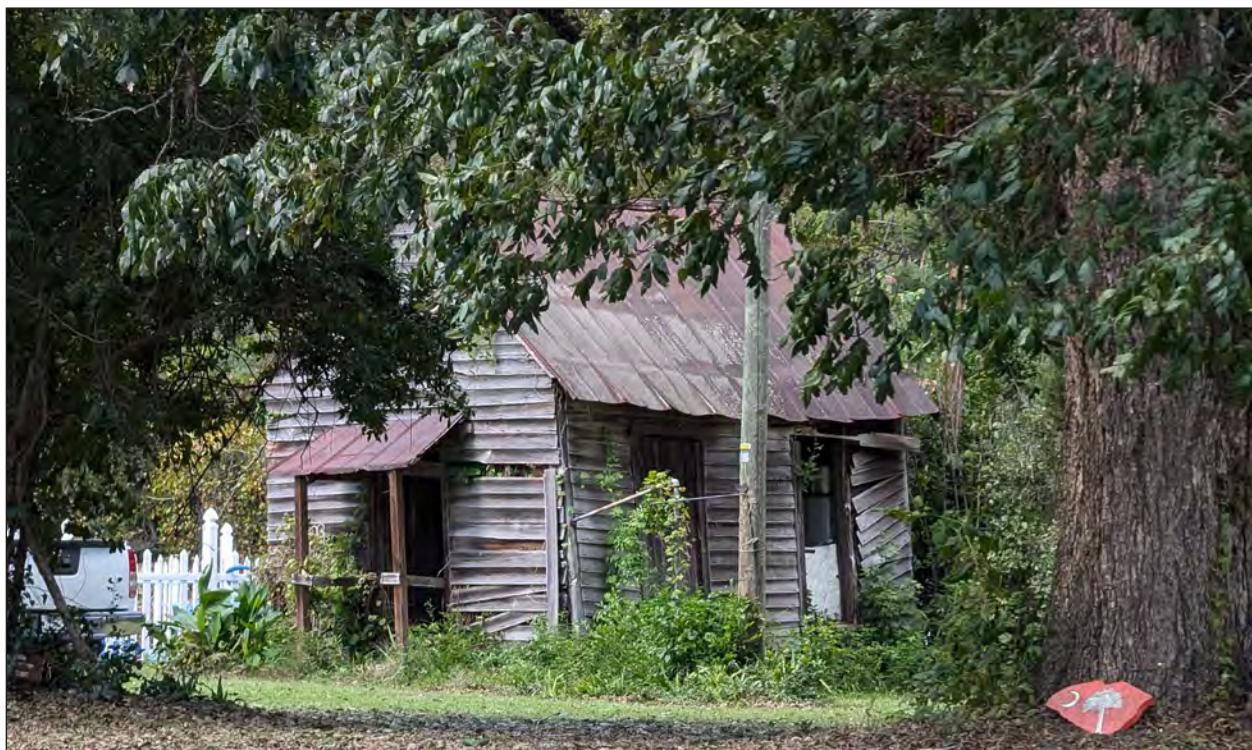
Figure 7.54.  
SHPO Site Numbers 0534.01 and 0534.02

SHPO Site Number 0534.01 is a frame barn that is located approximately 60 feet to the rear (west) of the main house. The building is clad in unpainted weatherboard siding and the gabled roof has a corrugated metal covering. A doorway that contains a vertical flushboard wooden door is centered on the east elevation, and the south roof slope extends to cover an open storage section that spans the south elevation and that has a ceiling as a result of the building frame overhanging the storage area. The roof along this side is supported by square wooden posts, and no other fenestration is visible from the ROW. The building is slightly raised off the ground, but the foundation is not visible (Figure 7.54a). Tax records list a date of 1950 for one of the property's outbuildings, so, based on its type and materials, the building is assumed to have been constructed around 1950.

SHPO Site Number 0534.02 is a frame smokehouse located approximately 40 feet north of the main house. The rectangular, front-gabled building is oriented towards the house. The roof is clad in PBR metal panels, the siding is unpainted weatherboard, and the foundation is not visible (Figure 7.54b). A small shed roof supported on square wood posts shelters the entrance that is centered on the south elevation. The east side has two openings, a door and a window, and the other elevations are not visible from the ROW. Tax records list a date of 1908 for one of the property's outbuildings, so, based on its type and materials, the building is assumed to have been constructed around 1908.

A. SHPO Site Number 0534.01, Looking North

B. SHPO Site Number 0534.02, Looking Northeast

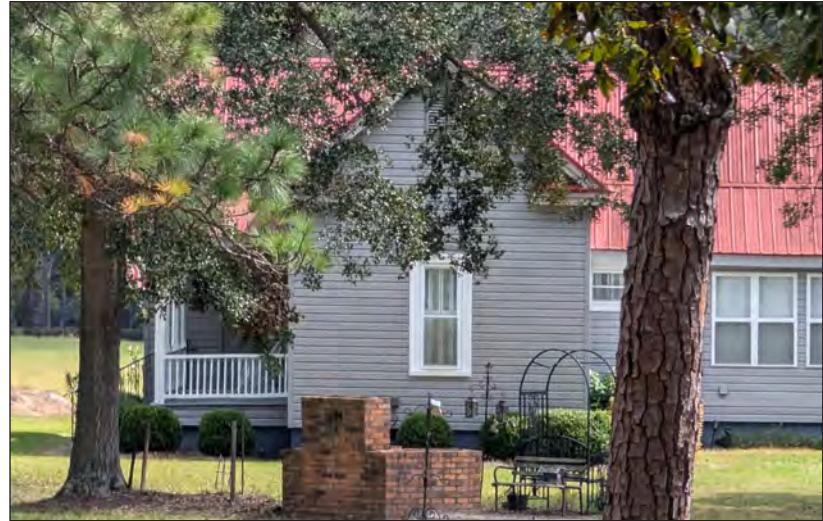
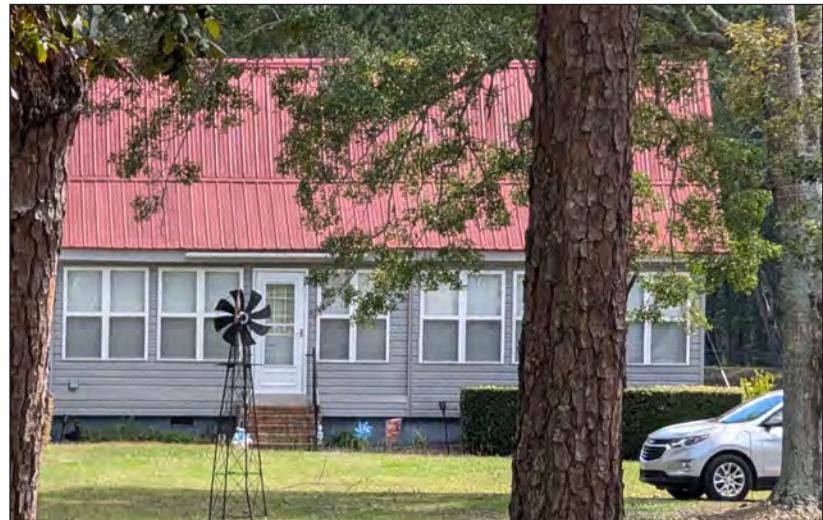
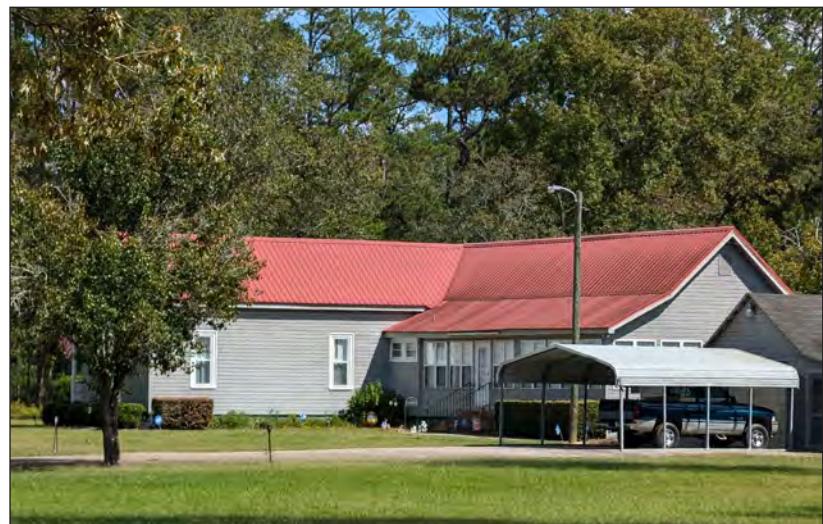
Figure 7.55.  
SHPO Site Number 0535

the south gable-end elevation, and observable windows throughout are vinyl replacement one-over-one sash. The exterior and eaves are clad with vinyl siding, and the foundation appears to be brick pier with infill (Figure 7.55).

A. West Elevation (Front),  
Looking East

B. West Elevation (Rear),  
Looking East

C. Rear Oblique, Looking  
Northeast

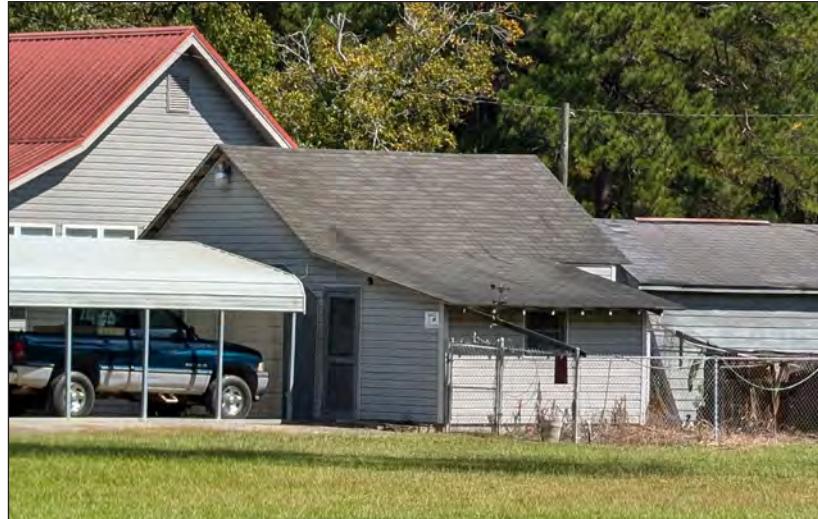
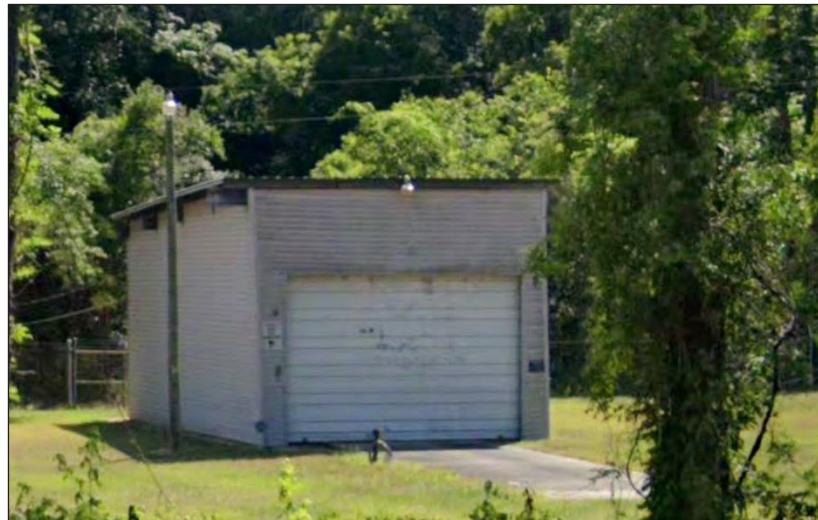
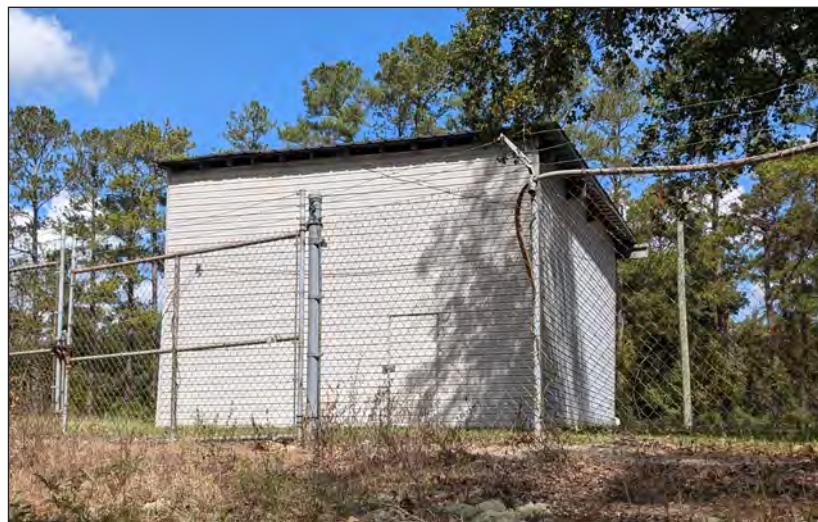
Figure 7.56.  
SHPO Site Numbers 0535.01 and 0535.02

SHPO Site Number 0535.01 is a combination garage/shed located a few feet to the rear of the house. It faces west towards the road with a concrete driveway running in between, and only the south and west elevations are visible from the public ROW. The rectangular frame building has a gabled roof clad in composition shingles, and the south roof slope has a pitch break with the lower section covering the shed portion of the building. The west elevation contains a non-historic metal garage door as well as a doorway into the shed portion that contains a screened door. A single window is centered in the south elevation, and exposed rafter tails are visible along this lateral elevation. The building is clad in vinyl siding and likely rests on a concrete slab that extends from the driveway (Figure 7.56a). There are several other non-historic or prefabricated outbuildings at the rear of the house that were not assessed.

SHPO Site Number 0535.02 is a rectangular frame garage located approximately 500 feet northwest of the house. The one-and-a-half-story building faces north towards I-26, and the shed roof that is covered in PBR metal panels slopes to the rear. A non-historic metal garage door is centered on the north elevation, and the south elevation has an off-center doorway that is designed to blend into the wall by having the same vinyl cladding as the rest of the exterior. The foundation is not visible, though it is likely on a slab (Figure 7.56b and c).

A. SHPO Site Number 0535.01,  
Looking Northeast

B. SHPO Site Number 0535.02,  
Looking Southwest

C. SHPO Site Number 0535.02,  
Looking Northwest

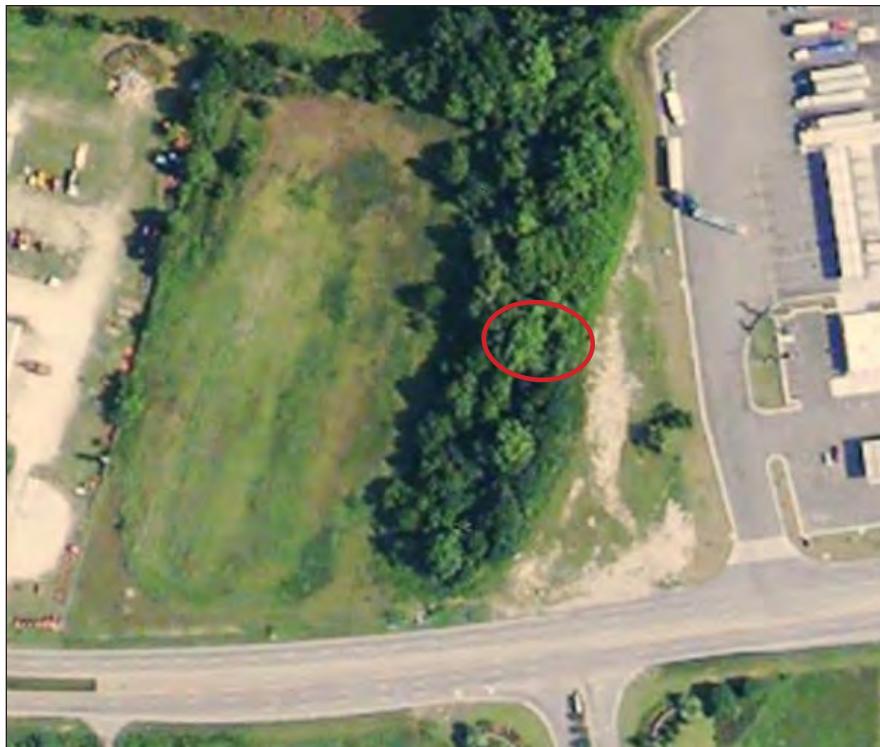
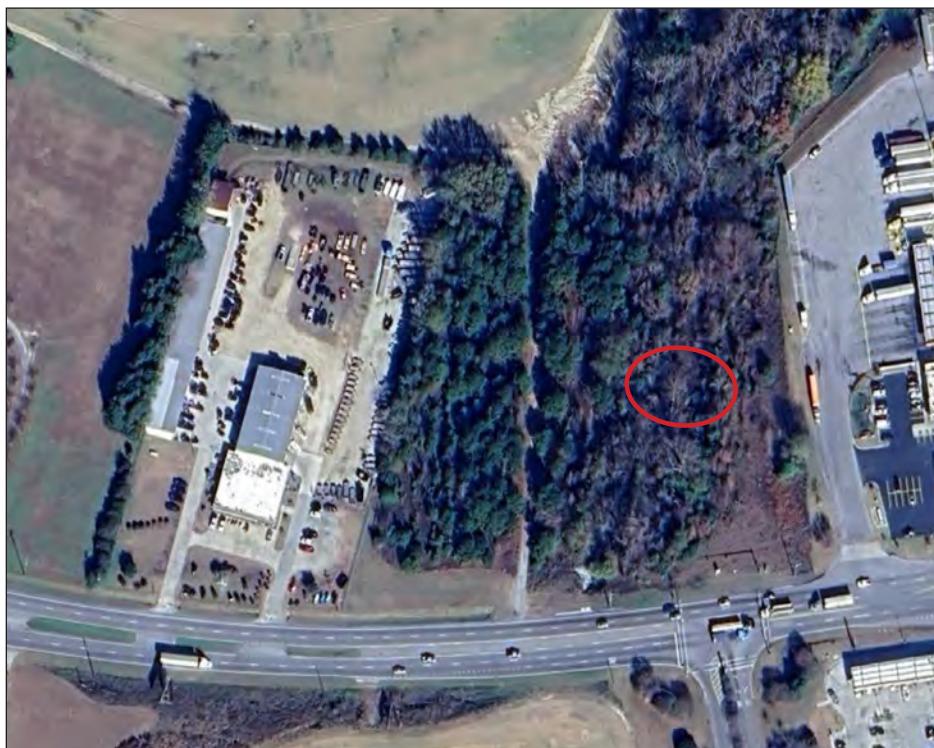
Figure 7.57.  
SHPO Site Number 0536, 1 of 2

Find A Grave states that “2 markers were found in 2000 by the Orangeburg County Historical Society (OCHS), but indications of more graves are there and [the area was] disturbed when logging went on” (Find A Grave 2013). Find A Grave provides no photos of the markers nor any indication of when the cemetery was established or who is buried there beyond the surnames that comprise the cemetery name, but the directional information states that it is “on the far side (northeast) of a field in the woods. No road to this cemetery, and is about a 20-minute walk through the field to the trees” (Find A Grave 2013). Google Earth Historical Imagery from 2005 corresponds to this description, but the aforementioned dirt drive was established by 2011, and what was described as a field in 2000 had by 2017 transformed into the densely wooded area that exists today. The architectural historian attempted to locate the cemetery during the field survey but could not find any markers (Figures 7.57 and 7.58).

A. Google Earth  
Historical Imagery from  
2005 that Matches  
Description of Cemetery  
from 2000

B. Google Earth  
Historical Imagery  
from 2023 Showing  
Current Conditions

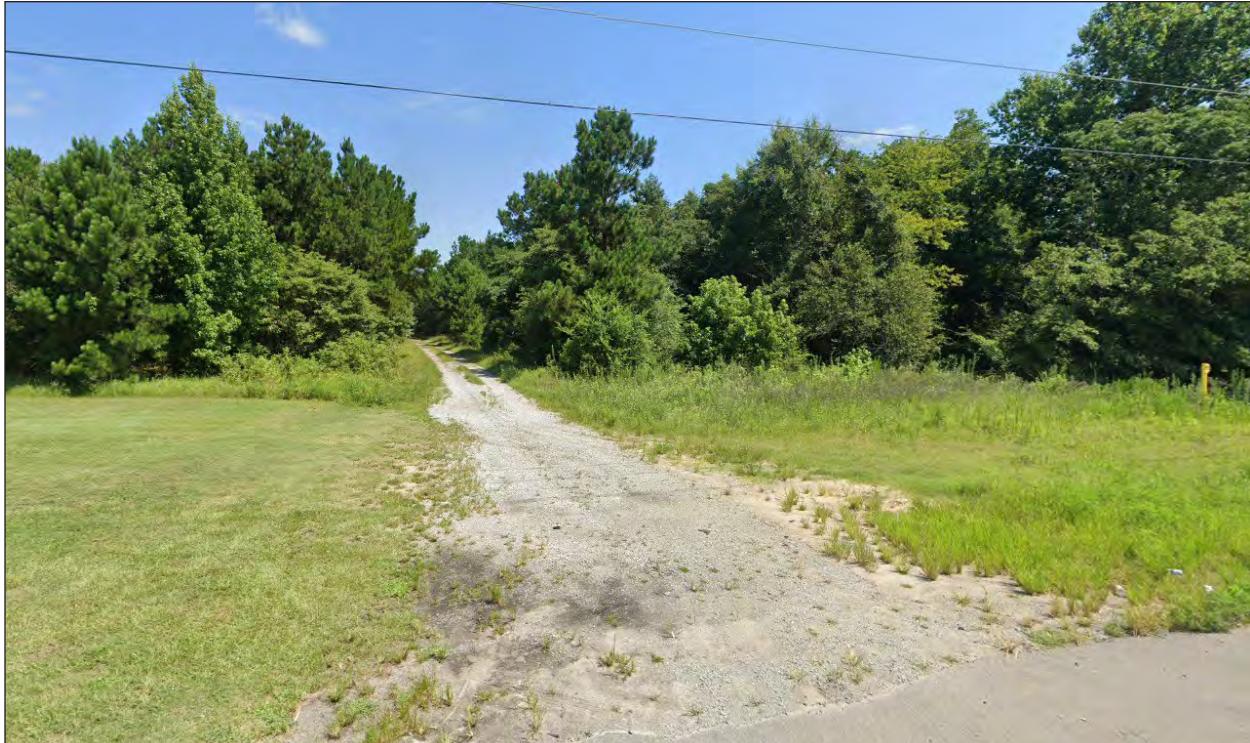
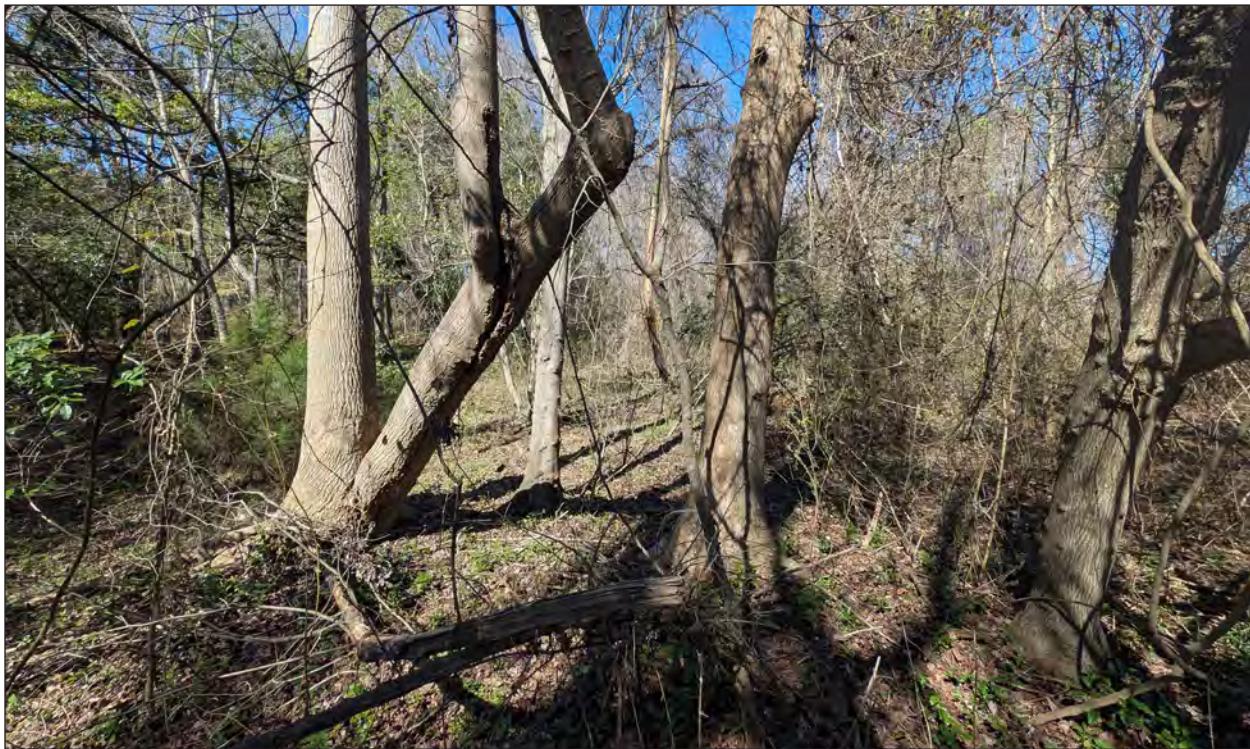
Figure 7.58.  
SHPO Site Number 0536, 2 of 2

A. View Looking Towards Cemetery from Private Dirt Drive, Looking East

B. View of the Cemetery Location Marked on the Find a Grave Website, Looking Northwest
