# **D-1: PHASE I CULTURAL RESOURCES SURVEY**

***RE: Phase I Cultural Resources Survey for the Proposed Widening of I-26 from Mile Marker 145-172, Orangeburg and Dorchester Counties, South Carolina and Phase I Cultural Resources Survey for the Proposed Widening of I-26 from Mile Marker 145 to 172 - ADDENDUM***

***SCDOT Project #: P041967 and 42454***

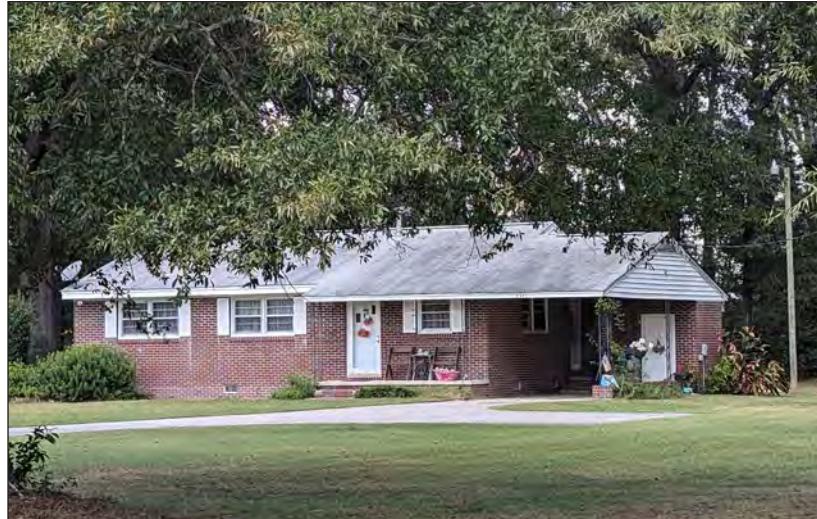
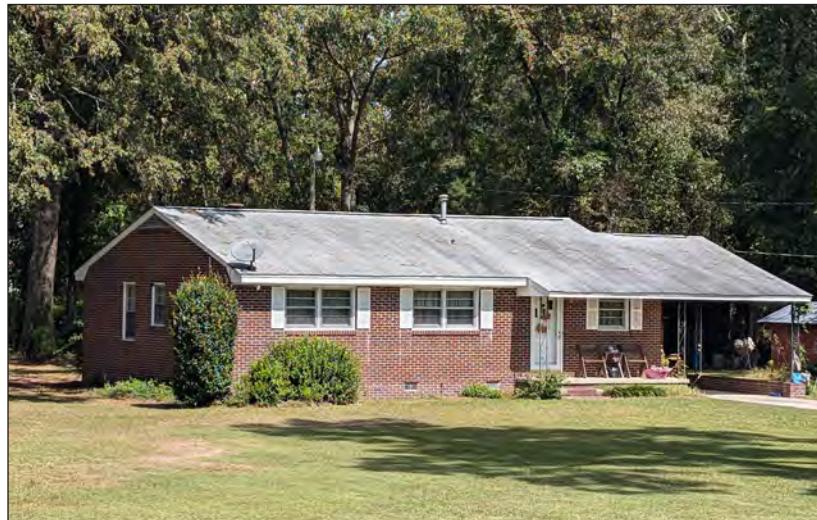
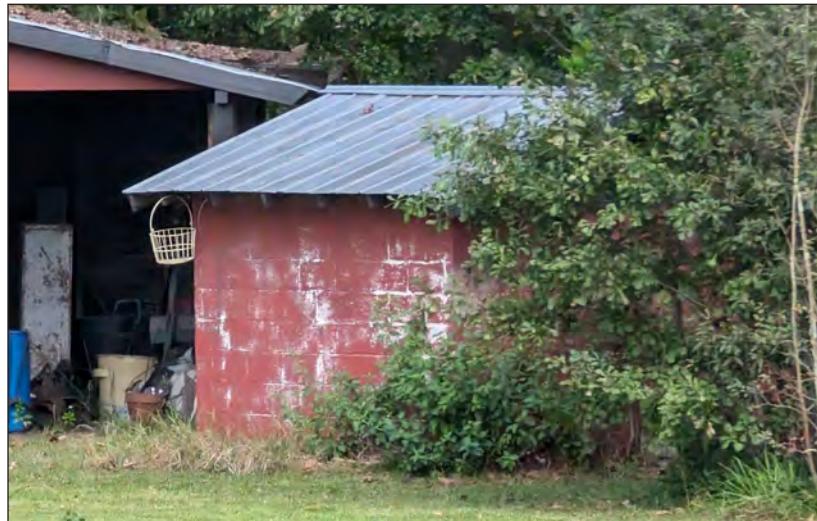
Figure 7.59.  
SHPO Site Numbers 0537 and 0537.01

contains three ascending glass panes from left to right at head height may be original. Both gable ends contain triangular louvered vents, but only the eastern gable end has vinyl cladding. The eaves are also vinyl or aluminum clad (Figure 7.59a and b).

SHPO Site Number 0537.01 is a concrete-block shed located approximately 30 feet east of the main house. It has a rectangular footprint and a gabled roof clad in PBR metal panels, and the primary façade is presumably the rear (north) elevation, because the entrance is not visible from the ROW. The foundation is not visible but is likely a slab or concrete block on a perimeter footing. Exposed rafter tails are visible along the lateral west elevation (Figure 7.59c). The frame garage or barn to the rear of the house does not appear in aerial imagery until the late 1980s, and the homeowner of SHPO Site Number 0538 (located directly across Five Chop Road) stated that it was moved there after he purchased his house in the early 1980s, so it was not assessed. SHPO Site Numbers 0537 and 0537.01 are situated on a trapezoidal 1.71-acre lot. The house is set back approximately 175 feet from Five Chop Road, and landscaping includes a large lawn with mature trees scattered throughout and ornamental shrubs and planting beds along the front and sides of the house.

A. Oblique, Looking Northwest

B. Oblique, Looking Northeast

C. SHPO Site Number 0537.01,  
Looking Northeast

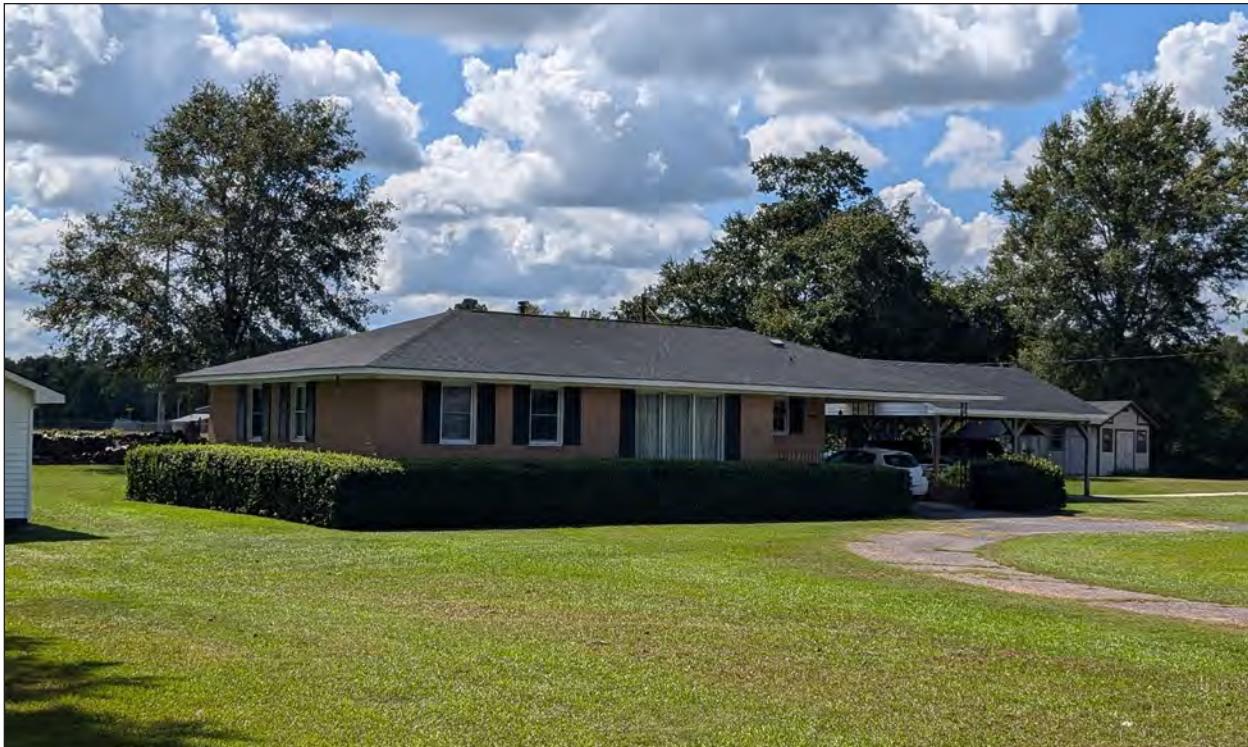
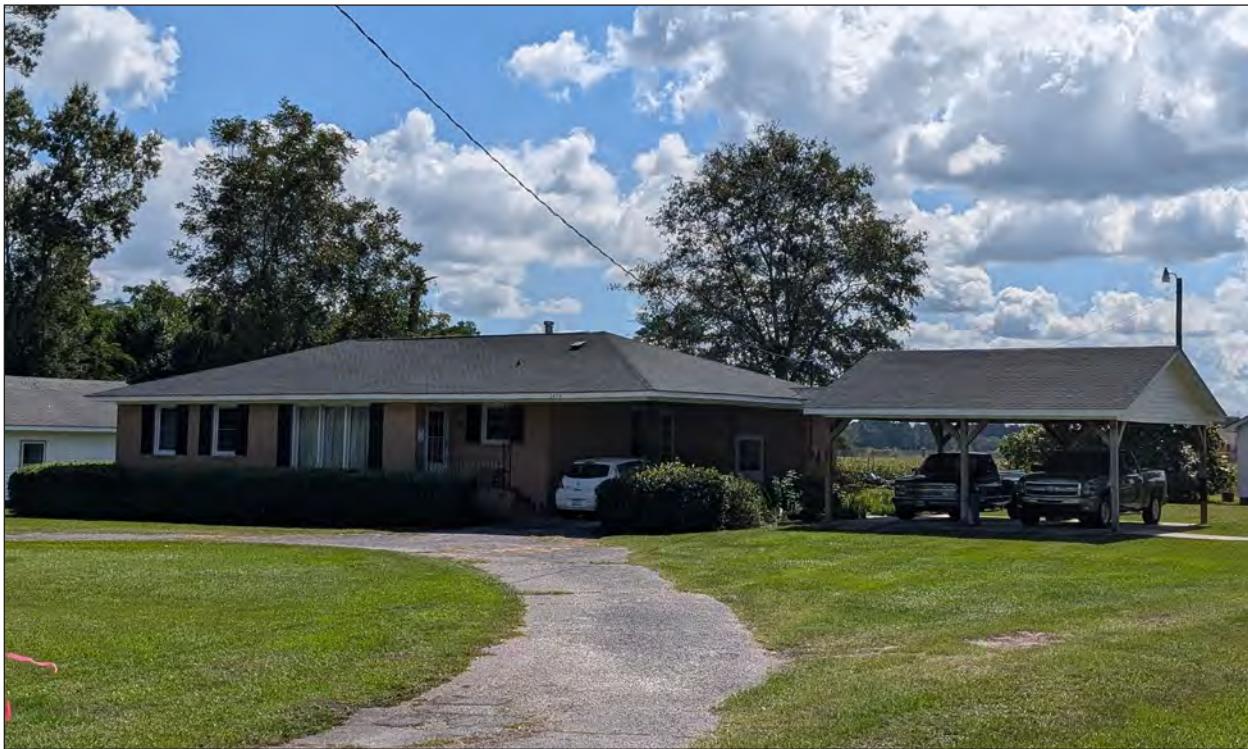
Figure 7.60.  
SHPO Site Number 0538

The frame house has a rectangular footprint with a hipped roof clad in composition shingles, and its brick veneer exterior conceals the foundation (Figure 7.60). The three-bay façade has windows of different sizes and types in each bay, and the entrance that is located in the western bay is oriented perpendicular to the road. A non-historic storm door obscures the actual front door, and an engaged raised porch with metal railings spans this bay. The roof overhang is supported by a single scrolled metal column at the corner of the porch and by two additional scrolled metal columns along the west side of the carport; a brick knee wall also runs along this side. Observable windows are non-historic vinyl sashes, though a triple set of fixed or casement windows is centered in the façade. The half-glazed and wood-paneled storage room door in the attached carport appears to be historic, and the wide overhanging eaves appear to be wooden. SHPO Site Number 0538 is situated on a trapezoidal 1.54-acre lot. The house has a setback of approximately 125 feet, and landscaping includes a large front lawn with a U-shaped driveway and a smaller backyard with small trees and non-historic outbuildings, while the eastern half of the lot is an undeveloped wooded area.

A. Oblique, Looking Southwest

B. Oblique, Looking Southeast

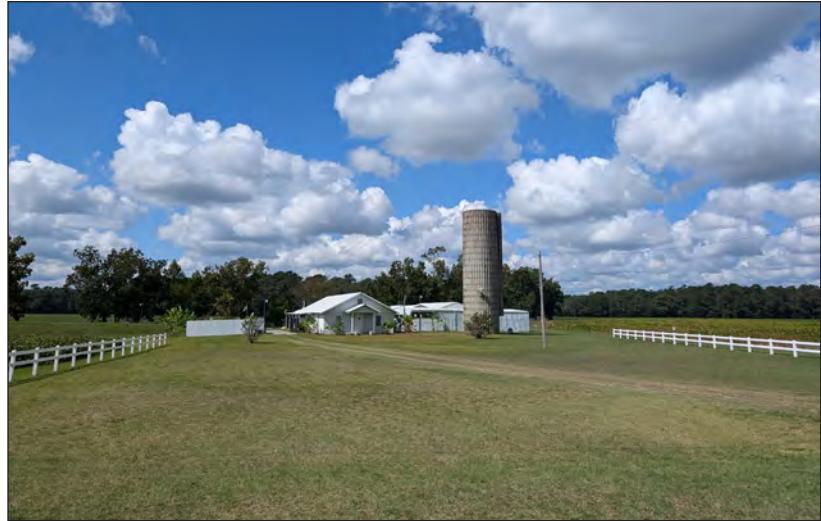
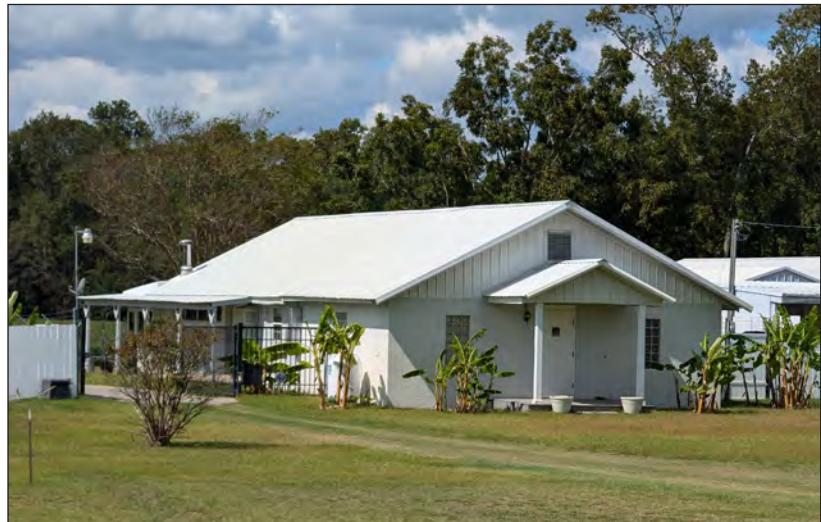
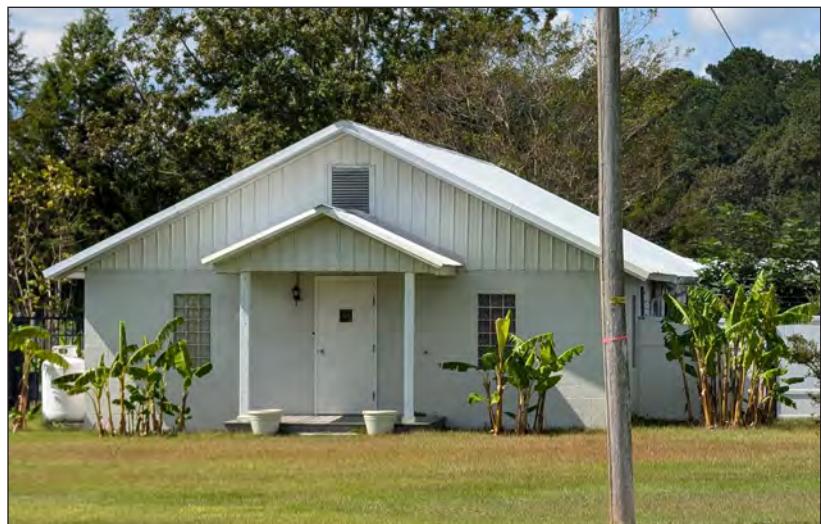
Figure 7.61.  
SHPO Site Number 0539

The concrete-block building has a rectangular footprint and a front-gabled roof clad in PBR metal panels. The entry-bay-only front porch is centered on the east elevation beneath a gable roof clad with the same metal material and supported on square wood posts. The outer façade bays each have 18-pane metal-frame windows. The porch gable end and main gable end above the eaves are also clad in PBR metal panels. A patio covered by a shed extension from the main roof spans the rear half of the south elevation, and there appears to be a frame addition on the rear (west) elevation. Side elevation windows are mostly non-historic vinyl sash. The foundation is not visible but is likely a slab or concrete block on a perimeter footing, and the eaves are metal clad (Figure 7.61).

A. Property Overview, Looking West

B. Oblique, Looking Northwest

C. Oblique, Looking Southwest

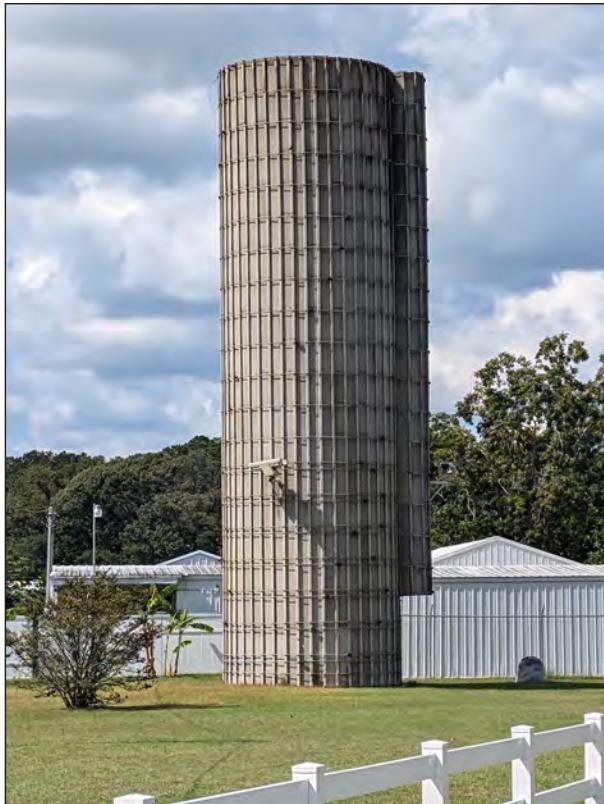
Figure 7.62.  
SHPO Site Number 0539.01

SHPO Site Number 0539.01 is a monolithic silo with a ribbed concrete structure ringed in steel bindings. The ladder appears to be contained within a second cylindrical structure attached to the silo's north side. This silo type generally has a spherical roof, but the 1974, and perhaps even the 1958, aerial imagery seems to show the roof missing, so it is unclear how long it has had an exposed top and/or has been nonfunctional (Figure 7.62). SHPO Site Numbers 0537 and 0537.01 are set back approximately 175 feet from Homestead Road and are situated on a multi-parcel approximately 295-acre lot that contains a mix of agricultural and forest land. Only the parcel with the surveyed resources contains buildings, but all of the other buildings on this parcel were constructed after 1994 (as was the pond on the south side of the buildings), so they were not assessed.

A. SHPO Site Number 0539.01, Looking  
Northwest

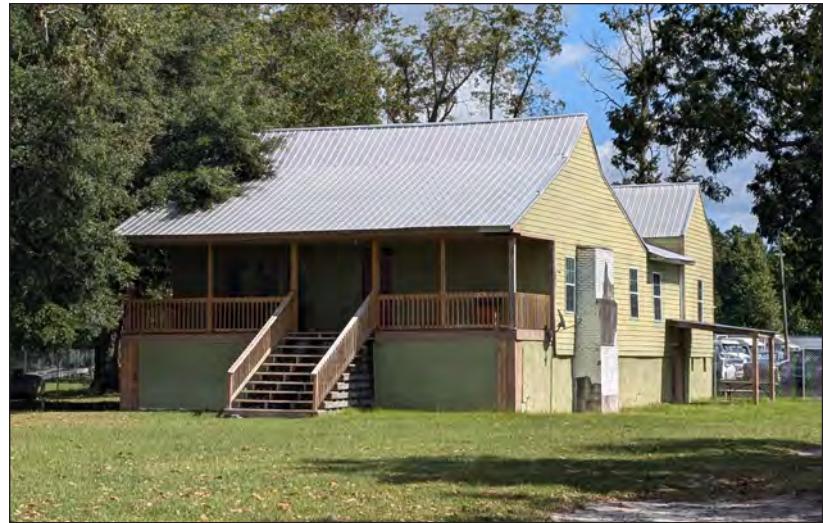
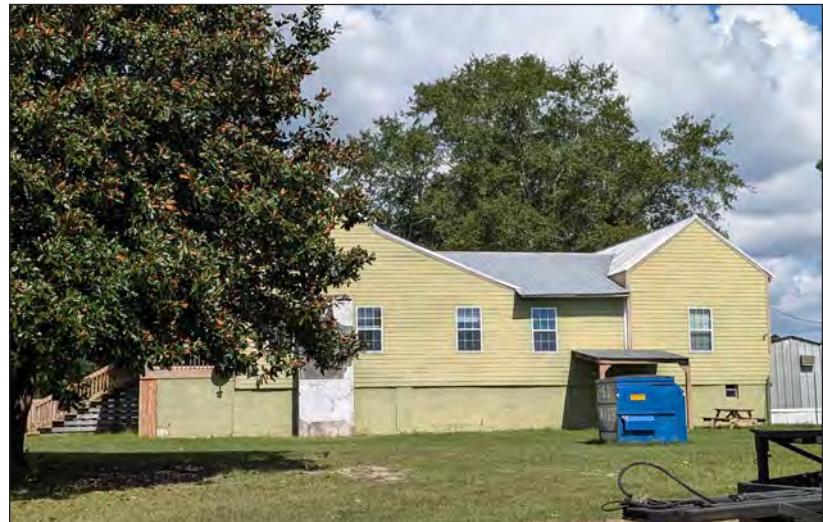
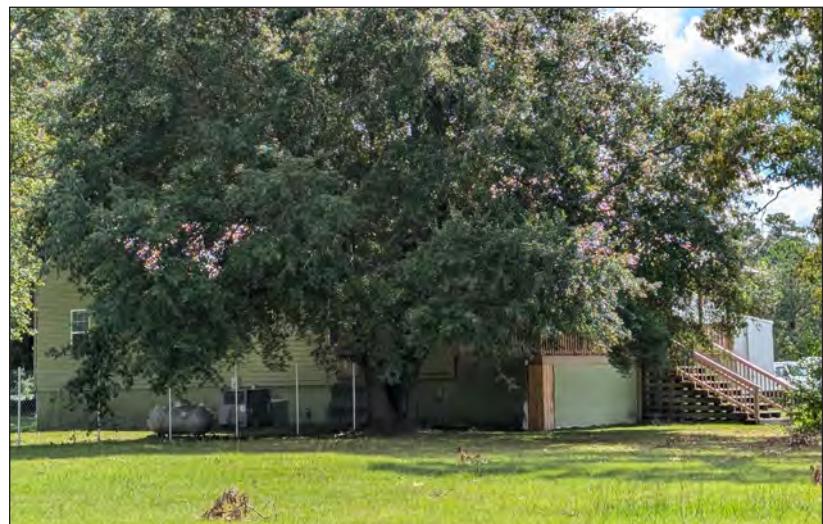
Figure 7.63.  
SHPO Site Number 0540

The front roof slope has a pitch break in line with the façade, and the full-façade front porch is sheltered by the roof below the pitch break. The façade has an offset front door and a triple set of vertical three-over-one wood sash windows to the left of the door. The doorway is centered on the front steps, which are off-center to the right, and contains a non-historic door. Google Maps Streetview imagery from 2008 shows that there were originally windows on the right side of the door that were removed or enclosed by 2013. That imagery also shows both that the chimneys on the gable ends of the historic core still extended to their full heights as recently as 2015, but that they had been truncated by 2023. The raised porch has unpainted wooden railings, and the roof is supported along the front by square wood posts. The building is clad in cementitious fiberboard siding, and the roof is clad in PBR metal panels and, except for the triple window on the façade, all observable windows are non-historic vinyl units (Figure 7.63).

A. Oblique, Looking Northeast

B. South Elevation, Looking  
North

C. Oblique, Looking Southeast

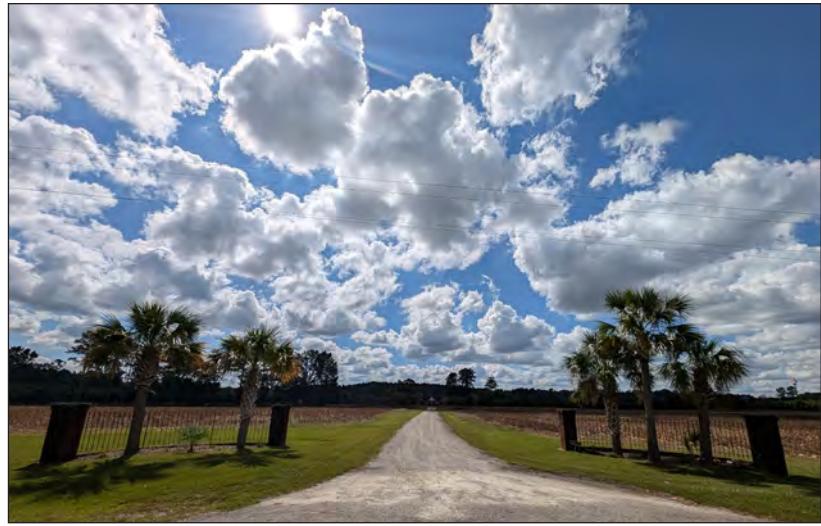
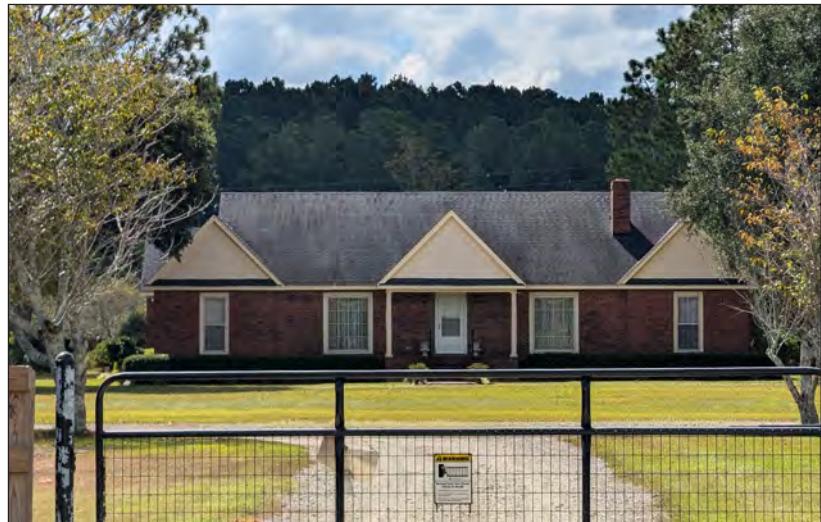
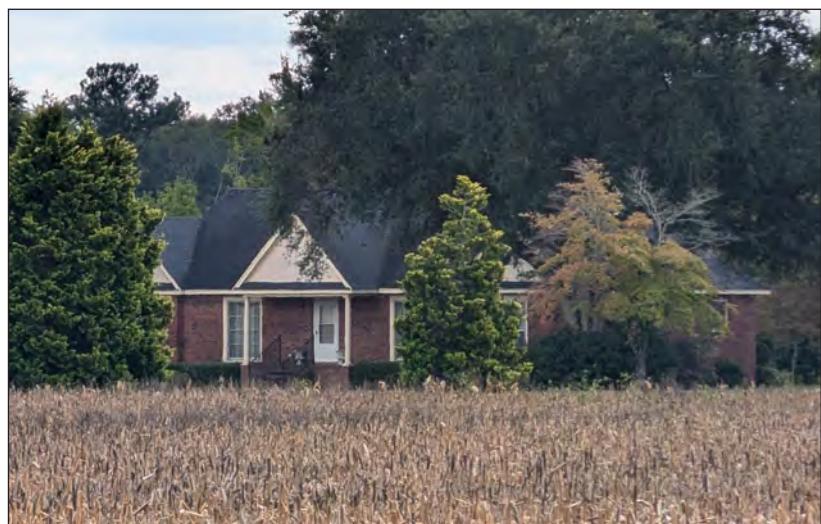
Figure 7.64.  
SHPO Site Number 0541

The house has a symmetrical five-bay façade, a rectangular footprint, and a laterally gabled roof clad in composition shingles. The house's brick veneer exterior conceals the foundation. The front slope features three front gables in line with the center and outer bays of the façade. Single sash windows are centered below the outer gables, and the façade beneath these gables is slightly stepped out, while the central gable extends forward several feet to shelter the entry-bay-only front porch. The porch roof is supported at the corners by Tuscan wooden columns, and a set of brick steps with metal railings ascends to the raised porch. The front door appears to be non-historic, and the bays flanking the entrance both contain fixed 16-pane windows. An interior brick chimney is located in the front slope behind the west-end front gable. A few sash windows punctuate the west side, which is the only other elevation that is partially visible from the ROW, and all of the observable windows are vinyl replacements. The garage attached to the rear (south) elevation at the east end is visible in 1974 aerial imagery, so it is original, but it cannot be seen from the ROW (Figure 7.64).

A. Property Overview from ROW,  
Looking South

B. Façade, Looking South

C. Oblique, Looking Southeast

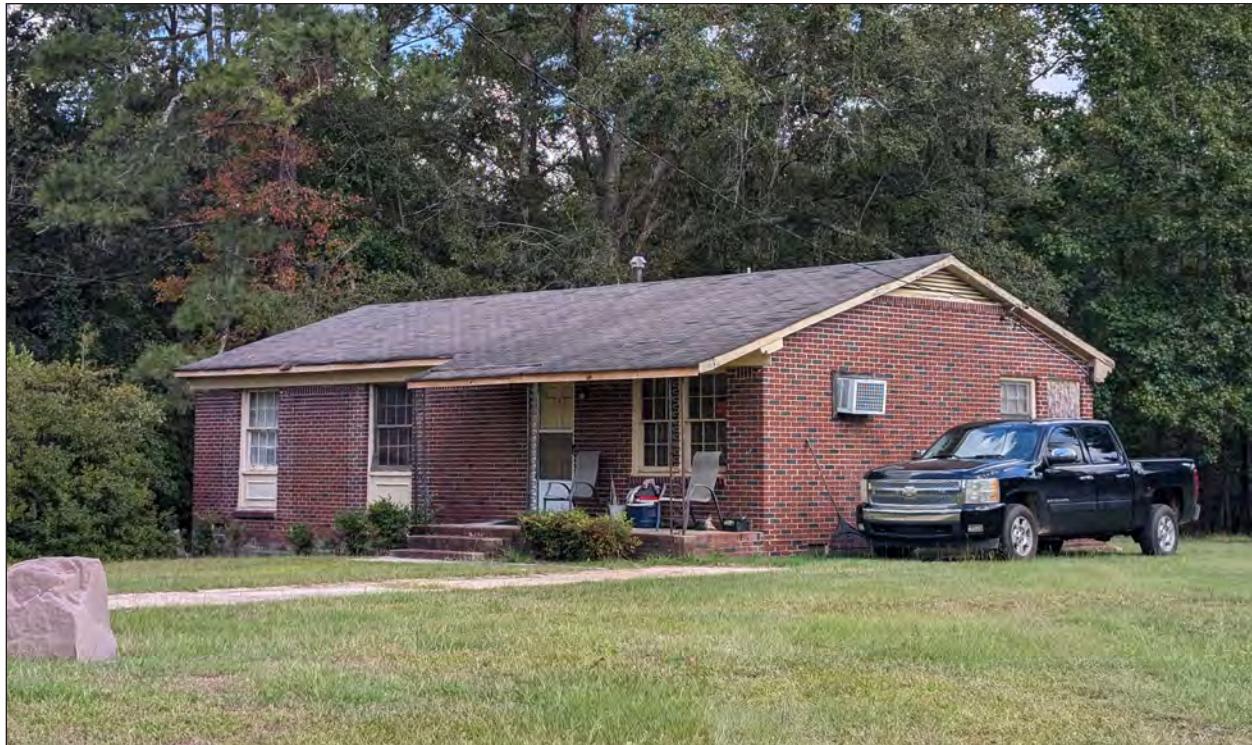
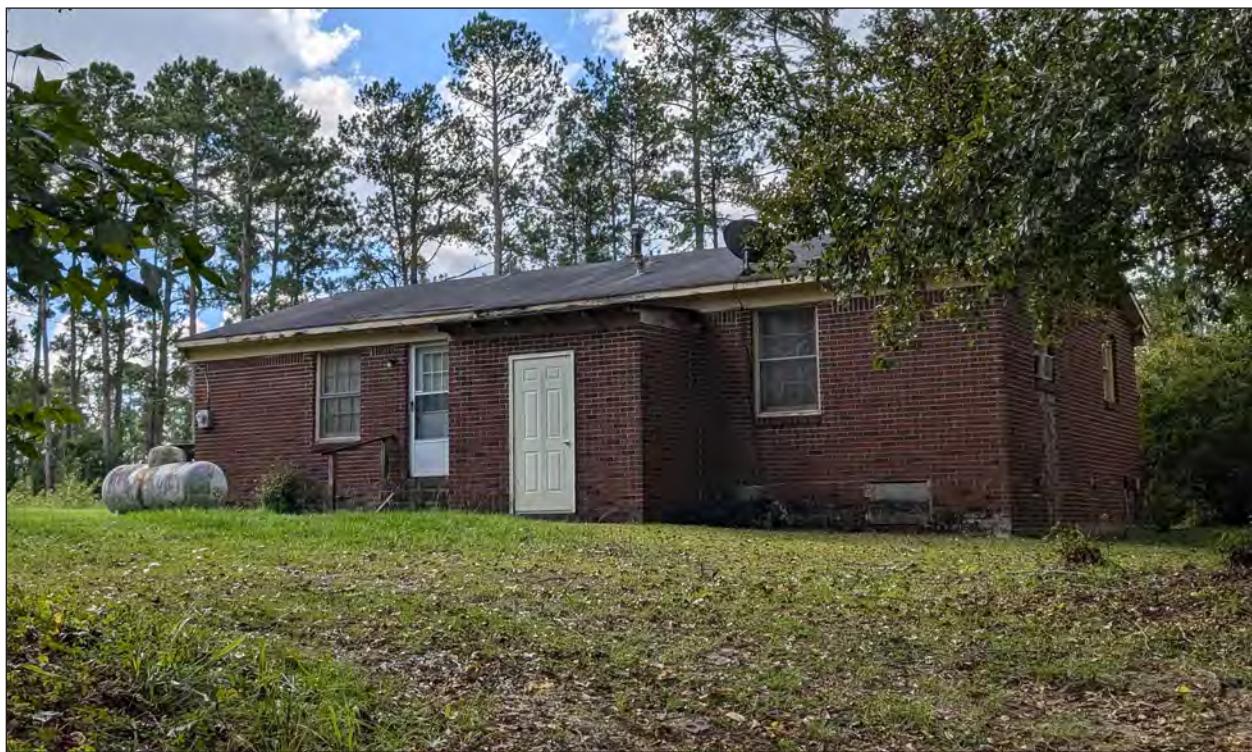
Figure 7.65.  
SHPO Site Number 0542

The four-bay façade has single windows in the northern bays, while the southern bays are sheltered beneath an extension of the front roof slope that contains the main entrance in the inner bay and a set of paired windows in the outer. The single windows are eight-over-eight double-hung wood sashes with inset molded wood panels below and brick sills. The paired windows are six-over-six double-hung wood sashes, and the entrance contains a wood-paneled door. The roof extension is supported by scrolled metal columns, and the raised porch is accessed by a set of brick steps. There is a back door (east elevation) and a boarded side entry on the south side, and windows on the sides and rear are six-over-six wood sash of varying sizes; a shed roof storage room is appended to the rear. The storage room has exposed rafter tails, while the core has boxed wooden eaves with a decorative soldier course on the lateral elevations below the frieze (Figure 7.65).

A. Oblique, Looking Northeast

B. Rear Oblique, Looking Southwest

SHPO Site Number 0542 faces west from its site on Midside Road. The Orangeburg County Tax Assessor records indicate this Compact Ranch House was built in 1953. However, it does not appear in 1958 or 1963 aerial imagery but is visible in 1973, so it is assumed to have been built circa 1968. The frame house has a rectangular footprint with a laterally gabled roof clad with composition shingles, and its brick veneer exterior conceals the foundation.

SHPO Site Number 0542 is situated on a multi-parcel 19.07-acre lot that is bisected by I-26; the parcel on the west side of I-26 contains a building, but it was not constructed until after 1983, so it was not assessed. SHPO Site Number 0542 has a setback of approximately 65 feet from Midside Road and approximately 200 feet from I-26, with a tree stand in between the roadways. Landscaping includes a surrounding lawn with small trees and shrubs and an open field on the south side of the house, but the parcels are primarily undeveloped forest land.

SHPO Site Number 0542 was evaluated for the NRHP under Criteria A, B, and C. Under Criteria A and B, the resource is not known to be associated with events or persons significant in the past. The house is located on property described as the Brunson Rush Estate that was conveyed to Brunson Rush in 1953 and that remained in his name until 2022, but, although he served in the Korean War and established a local business called Rush's Snack Bar, these attributes do not elevate Rush or his estate to the level of significance required for eligibility under Criteria A or B (OCROD 2111:94-98; The Times and Democrat 2012). Under Criterion C, Site Number 0542 was evaluated for significance in the area of architecture. SHPO Site Number 0542 is a Compact Ranch House, but it is not a distinctive or noteworthy example of this house type, which is common in South Carolina. The house was not found to possess significance for its engineering or materials. Therefore, the resource is recommended not eligible for the NRHP under Criteria A, B, or C.

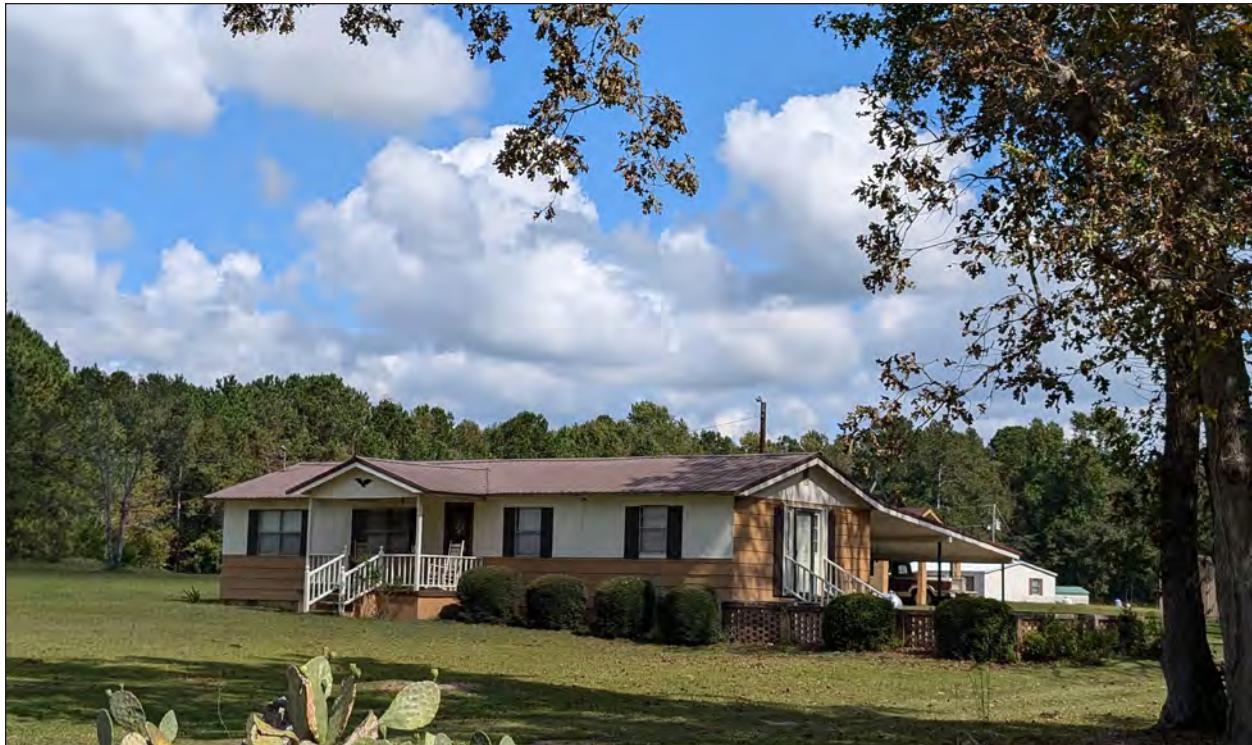
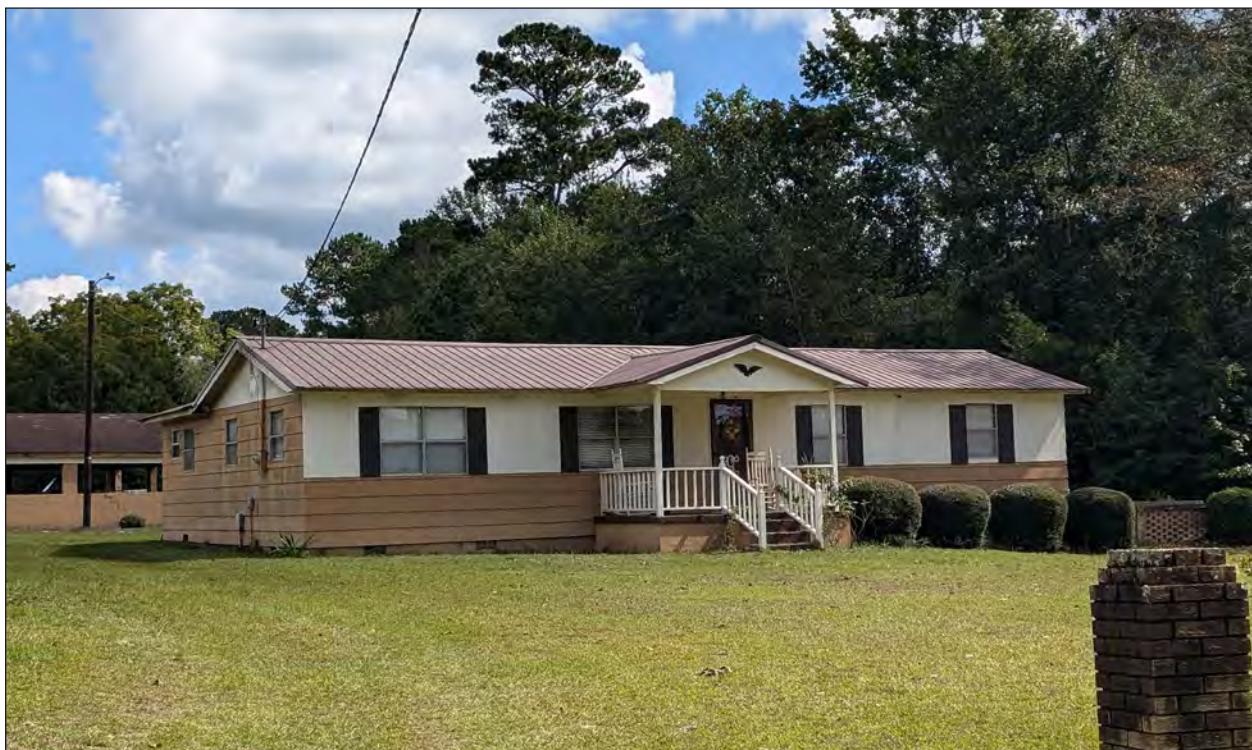
Figure 7.66.  
SHPO Site Number 0543

The frame house has an asymmetrical, five-bay façade with single windows in the southern bays and paired windows in the northern bays. The front entrance is within the centrally located porch, consisting of a gable roof supported by square wood posts. The front door is non-historic, and the windows are one-over-one metal sash. The north elevation has several windows spaced across it, while an entry with half-glazed and wood-paneled sidelights and a non-historic door is centered in the south elevation. The wooden eaves on the core are open, while the gable addition has boxed wooden eaves. The house has a continuous concrete-block foundation (Figure 7.66).

A. Oblique, Looking Northeast

B. Oblique, Looking Southeast

SHPO Site Number 0543 is situated on an approximately one-acre lot. The house has a setback of approximately 120 feet from Midside Road and approximately 215 feet from I-26, with a tree stand in between the roadways. Landscaping includes a lawn with some shrubs and a few mature trees, as well as a lattice brick wall that encircles a small yard on the south side of the house and wraps around to connect to the rear covered patio.

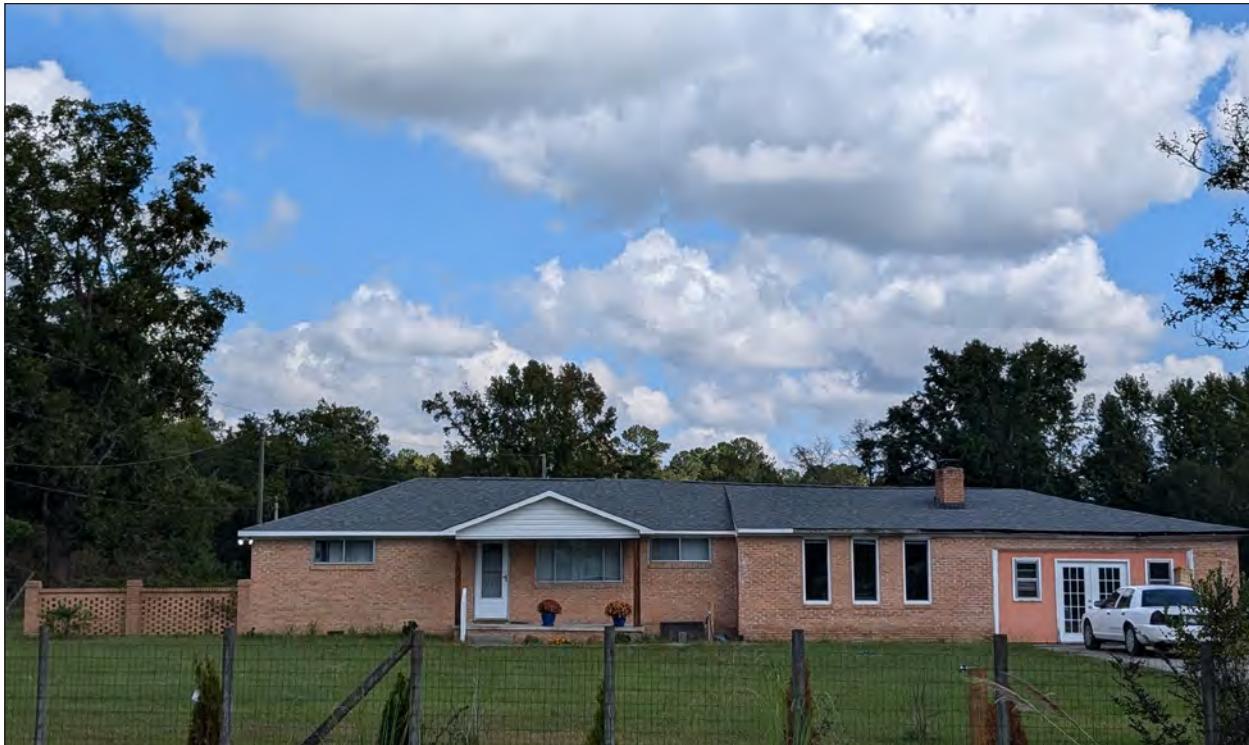
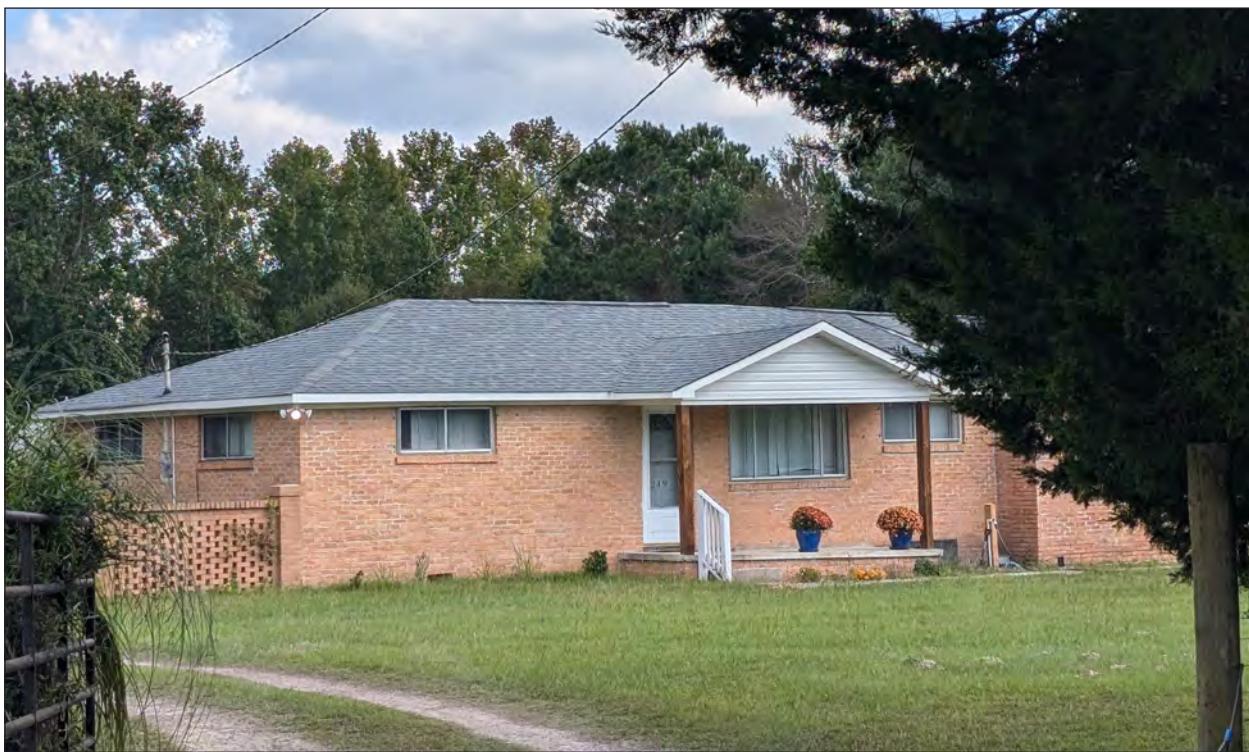
Figure 7.67.  
SHPO Site Number 0544

SHPO Site Number 0544 faces west from its site on Midside Road. The Orangeburg County Tax Assessor records indicate this modified Linear Ranch House was built in 1958. However, the house does not appear in 1958 aerial photography but is visible in 1963, so it is assumed to have been built circa 1960. The house has a rectangular historic core with a hipped roof clad in composition shingles, and the exterior is clad in brick veneer that conceals the foundation. The façade projection seems to appear in 1983 aerial imagery, while the extension at the south end and the cross-gabled addition on the rear (east) elevation are visible in aerial imagery by 1994. The house has an asymmetrical façade with roughly three bays in the core section and two wide bays in the stepped-out southern section. The central core bay is sheltered by a gable roof that extends from the main roof to cover the raised porch that contains the entry and a picture window with flanking windows. The bays on either side of the porch have two-pane sliding windows, and these windows are all metal frame. The expanded façade has three tall, rectangular, fixed windows and what was originally a garage, but the opening was enclosed with a frame wall that contains a double-leaf doorway with flanking windows. The north elevation has two of the two-pane

sliding windows above head height, and there is an interior brick chimney in the front slope that may have originally been an exterior chimney on the south elevation prior to the façade expansion/addition (Figure 7.67).

A. Façade, Looking East

B. Oblique, Looking Southeast

SHPO Site Number 0544 was evaluated for the NRHP under Criteria A, B, and C. Under Criteria A and B, the resource is not known to be associated with events or persons significant in the past. Under Criterion C, Site Number 0544 was evaluated for significance in the area of architecture. SHPO Site Number 0544 is a Linear Ranch House, but it is not a distinctive or noteworthy example of this house type, which is common in South Carolina. It was not found to embody the distinctive characteristics of a period or method of construction and does not possess significance for its engineering or materials, and its integrity is negatively impacted by alterations that include additions and added non-historic windows, doors, and siding materials. Therefore, the resource is recommended not eligible for the NRHP under Criteria A, B, or C.

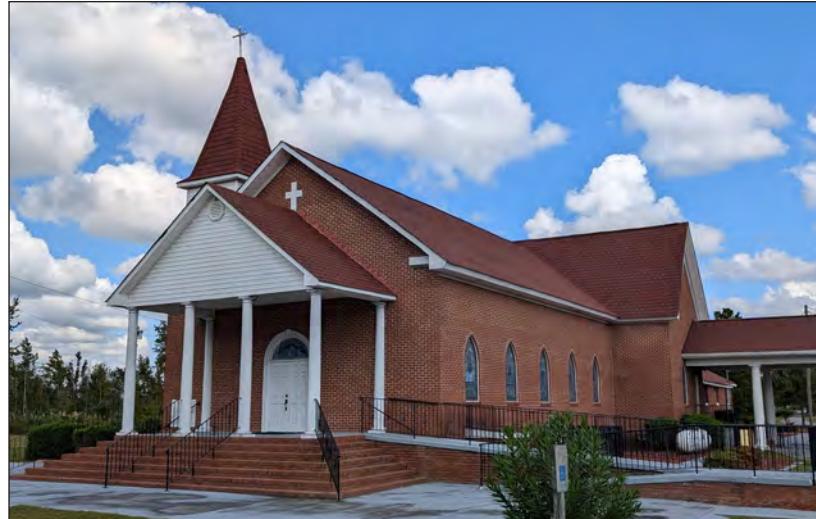
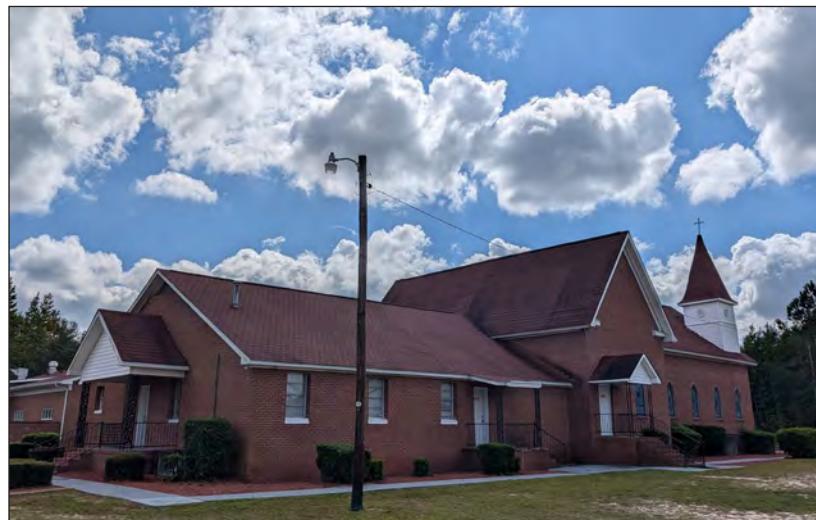
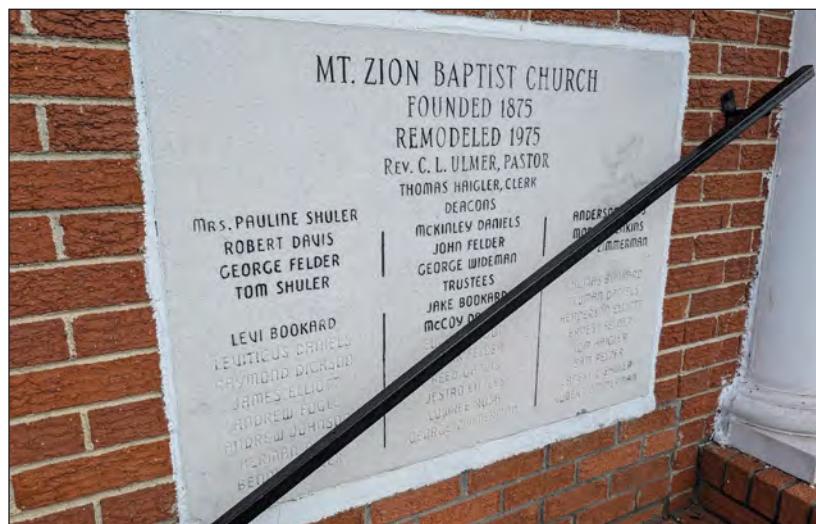
Figure 7.68.  
SHPO Site Number 0545

The T-shaped core sits on a raised foundation that is concealed by the brick veneer exterior. The one-and-a-half-story front-gabled building has a cross-gabled core, a front-gabled porch roof, and a pyramidal tower with a crucifix finial rising from the western slope of the core roof, all clad in composition shingles. The porch roof gable end and tower exterior are clad in vinyl siding, and the porch roof is supported by four Tuscan wood columns and two pilasters (Figure 7.68). The façade (south elevation) contains a central double-leaf door with fluted casings and an arched stained-glass transom, and a painted white crucifix is centered on the façade above the porch roof. The stairs ascending to the front porch are three-sided. The side elevations (east and west) each have five bays that contain Gothic-arched stained-glass windows. The gable ends of the cross-gabled section each have one Gothic-arched stained-glass window and one doorway. The doorway on the west gable end is sheltered by a small gable roof supported by scrolled metal columns and is accessed by a set of brick stairs, while the doorway on the east gable end leads to the breezeway and 2012 addition. The boxed eaves are clad with vinyl and aluminum. The rear wing has matching brick veneer, and there are raised entrances within gable roofs also supported by scrolled metal columns on the west and north sides. The doors are non-historic, and the windows are all horizontal two-over-two metal sashes.

### A. Oblique, Looking Northwest

### B. Rear Oblique, Looking Southeast

### C. Cornerstone Detail

The church cornerstone states that the congregation was founded in 1875, but it was likely convened at a different location before erecting a building at the current site. The “History” page on the church’s website is blank and provides no information in this regard, and the land on which the church sits was donated to the congregation “by deed of Jacob and Martha Elliott dated February 24, 1886 and recorded August 17, 1912,” so even the deed is unclear as to whether the congregation may have settled here in the 1880s or around 1912 (OCROD 1425:4-9). In addition, although burials in the churchyard indicate it was established around 1915, the land only passed into the church’s possession between the 1940s (primary burial ground) and the 1980s (western section; OCROD 1425:4-9). The cornerstone also states that the building was remodeled in 1975. This is supported by the fact that 1974 aerial imagery only shows the cross-gabled core, and that the rear wing is then visible in 1983 aerial imagery. A gabled structure that was located on the west side of the church appeared by 2011 but was gone by 2017, while the large addition on the east side connected by a breezeway was built in 2012.

SHPO Site Number 0545 was evaluated for the NRHP under Criteria A, B, and C. Beyond those events and persons associated with its establishment and expansion from the early through the late twentieth century, the building is not known to be associated with past events or persons significant in the larger context of Orangeburg County’s religious history. Under Criterion C, Site Number 0545 was evaluated for significance in the area of architecture. SHPO Site Number 0545 is not a noteworthy example of a church building.

In addition to being one of dozens of churches in Orangeburg County, SHPO Site Number 0545 is much less ornate and more altered than some of the comparable examples. It was not found to embody the distinctive characteristics of a period or method of construction, and does not possess significance for its engineering or materials, and it does not retain integrity due to the alterations that include additions and added non-historic materials. Therefore, the resource is recommended not eligible for the NRHP under Criteria A, B, or C.

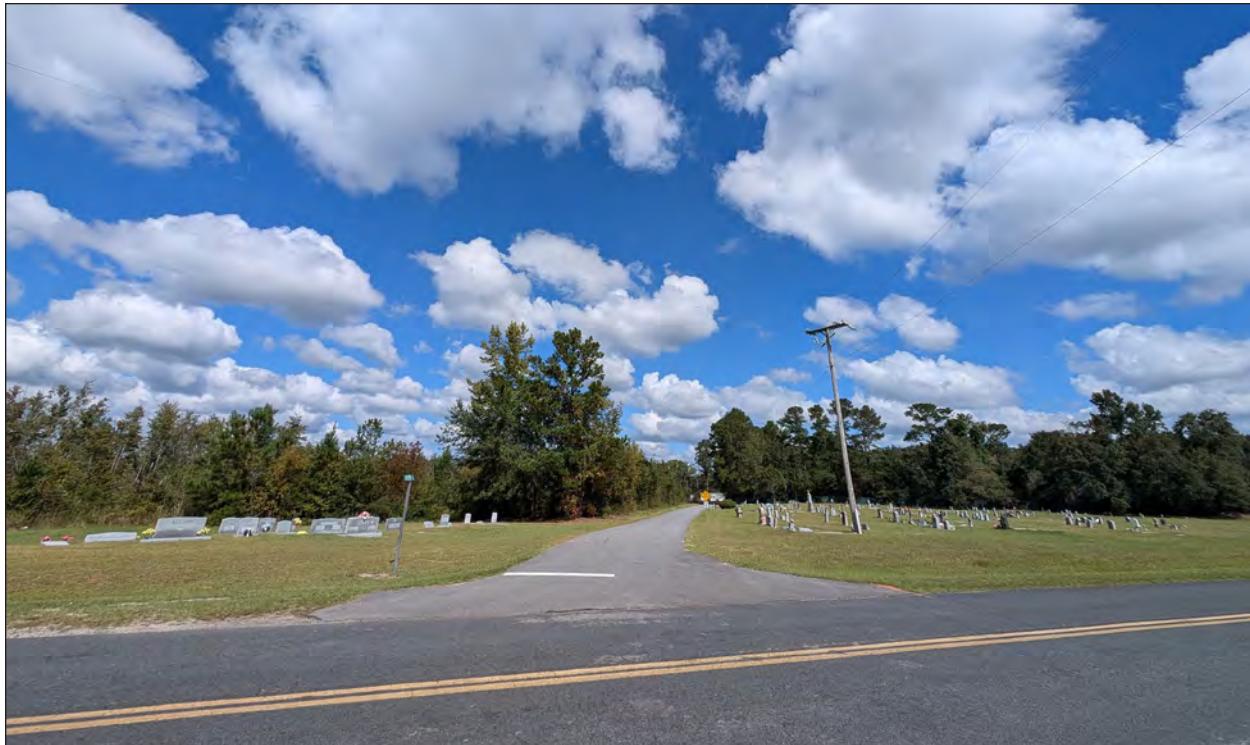
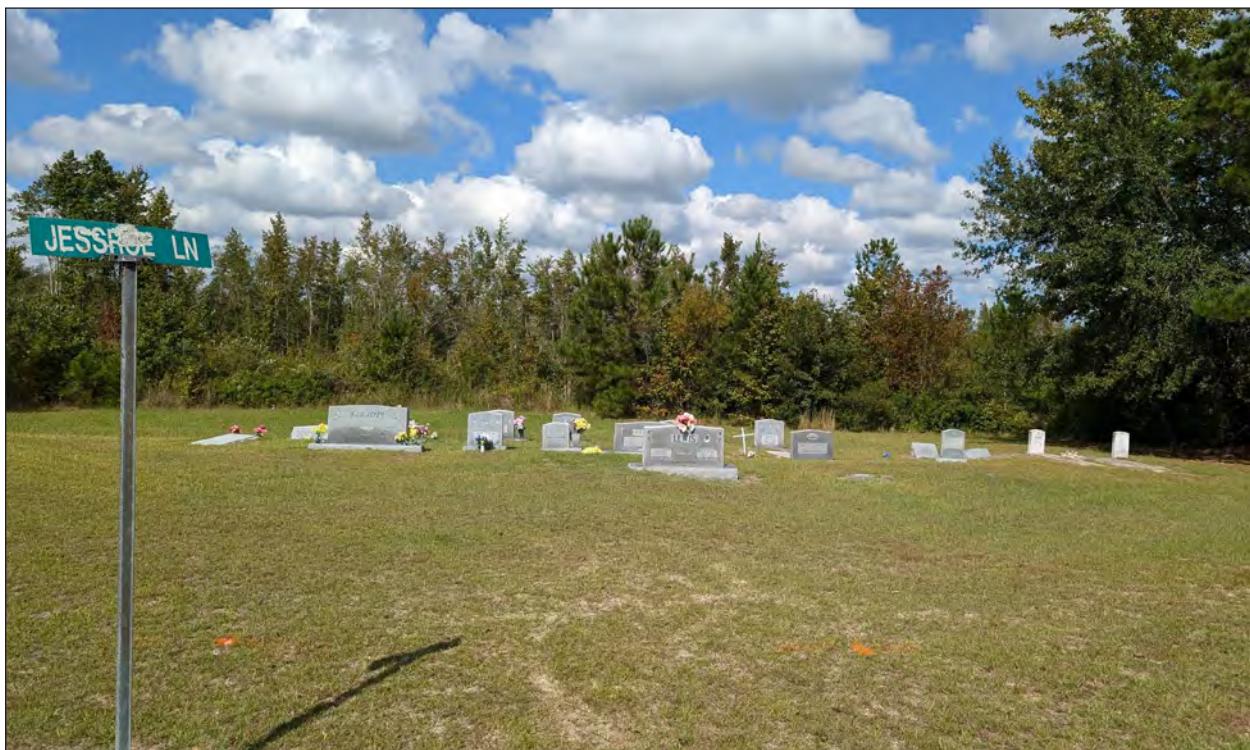
Figure 7.69.  
SHPO Site Number 0545.01, Cemetery Overviews, 1 of 2

southwestern corner, and the smaller yard on the west side contains around 20 markers that all date to the late twentieth to early twenty-first century. Find A Grave lists 66 memorials in the cemetery, but a rough estimate based on aerial imagery is that there are probably between 200 and 300 marked graves (Find A Grave 2017). In addition to the roadside parking along Jessroe Lane, there is a gravel pullout on Arista Road, but the cemetery has no gate, formal entry, or signage (Figures 7.69 and 7.70).

Graves are clustered in a grass clearing that has a wooded buffer along the north side, and markers in the main yard all face southwest, while those in the small western section face southeast. Modern graves are roughly arranged in rows, while the historic markers are more scattered. Many graves, both modern and historic, are covered with concrete ledgers, and some even have a metal cover atop the ledger. There are several vernacular memorials, including the poured concrete marker for Sallie Boyd that dates to 1917, while one of the more formal markers is the acorn-capped, obelisk-inspired marble monument for Reverend Jacob C. Elliot, who died a few months after Mrs. Boyd (Figure 7.71). Historic gravestones range from arched to flat-topped tablets and from obelisks to Woodmen of the World memorials, while non-historic gravestones are mostly arched tablets, although some are in shapes such as hearts. There are several shared graves, but the dominant type remains single burials, and grave goods include flags, flowers, and candles. From Find A Grave, “families buried here include the Adams, Berry, Canady, Carson, Corbitt, Coulter, Crum, Dantzler, Dickson, Felder, Fogle, Funchess, Glover, Hellard, Jenkins, Johnson, Kelly, Lee, Lewis, McDaniel, Moorer, Rhines, Shuler, Sweat, Williams and Yongue” (Find A Grave 2017). A number of these names appear on the cornerstone, and both the current congregation and those buried in the cemetery are predominantly of African American descent.

A. Jessroe Lane Bisecting the Cemetery at the Southwestern Corner, Looking North

B. Burial Plot on the West Side of Jessroe Lane, Looking Northwest
