# **D-1: PHASE I CULTURAL RESOURCES SURVEY**

***RE: Phase I Cultural Resources Survey for the Proposed Widening of I-26 from Mile Marker 145-172, Orangeburg and Dorchester Counties, South Carolina and Phase I Cultural Resources Survey for the Proposed Widening of I-26 from Mile Marker 145 to 172 - ADDENDUM***

***SCDOT Project #: P041967 and 42454***

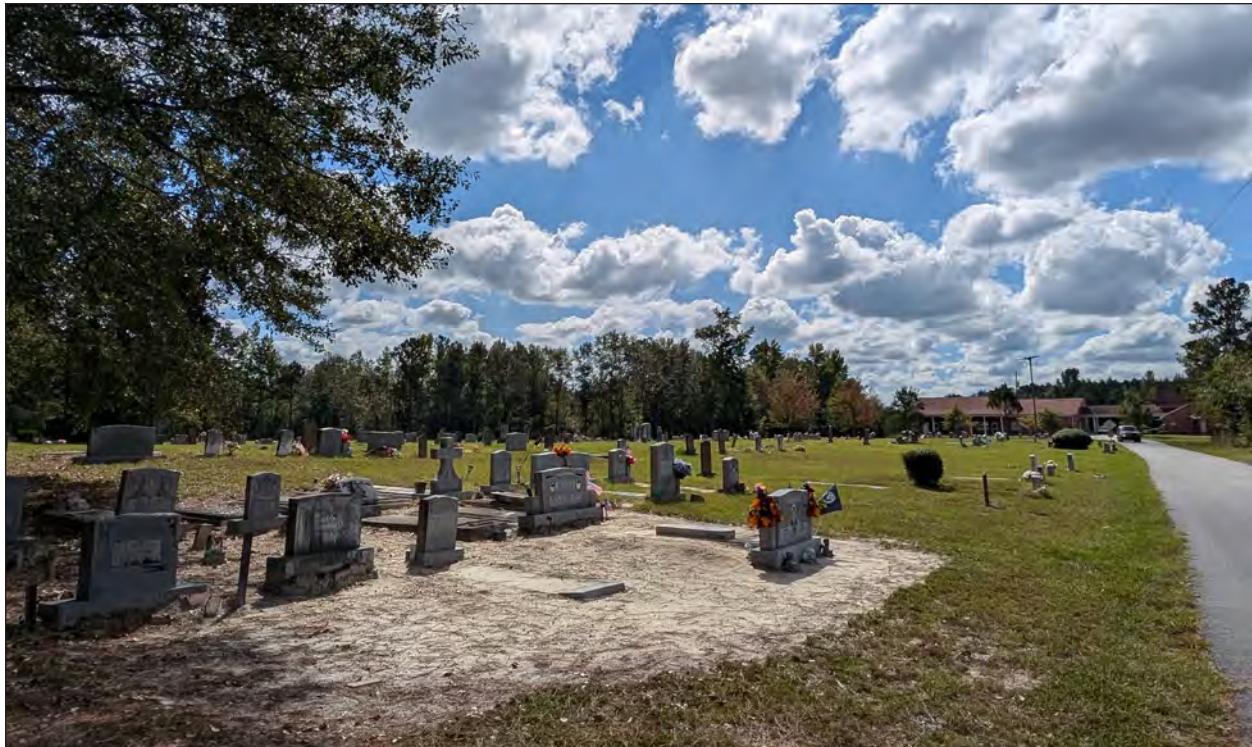
Figure 7.70.  
SHPO Site Number 0545.01, Cemetery Overviews, 2 of 2

southwestern corner, and the smaller yard on the west side contains around 20 markers that all date to the late twentieth to early twenty-first century. Find A Grave lists 66 memorials in the cemetery, but a rough estimate based on aerial imagery is that there are probably between 200 and 300 marked graves (Find A Grave 2017). In addition to the roadside parking along Jessroe Lane, there is a gravel pullout on Arista Road, but the cemetery has no gate, formal entry, or signage (Figures 7.69 and 7.70).

A. Primary Burial Ground Overview from Jessroe Lane, Looking South

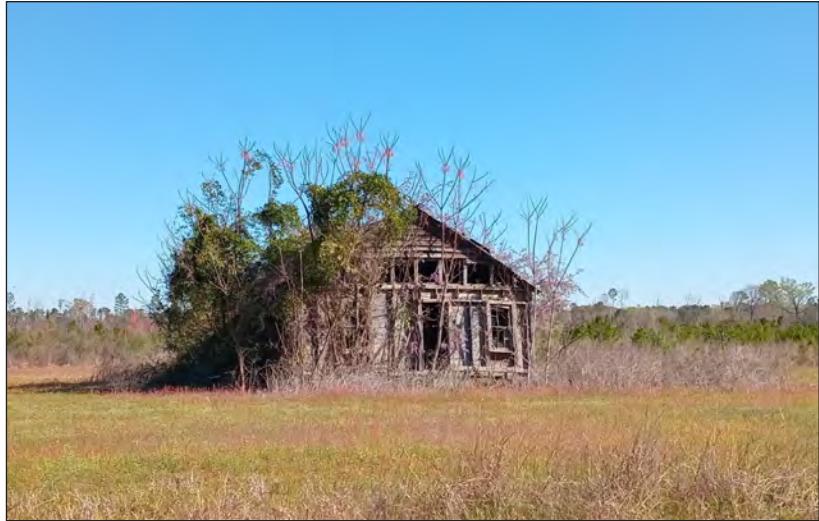
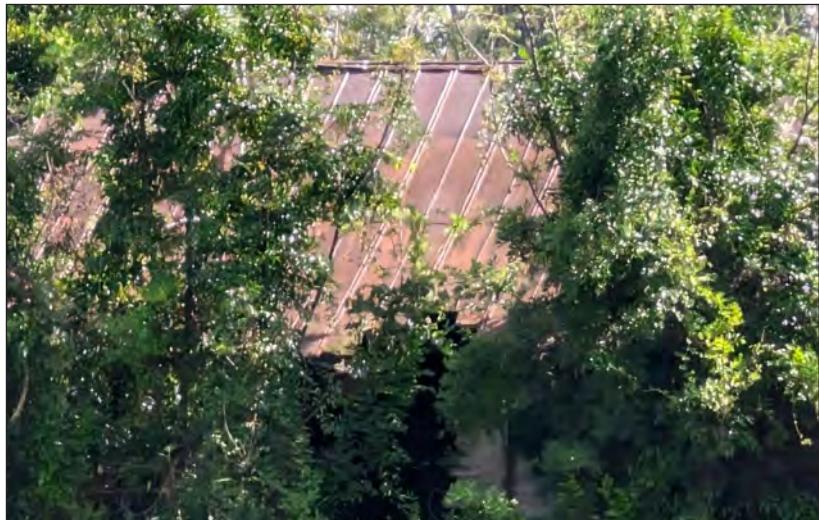
Figure 7.72.  
SHPO Site Number 0546

The details that are, in fact, visible from the ROW are few. The building has a gabled metal roof with the ridge running north to south, but the level of overgrowth completely obscures anything else in terms of form or materials, although the exterior material is most likely unpainted weatherboard siding (Figure 7.72). Google Earth Historical Imagery and Google Streetview imagery, however, provide a few more details.

A. South Elevation, Looking  
North

B. West Elevation Detail,  
Looking Northeast

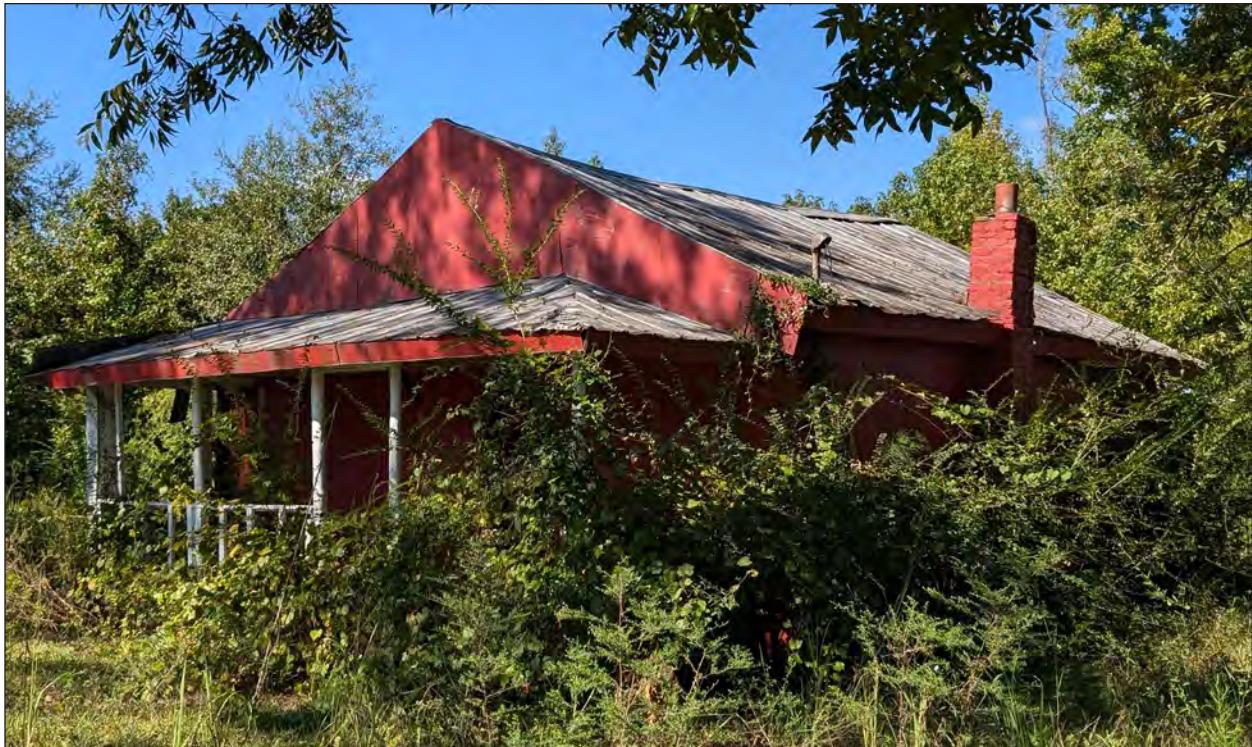
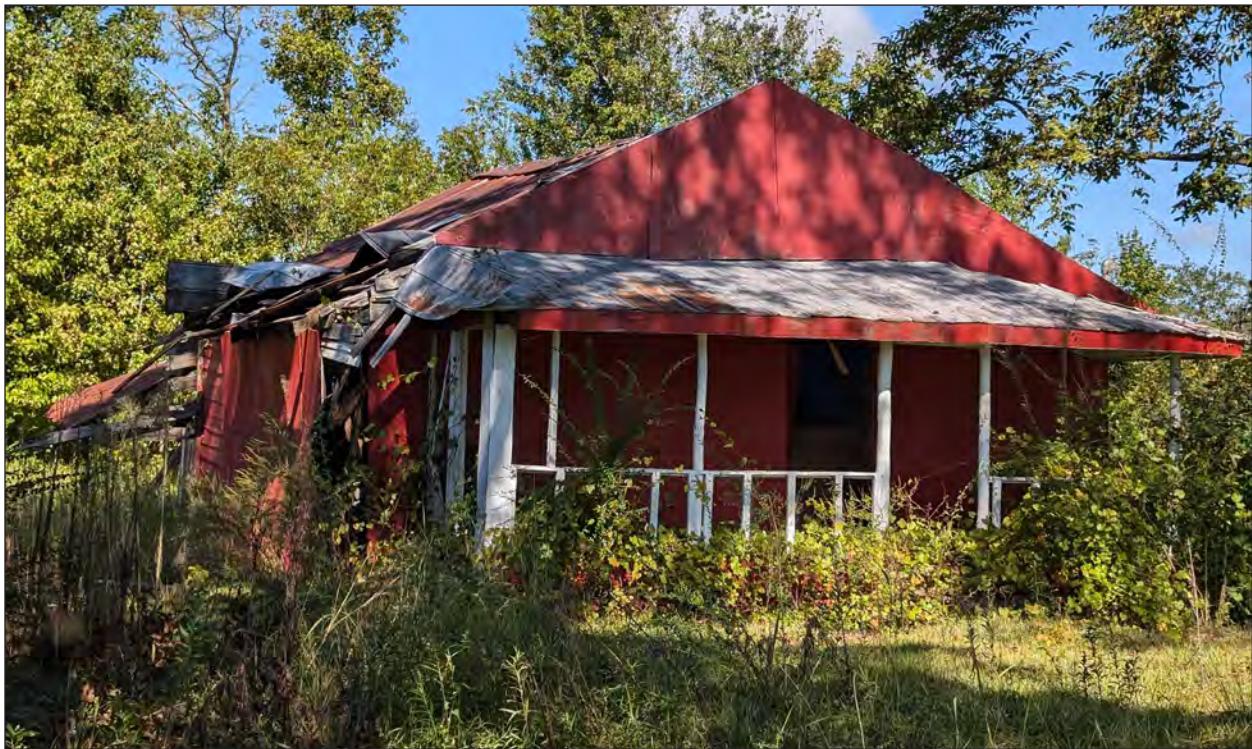
Figure 7.77.  
SHPO Site Number 0548

The one-story, frame bungalow has an asymmetrical façade, a front-gable roof, and a full-façade hipped front porch. Both the main and porch roofs are clad with PBR metal panels. The eaves are wood, and the primary exterior cladding is plywood, though a section of weatherboard siding is visible on the south elevation at the rear of the house. The roof, eaves, and wall on this side of the house are in advanced states of deterioration/collapse. The main entrance is off-center to the right, and the door appears to be a piece of plywood that no longer closes. No windows are visible on the façade or side elevations, but a six-over-six wood sash window on the rear elevation is visible through the open front door. Google Streetview imagery from 2013 shows an intact front door flanked on both sides by paired windows and a front porch that had a diamond-pattern lattice design across its face, but the porch today has simple wood railings, and the porch roof is supported by unhewn wood posts. An exterior brick chimney is appended to the midpoint of the north elevation, and the foundation is obscured by the surrounding overgrown foliage (Figure 7.77).

A. Oblique, Looking Southwest

B. Oblique, Looking Northwest

SHPO Site Numbers 0548 and 0548.01 were evaluated for the NRHP under Criteria A, B, and C. Under Criteria A and B, the resources are not known to be associated with events or persons significant in the past. Glenn W. Jenkins purchased the property in 1904, and, following his death in 1924, it passed to his wife, Leila Jenkins, who lived until 1998 (OCROD 2072:209-216). Probate proceedings following her death lasted until 2020, and the property eventually passed to Glenn and Leila's grandson Booker T. Wideman, though the tax record currently lists his brother David as the primary owner (OCROD 2105:213-217). The Jenkins Rosenwald School is depicted nearby on both the 1938 and 1951 General Highway and Transportation Maps of Orangeburg County, but the 1962 map shows I-26 in the former location of the school.

Despite the Jenkins family connection, the house and its occupants do not appear to be directly related to the school that coexisted with SHPO Site Number 0548 for at most 10 to 15 years. Under Criterion C, the buildings were evaluated for significance in the area of architecture. Although SHPO Site Number 0548 is a bungalow, it is not a distinctive or noteworthy example of this house type and does not possess significance for its engineering or materials. It does not retain integrity due to both the addition of non-historic materials and the substantial loss of original materials. SHPO Site Number 0548.01 is a garage of no distinct style or type that does not possess significance for its engineering or materials. Therefore, the resources are recommended not eligible for the NRHP under Criteria A, B, or C.

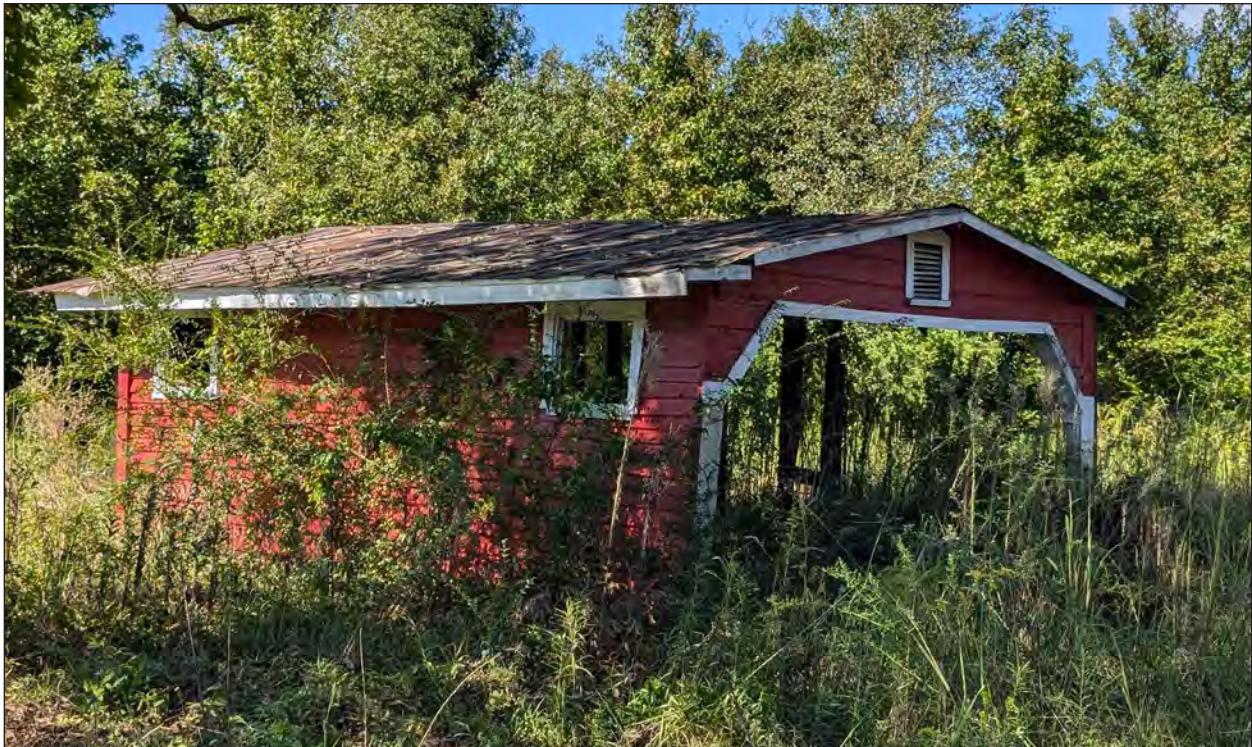
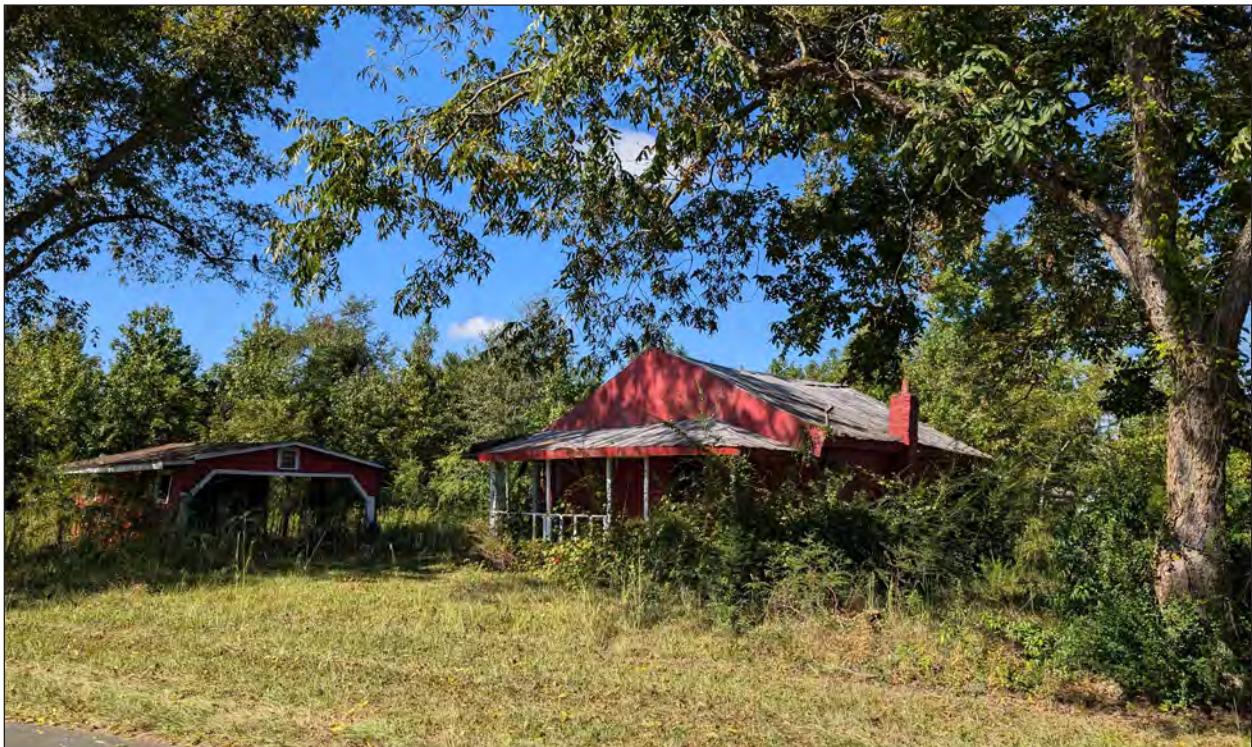
Figure 7.78.  
SHPO Site Number 0548.01

SHPO Site Number 0548.01 is a gabled garage that is located approximately 15 feet south of the house. The garage faces north towards the house, and 2013 Google Streetview imagery shows the buildings were previously connected by a covered breezeway. The rectangular frame building is one story tall and has a front-gabled roof clad in PBR metal panels. The garage has wooden eaves and is clad on the south and east elevations with weatherboard siding. The west side is open, while the north side is an open garage bay with clipped corners. The cladding surrounding the garage bay is novelty siding. There are two window openings, without windows, on the east elevation, and either a window or door opening on the south wall that is enclosed with plywood. A louvre vent is centered above the garage bay. The foundation is not visible (Figure 7.78).

A. Oblique, Looking Southwest

B. Property Overview with SHPO Site Number 0548 at Right, Looking Southwest

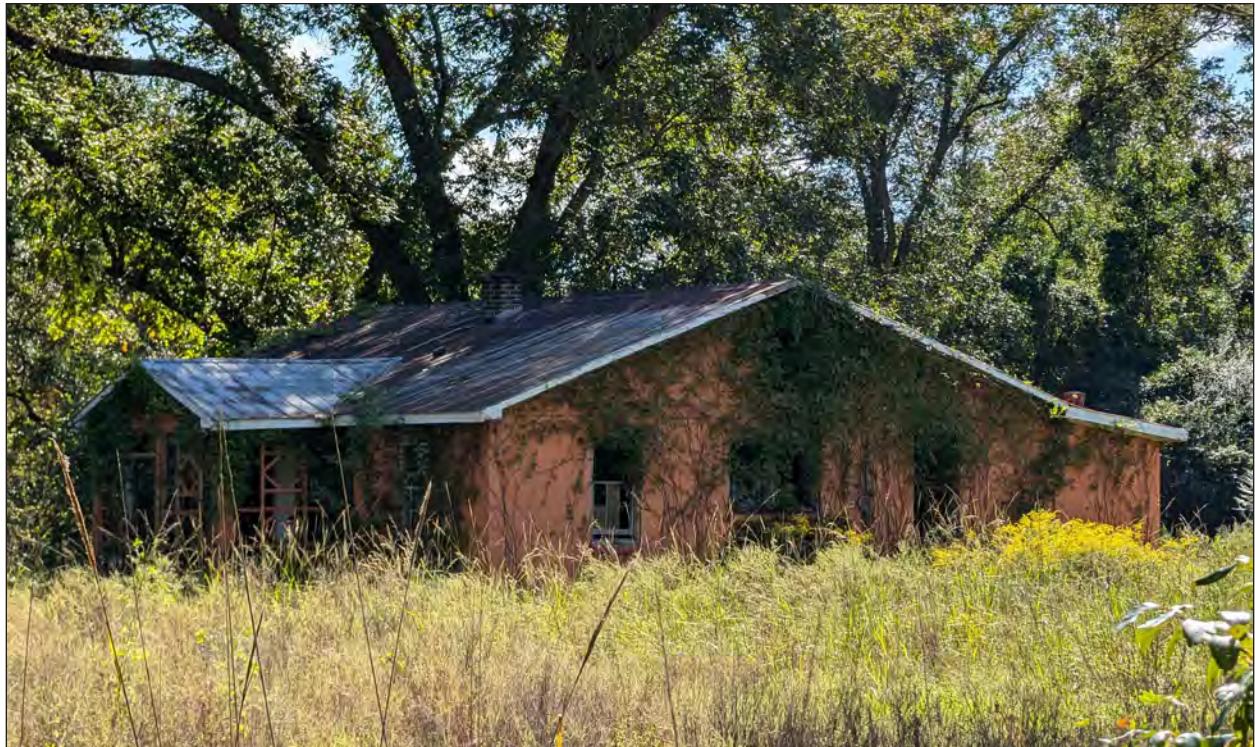
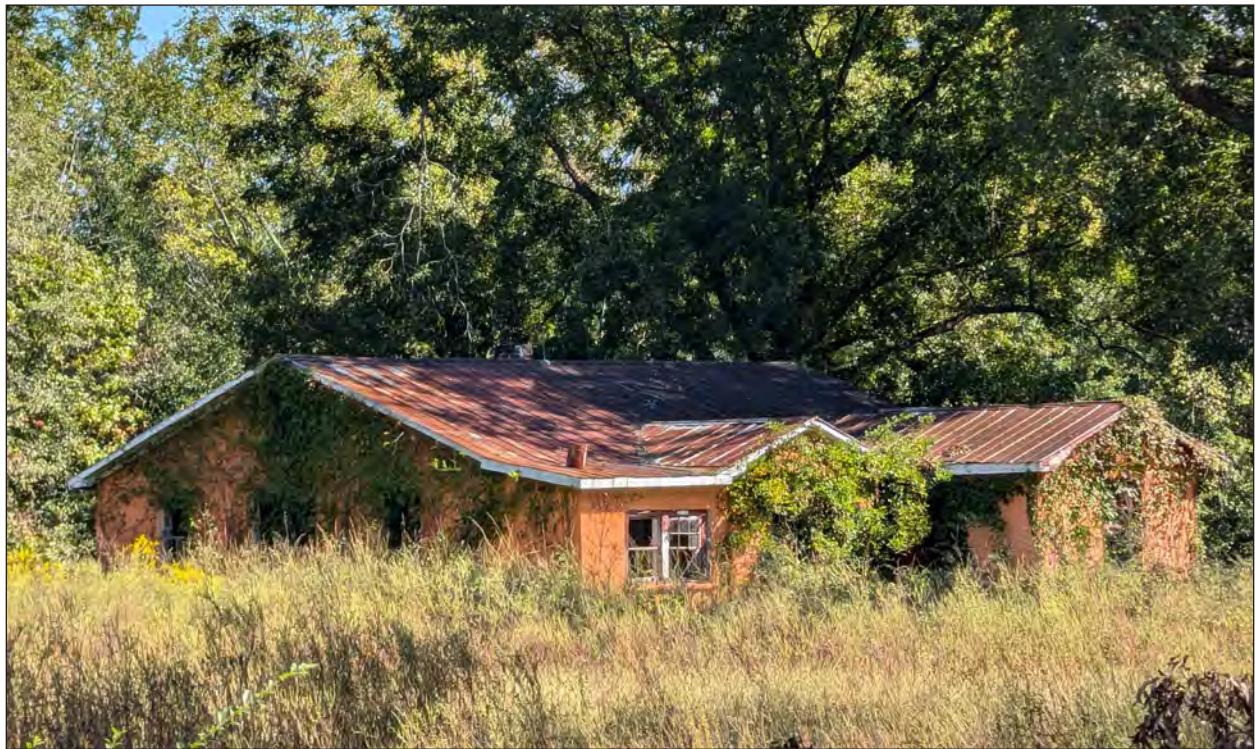
Figure 7.79.  
SHPO Site Number 0549

The concrete-block house of no distinct style or type has a rectangular historic core and a laterally gabled roof clad with PBR metal panels. The house's exterior cladding is concrete block, although either weatherboard or pressed fiberboard (Masonite) siding is visible in the west elevation gable end above the lateral eaves. The three-bay façade has a central entry-bay-only front porch that is sheltered by a gabled roof that extends from the main roof. The porch exterior walls have the same diamond-pattern lattice design that was visible across the porch of the neighboring SHPO Site Number 0548 in 2013 Google Streetview imagery. Observable windows are six-over-six and horizontal two-over-two double-hung wood sashes, although most openings contain either one sash or none. The eaves are clad in aluminum. The rear (south) elevation has a combination shed and gabled addition that contains a paired window opening and a rear egress across its central and western bays, and a gabled addition with a single window opening across its eastern bay. There is an interior chimney in the front slope, and the foundation is not visible but is likely a slab or concrete block on a perimeter footing (Figure 7.79).

A. Oblique, Looking Southeast

B. Rear Oblique, Looking Northeast

SHPO Site Number 0549 is situated on a multi-parcel, approximately 100-acre property that also includes the neighboring SHPO Site Number 0548. SHPO Site Number 0549's north-facing orientation is perpendicular to Ebenezer Road, from which it is set back approximately 175 feet. The house is surrounded by an overgrown lawn with a few mature trees, and both the building and property are densely overgrown.

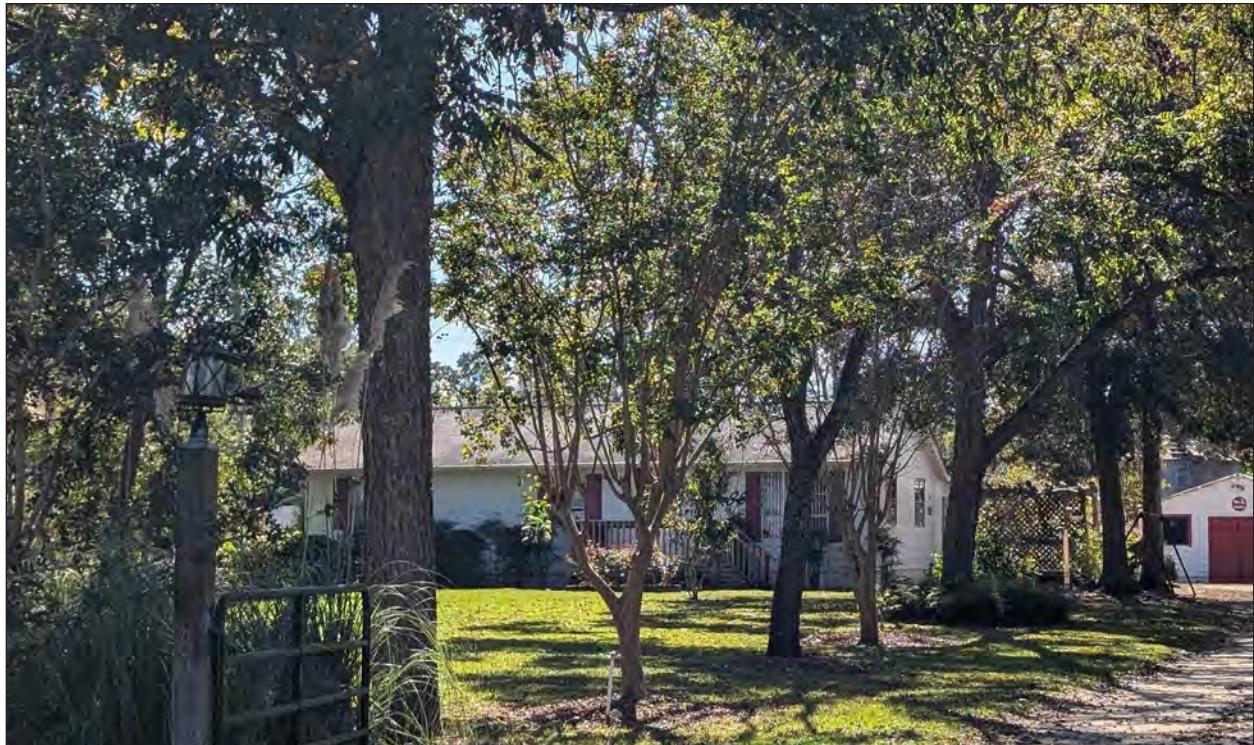
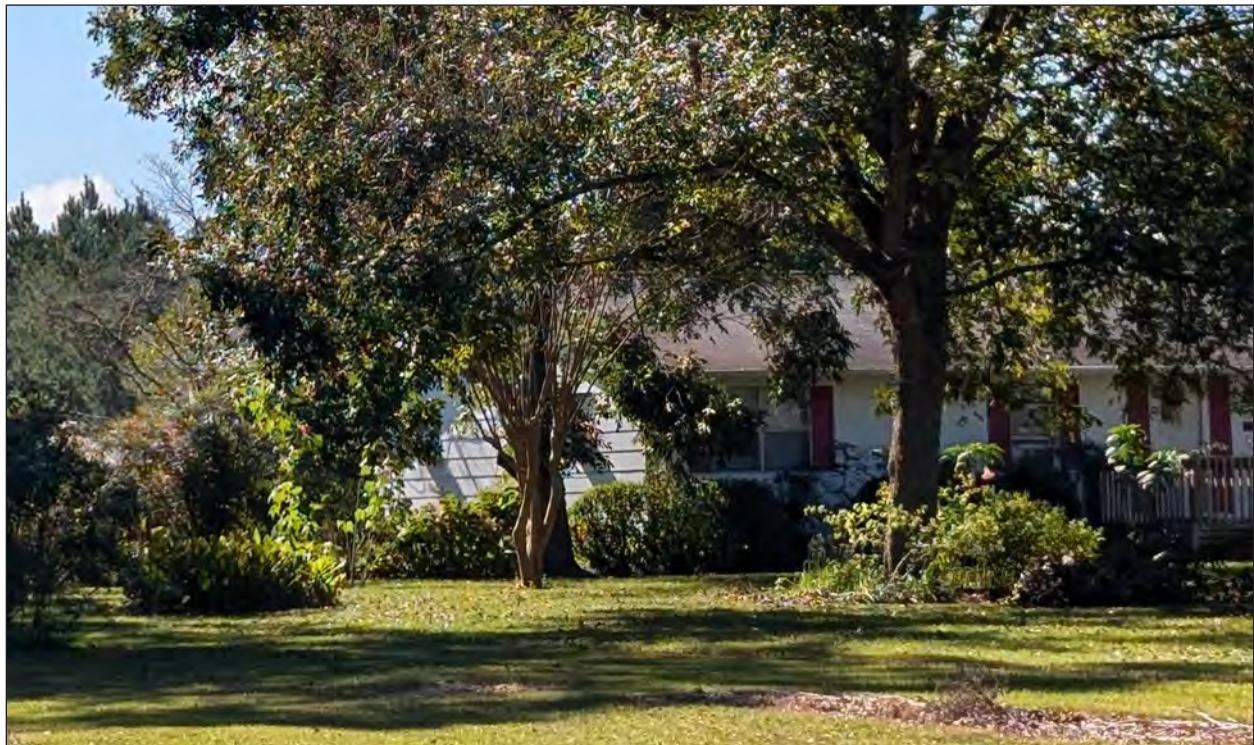
Figure 7.80.  
SHPO Site Number 0550

sash or awning windows with faux shutters. The front door is accessed by a small wood frame deck and steps, and two evenly spaced windows are visible on both side elevations. The eaves are also aluminum-clad, and the foundation is continuous concrete block. The rear (east) elevation is not visible from the ROW, but aerial imagery shows at least one rear addition (Figure 7.80).

A. Oblique, Looking Northeast

B. Oblique, Looking Southeast

SHPO Site Numbers 0550–0550.02 were evaluated for the NRHP under Criteria A, B, and C. The resources are located on property that was conveyed to William A. Whetsell in 1964, and Whetsell is still listed as the property owner today. Although research uncovered mentions of Whetsell in the local news, including advertisements dating to 1974 for an unsuccessful bid for the school board and classified postings for “fresh okra for sale \$7 a bushel or smaller quantities”, these attributes do not equate with being a historically significant person, nor would such events be considered significant historical events (The Times and Democrat 1974a, 1974b).

Under Criterion C, the resources were evaluated for significance in the area of architecture. Although SHPO Site Number 0550 is a Compact Ranch House, it is not a distinctive or noteworthy example of this house type, which is common in South Carolina. It was not found to embody the distinctive characteristics of a period or method of construction and does not possess significance for its engineering or materials. SHPO Site Number 0550.01 is a garage of no distinct style or type that does not possess significance for its engineering or materials, while SHPO Site Number 0550.02 is a barn of no distinct style or type that does not possess significance for its engineering or materials. Therefore, the resources are recommended not eligible, either individually or collectively, for the NRHP under Criteria A, B, or C.

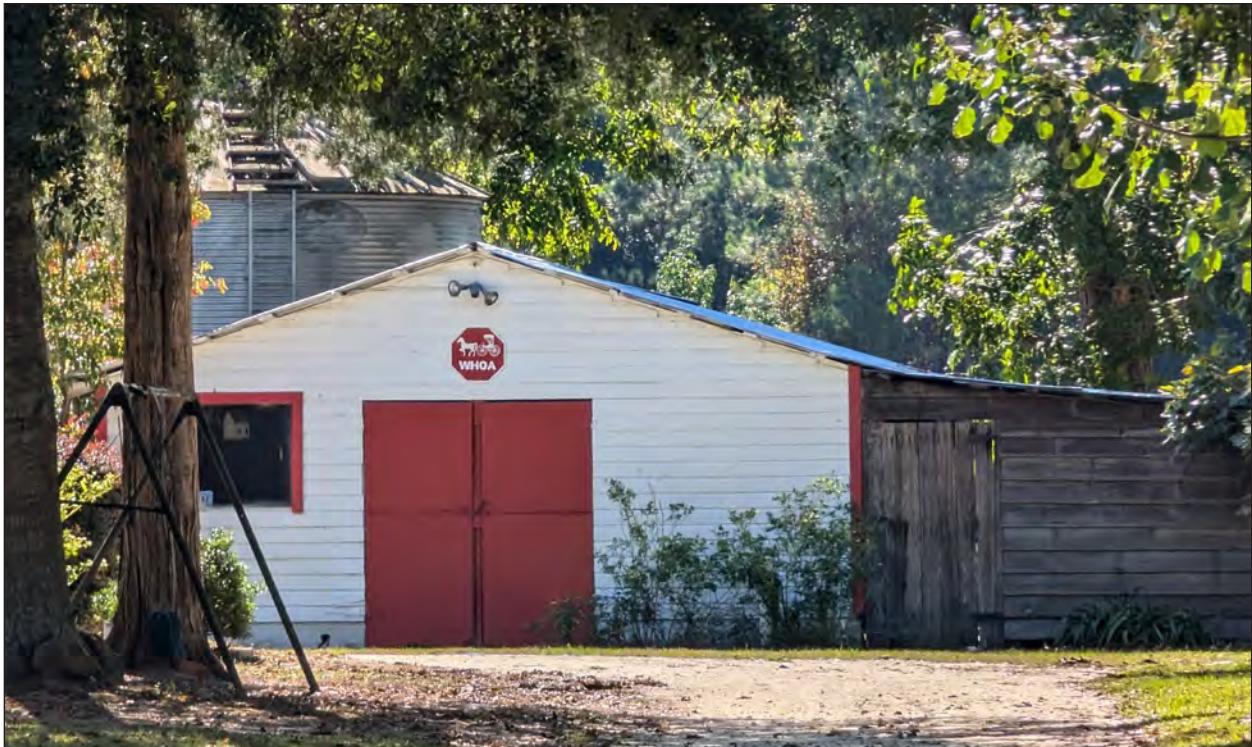
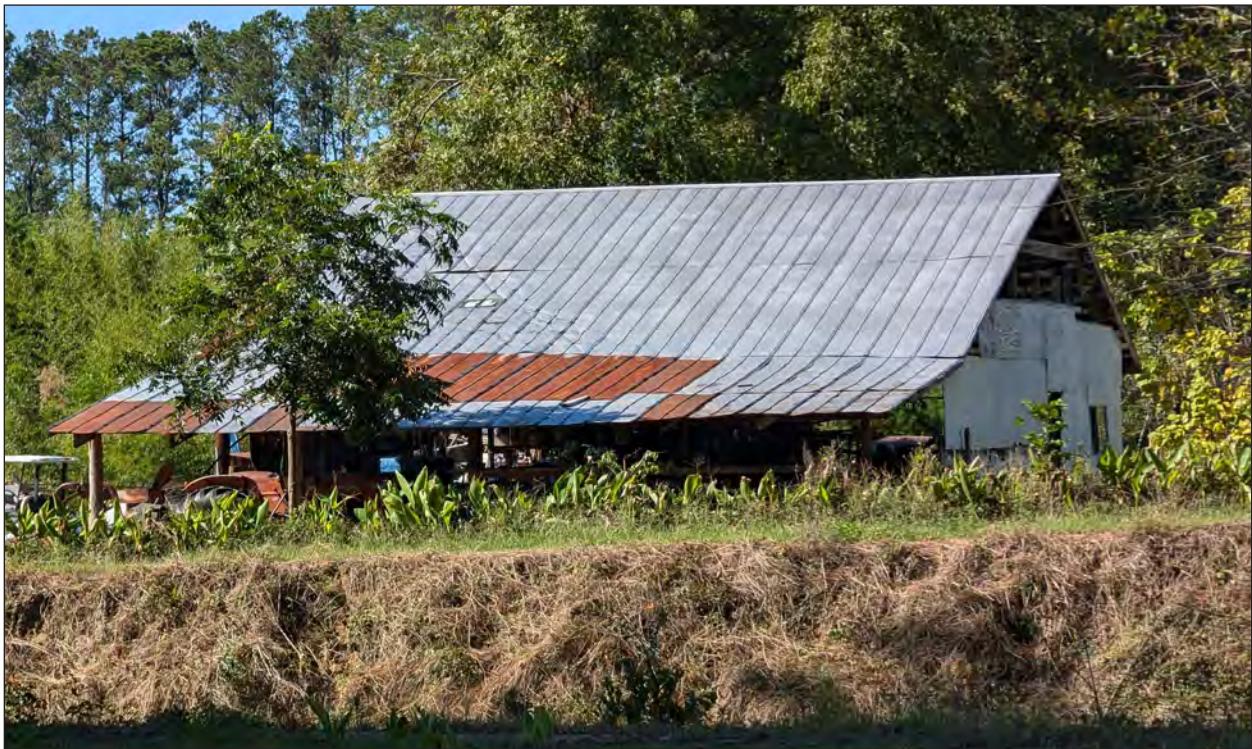
Figure 7.81.  
SHPO Site Numbers 0550.01 and 0550.02

SHPO Site Number 0550.01 is a gabled garage that is located approximately 40 feet to the rear (south) of the house. The garage faces west towards the road, and only the south elevation is visible from the public ROW. The frame building is one story tall and rectangular in plan, and it has a front-gabled roof clad in PBR metal panels. The building is clad in novelty siding, and a side-hinged double-leaf wooden garage door is centered in the façade with a single-pane fixed window located to the left. The foundation is stuccoed masonry or concrete block. An addition on the south side is covered by a shed roof extension from the front-gable roof and is clad in unpainted weatherboard siding and has a vertical flushboard door (Figure 7.81a).

SHPO Site Number 0550.02 is a gabled barn that is located approximately 100 feet to the rear (southeast) of the main house. The frame building is partially clad in plywood, and the roof is covered in PBR metal panels. A doorway is centered in the north elevation with a window opening to its right, but neither contains a door or a window. The south elevation appears to be partially enclosed as well, but the lateral elevations are not enclosed, and the east roof slope extends to cover an open storage section that spans the full elevation (Figure 7.81b).

A. SHPO Site Number 0550.01, Looking East

B. SHPO Site Number 0550.02, Looking Southeast

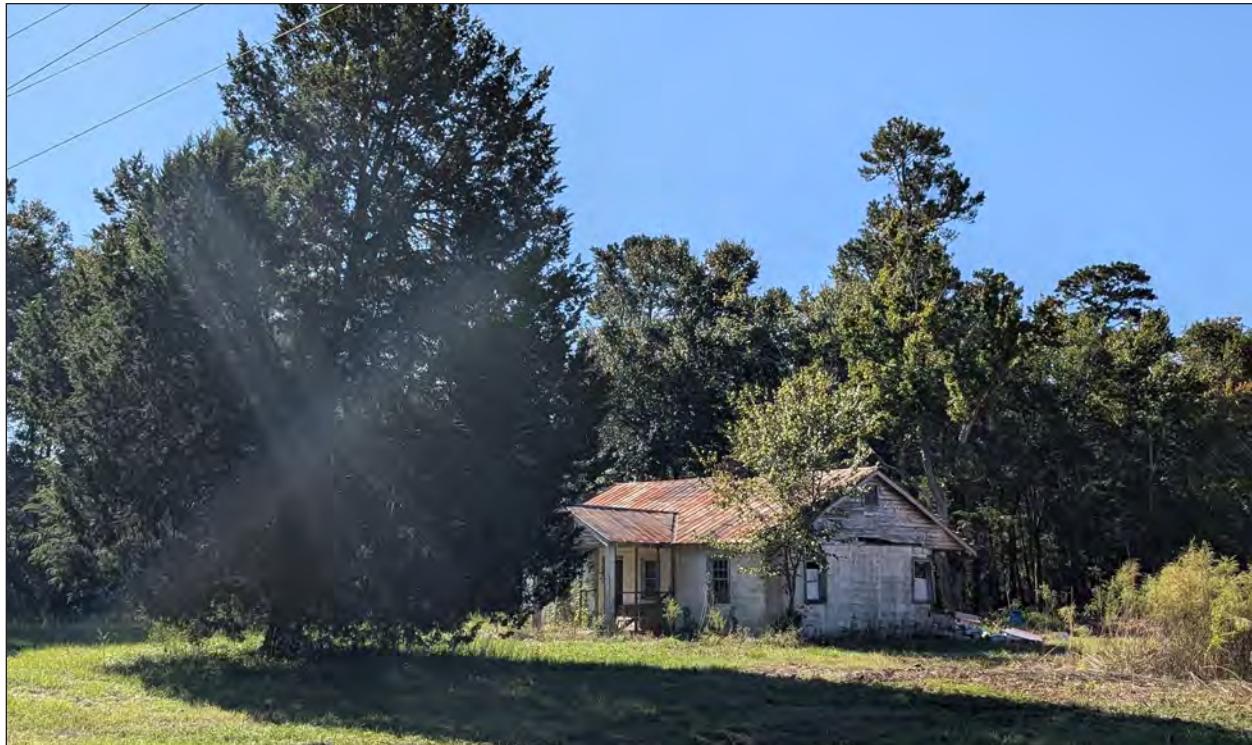
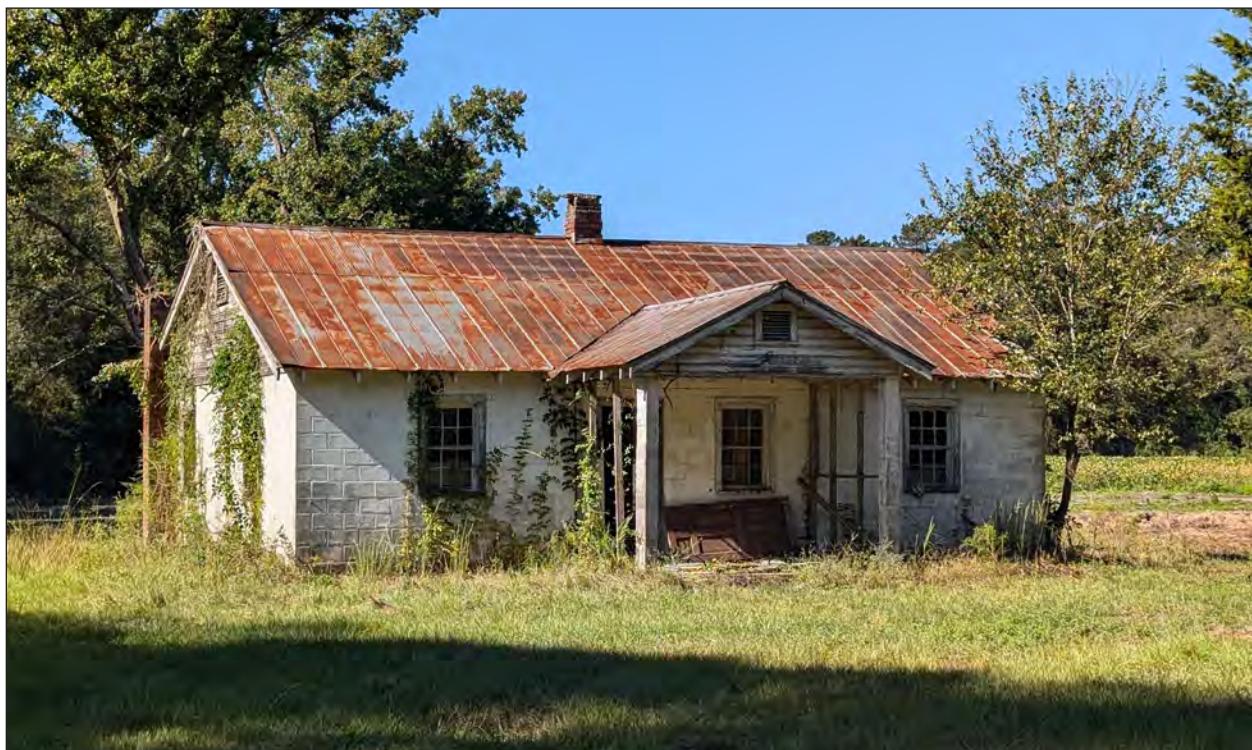
Figure 7.82.  
SHPO Site Number 0551

collapse of the exterior wall at the southwest corner, as well as the collapsed shed roof wing. The foundation is not visible but is likely a slab or concrete block on a perimeter footing (Figure 7.82).

A. Oblique, Looking Southeast

B. Oblique, Looking Northeast

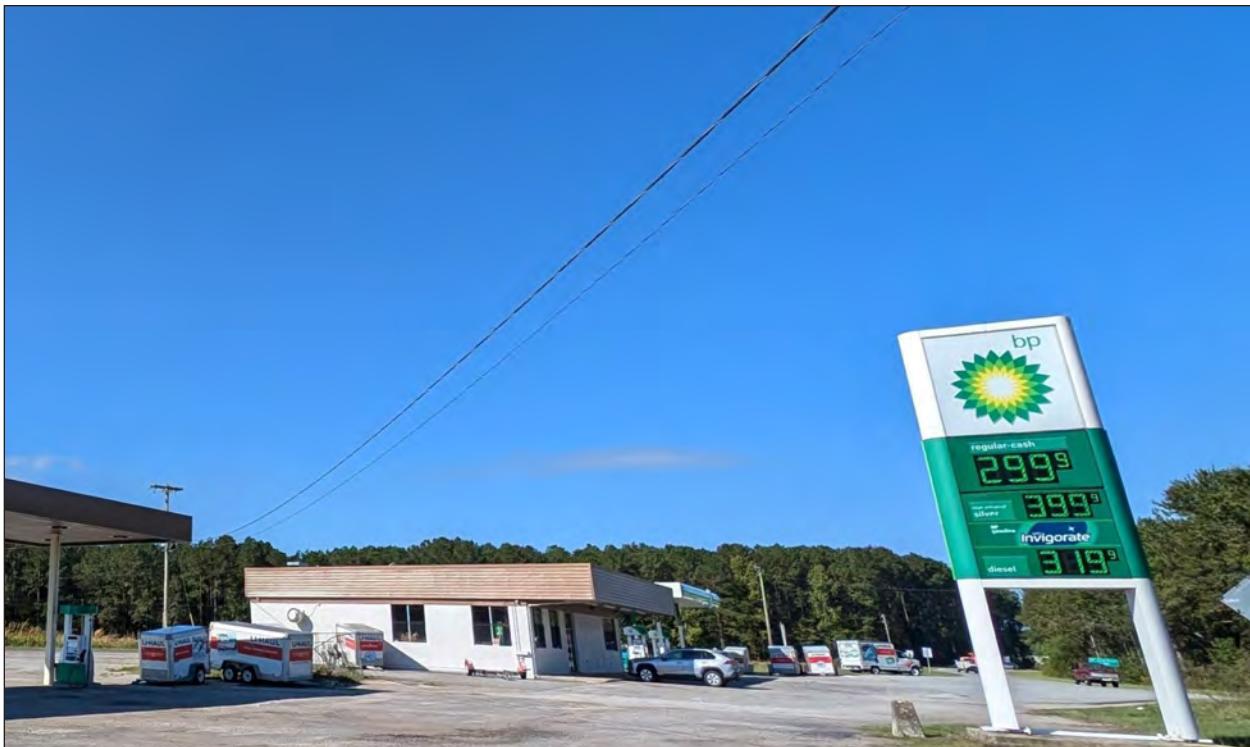
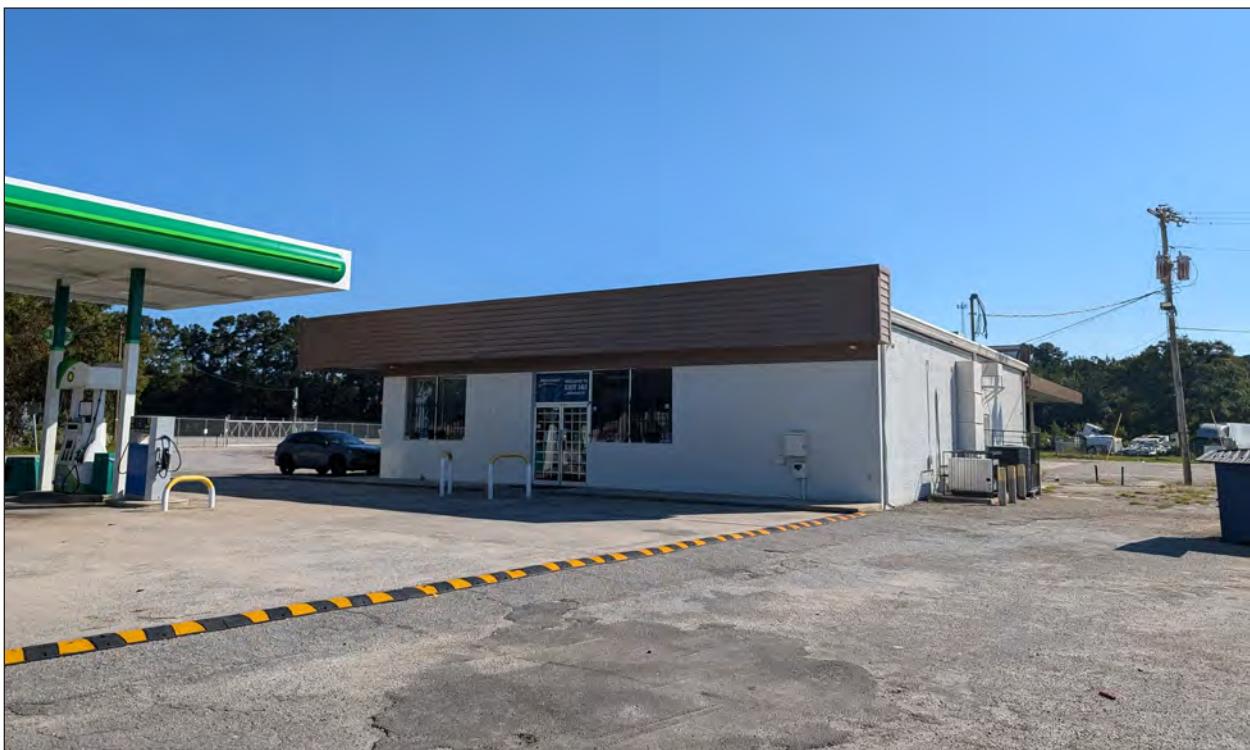
Figure 7.83.  
SHPO Site Number 0552

The rectangular Oblong Box gas station has a painted brick veneer exterior and a boxed canopy roof that wraps around three sides of the building and overhangs for the width of the sidewalks on both the façade (north) and the west elevation. The metal canopy features a beaded weatherboard siding profile that matches the design of the west-side (auto-fuel) canopy, so it may have been added along with that canopy around 1986. The very low-pitched gable roof is clad in PBR metal panels and sheds water to the rear (south) and front. The rear elevation has an external gutter with downspouts at each end, while the canopy along the front of the building appears to contain a built-in gutter, based on the downspout that is attached to the canopy's underside at the northeast corner. The façade has an off-center metal-and-glass double-leaf door with a transom and three sets of paired plate-glass windows. The west elevation has a matching door and transom and two sets of paired windows. The east elevation has two paired windows, and the south elevation has a single-leaf door and is also home to mechanical equipment. The windows all have exterior metal security grates, while the customer doors have internal metal security grates. The gas station most likely sits on a concrete slab foundation. The building is surrounded by concrete sidewalks and curbing with asphalt paving beyond that (Figure 7.83). Aside from the building and the surrounding paved parking and fuel station areas, there is a triangular wedge of lawn at the west end of the parcel and a larger lawn on the east side that is a parking and storage lot for U-haul and long-haul trucks and that contains the circa 1986 outbuilding.

A. Oblique, Looking Southwest

B. Rear Oblique, Looking Northeast

SHPO Site Number 0552 is situated on a triangular, approximately four-acre lot that was consolidated from two separate parcels between 1970 and 1973, with the building being located on the portion that was acquired in 1970 (OCROD 336:587-590, 383:347-350). SHPO Site Number 0552 was evaluated for the NRHP under Criteria A, B, and C. Under Criteria A and B, the resource is not known to be associated with events or persons significant in the past. The building was evaluated under Criterion C for significance in the area of architecture. SHPO Site Number 0552 is not a noteworthy example of an Oblong Box gas station, which is a common commercial building type in South Carolina. As a result, it was not found to embody the distinctive characteristics of a period or method of construction and does not possess significance for its engineering or materials. Therefore, the resource is recommended not eligible for the NRHP under Criteria A, B, or C.

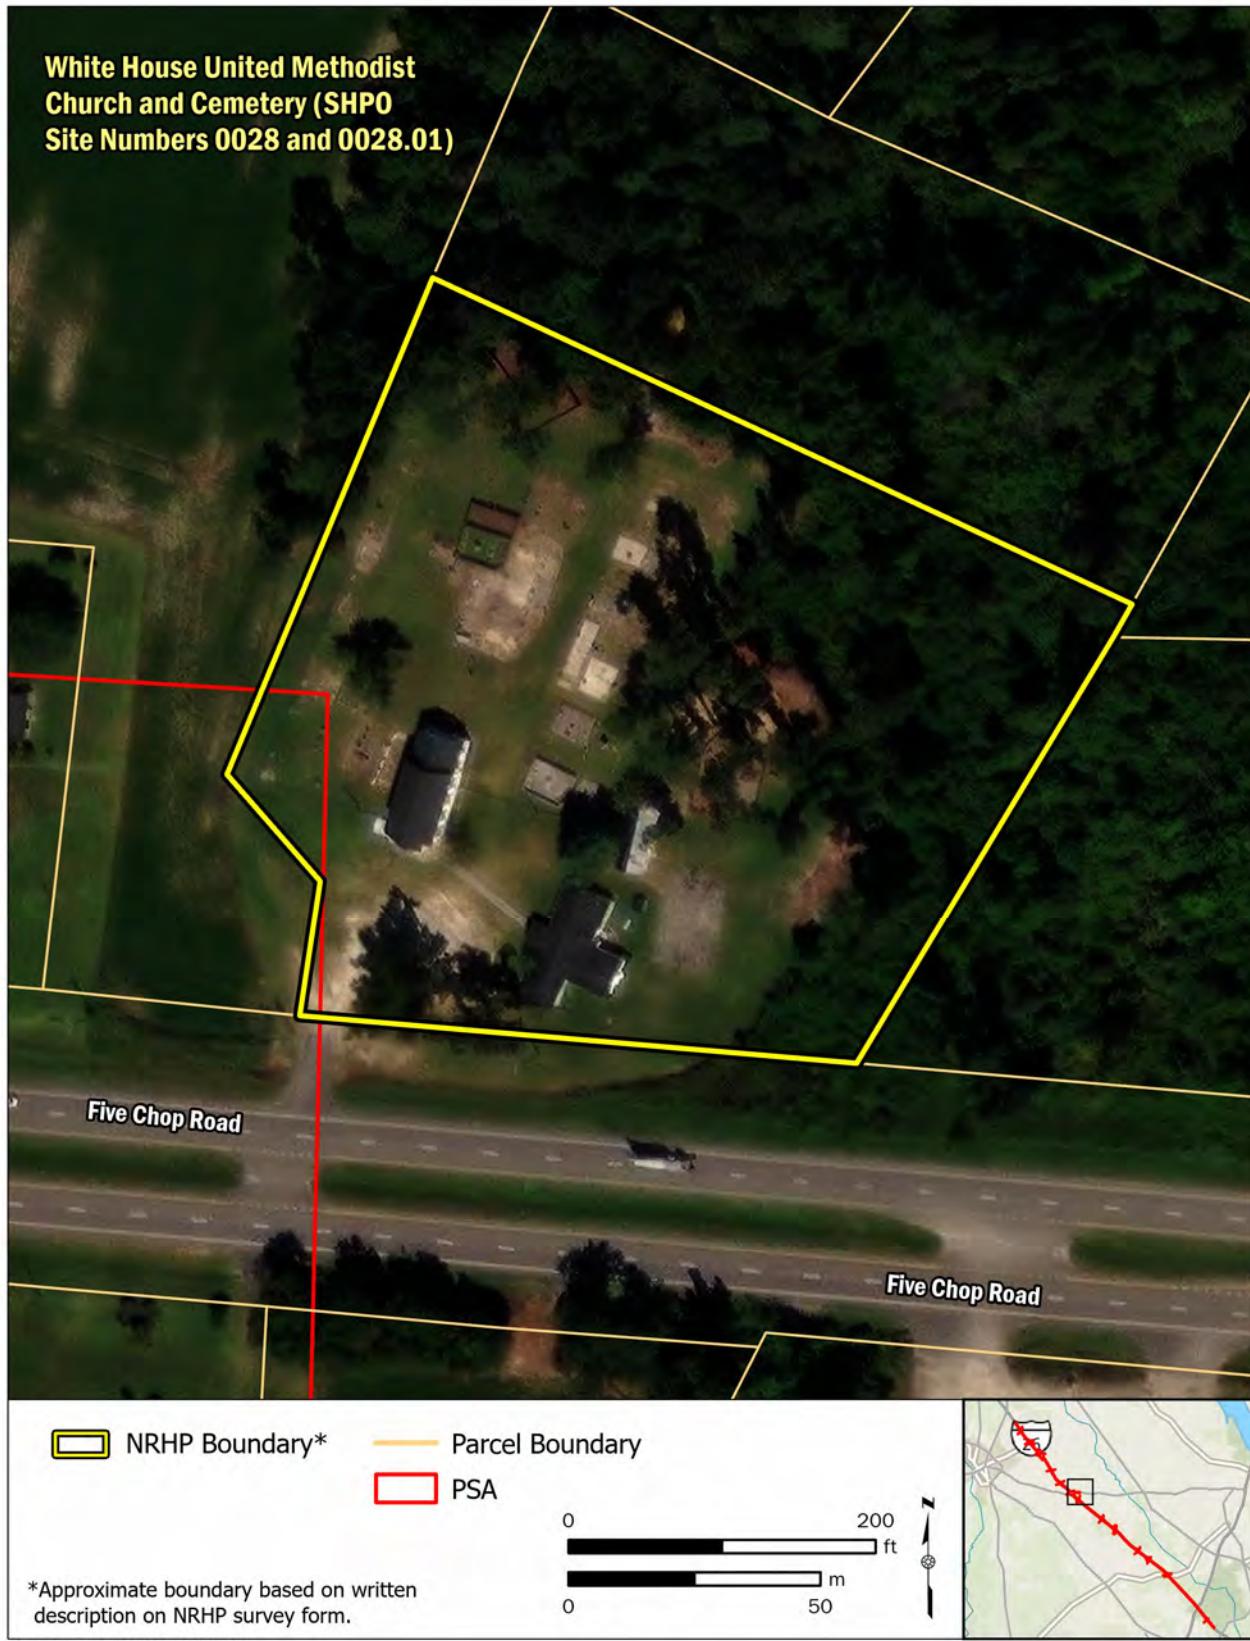
NRHP Boundary for the White House United Methodist Church and Cemetery (SHPO Site Numbers 0028 and 0028.01/Site 380R462) with PSA Overlap Depicted

In addition to SHPO Site Number 0028.01, the survey included documentation and evaluation of four other cemeteries, but none of these or any of the other revisited or newly surveyed resources or subresources are recommended eligible for the NRHP. Three of the four other cemeteries, not including the Pearson-Cain Family Cemetery, were evaluated and assessed for the NRHP in a multidisciplinary manner as both historic architectural and archaeological resources. Brantley Cemetery also underwent a certain degree of archival and chain of title research, as specified in the project scope. Three of the cemeteries, including the NRHP-contributing White House United Methodist Church Cemetery, the Brantley Cemetery, and the Mount Zion Baptist Church Cemetery (see Figure 8.2), are either bisected by or contained entirely within the project area. All cemeteries are protected under several South Carolina laws, such as South Carolina Code 27-43-10, Removal of Abandoned Cemeteries; 27-43-20, Removal to Plot Agreeable to Governing Body and Relatives; 27-43-30, Supervision of Removal Work; and 16-17-6000, Destruction of Graves and Graveyards. Regardless of eligibility, the roadway design must avoid adverse impacts to these historic resources.

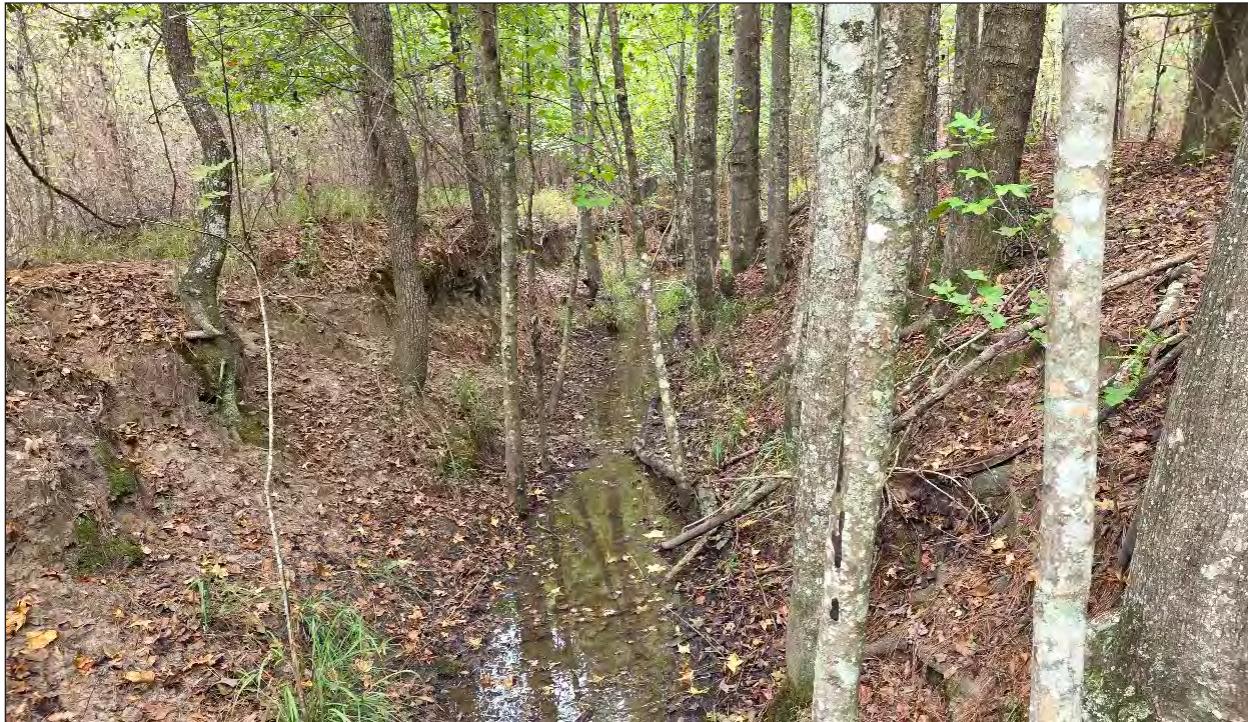
Figure 10.  
Current Conditions of the Westbound Rest Stop Area

A. Example of Not Excavated Area Due to Deep Drainage Ditches with Surface Water, Looking Northwest
