# **D-1: PHASE I CULTURAL RESOURCES SURVEY**

***RE: Phase I Cultural Resources Survey for the Proposed Widening of I-26 from Mile Marker 145-172, Orangeburg and Dorchester Counties, South Carolina and Phase I Cultural Resources Survey for the Proposed Widening of I-26 from Mile Marker 145 to 172 - ADDENDUM***

***SCDOT Project #: P041967 and 42454***

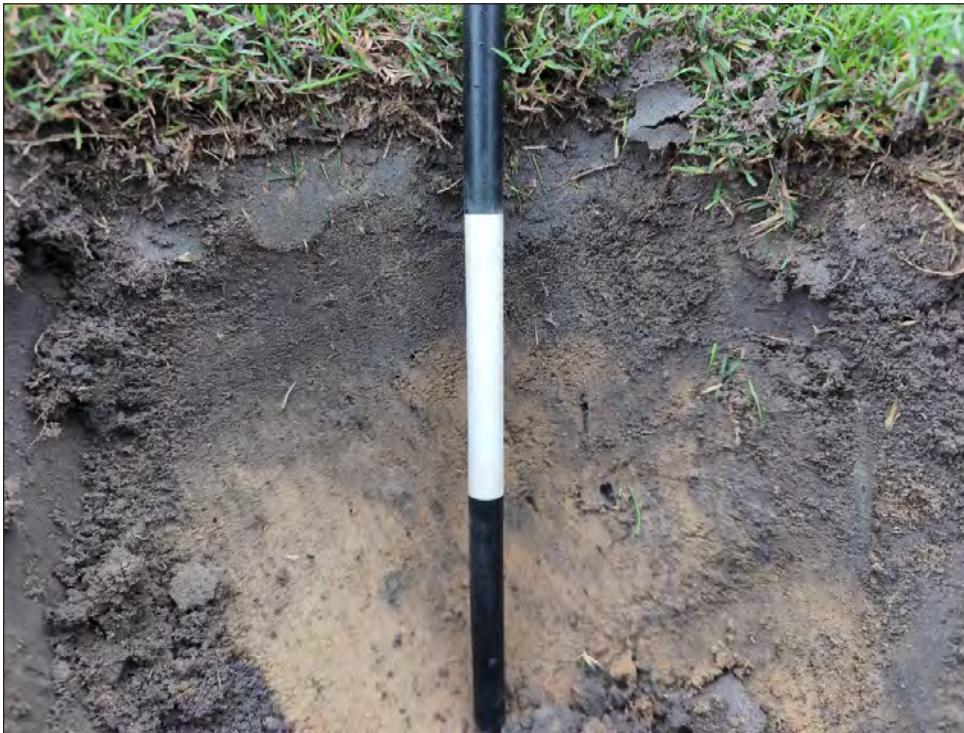
B. Example Soil Profile of STPs in Westbound Rest Stop Area, Looking Southeast

The westbound rest stop area consists of the existing rest stop with the additional areas to the north, east, and south predominantly wooded with agricultural fields (Figure 8). In the proposed westbound rest stop area, a total of 344 shovel test locations were investigated, of which 303 STPs were negative (Figure 9). The remaining 42 STPs were not excavated due to surface water (n=25), steep slopes (n=8), previous disturbance such as ditches and development (n=7), buried utilities (n=1), and no access (n=1) (Figure 10a). Two soil profiles were observed in the westbound rest stop area: one specific to the sod field, and the other observed in the wooded area. The soil profile observed in the sod field consisted of 15 cm of dark grayish brown (10YR 4/2) sandy clay loam over 10 cm of brownish yellow (10YR 6/8) sandy clay. The typical shovel test profile observed in the wooded areas contained grayish brown (10YR 5/2) sandy loam from 0-15 centimeters below surface (cmbs) over 10 cm of pale brown (10 YR 6/3) sandy clay subsoil (Figure 10b).

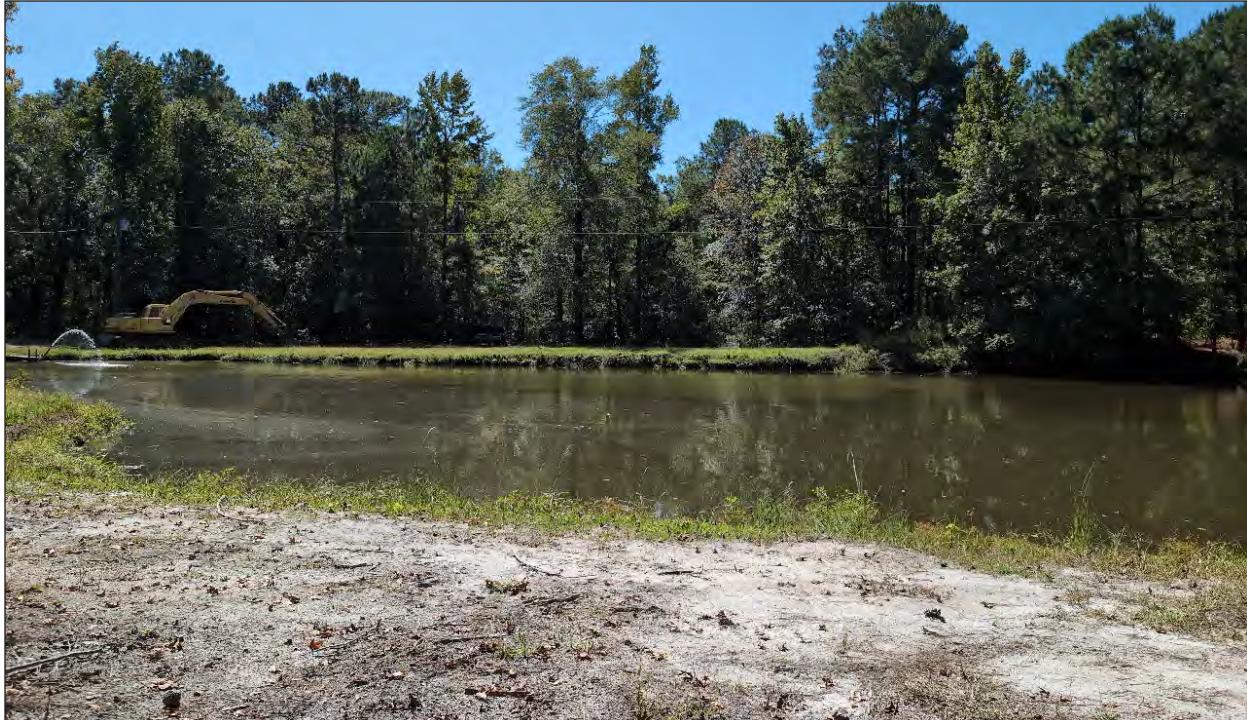
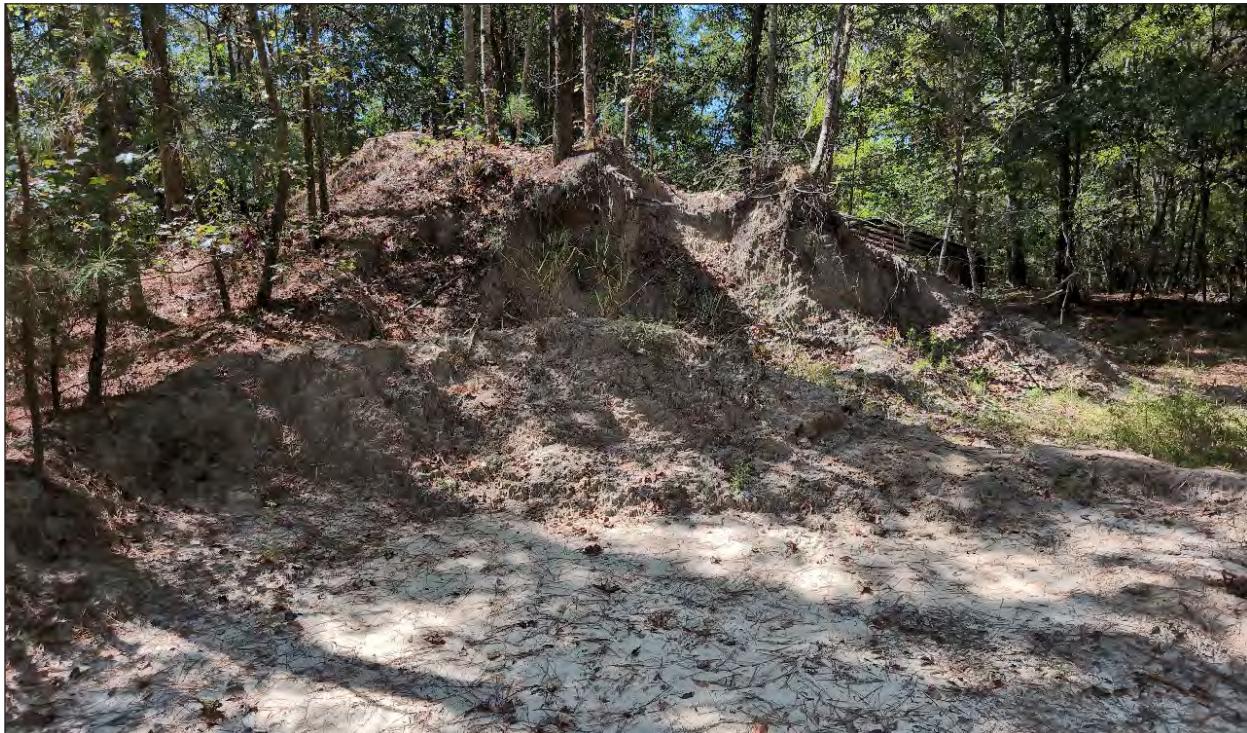
Figure 13.  
Examples of Ground Disturbance in the Eastbound Rest Stop Area

A. Large Artificial Retention Pond dug by Landowner in Southern Portion of Eastbound Rest Stop Area, Looking Southwest

B. Large Push Pile from Grading Access Roads, Looking West

The eastbound rest stop area is residential with approximately half wooded, and the remainder is maintained yards (Figure 11). There were 160 pre-plotted shovel test locations investigated in the eastbound rest stop area (Figure 12). A total of 127 STPs were negative and 33 STPs not excavated due to previous disturbance such as paved or gravel areas (n=13), ditches and modern refuse piles (n=8), buried utilities (n=4), buildings (n=4), water (n=1), and no access (n=1) (Figure 13). One general soil profile was observed in the eastbound rest stop area. A typical shovel test contained approximately 20 to 30 cm of grayish brown (10YR 5/2) sandy loam over 30 to 40 cm of light yellowish gray (10 YR 6/4) sand beneath which was 10 to 20 cm of brownish yellow (10YR 6/6) sand.

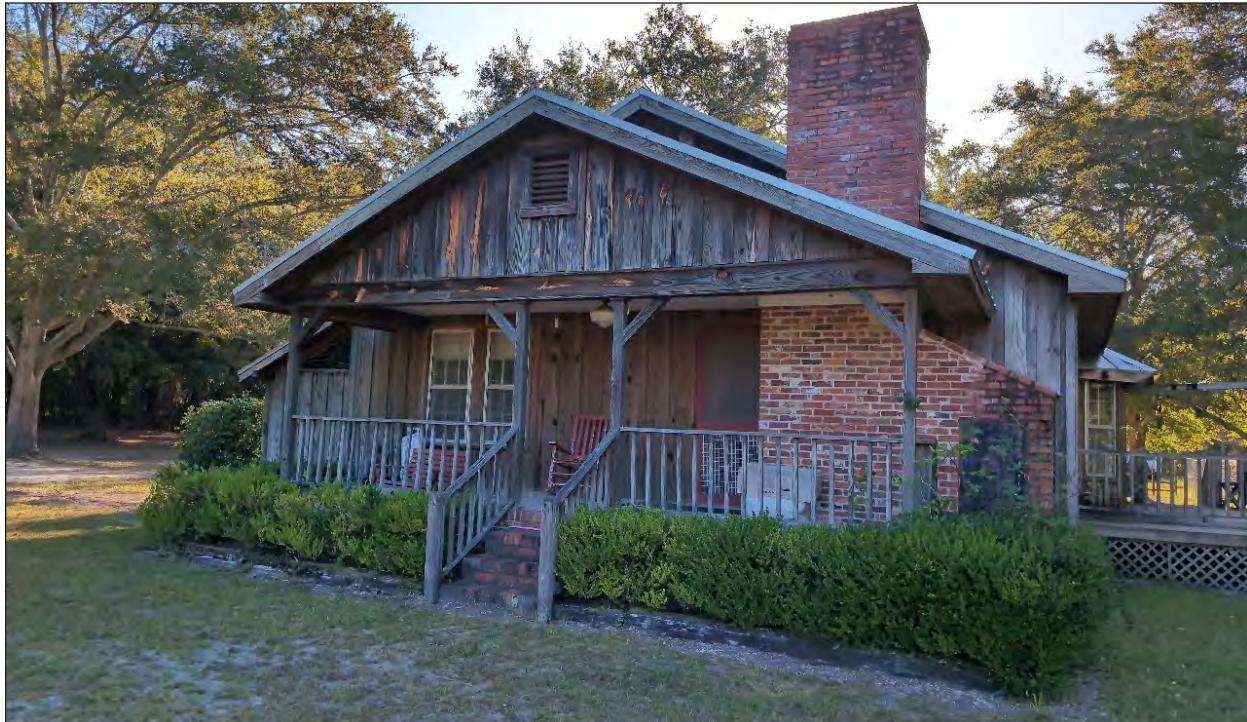
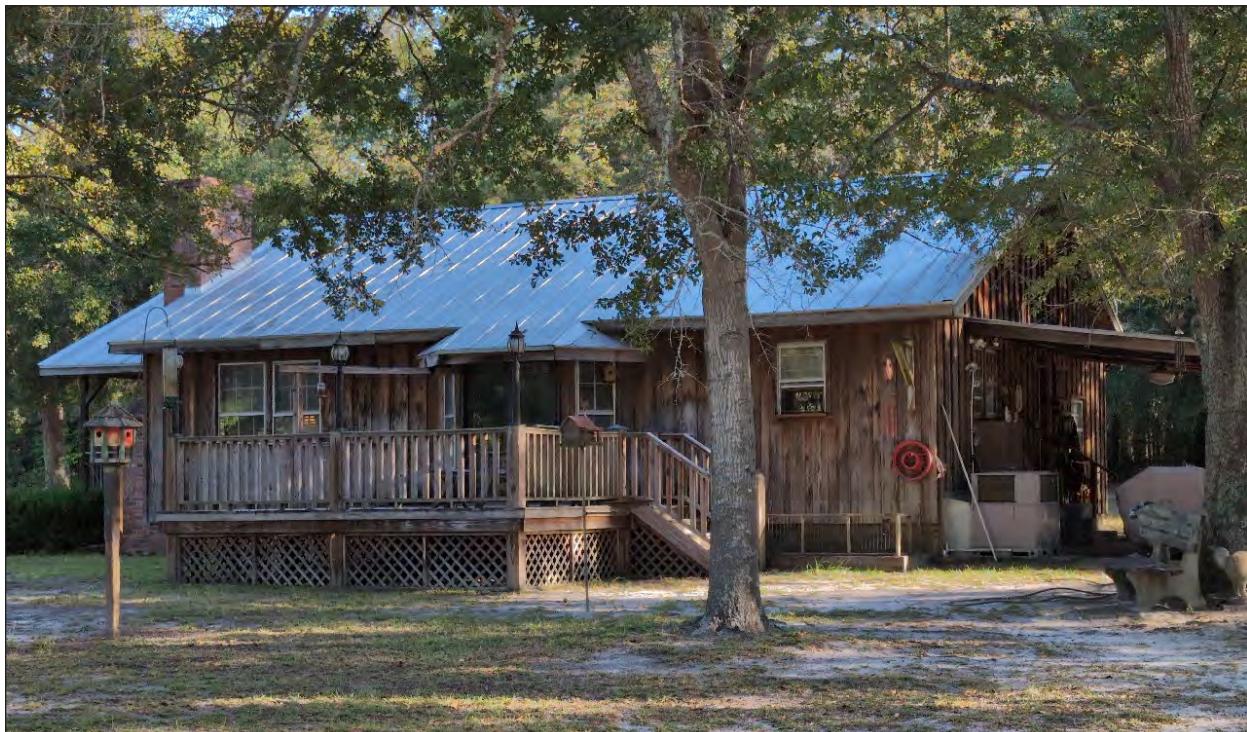
Figure 15.  
SHPO Site Number 0572 - Bungalow

A. Right Oblique, Looking Northeast

B. Rear Oblique, Looking North

SHPO Site Numbers 0572 and 0572.01 are located on the west side of I-26 and nearly 1,000 ft. down a private gated drive called Rooster Lane, which hindered survey from the ROW (Figure 8). Orangeburg County tax records do not provide a build date for this front-gabled bungalow and carport/storage shed, but aerial imagery shows that they appear between 1974 and 1981, so they are assumed to have been constructed circa 1975. SHPO Site Number 0572.02 is a monitor barn located on the north side of the intersection of Rooster Lane and Whitford Stage Road. Tax records also do not provide a build date for the barn, but it appears in 1958 aerial imagery and may be represented on 1940s topographic maps, so it is assumed to have been built circa 1940 (NETROnline 2025).

SHPO Site Number 0572 faces northwest and has a nearly full-façade front porch and a shed-roof addition on the north elevation. A massive chimney with a shoulder on the right side that is attached to the façade rises through the porch roof, and, within the porch, the entrance is off-center to the right, and a paired window set is in the left corner. The porch is accessed by a set of brick steps with wood balustrades, and the porch roof is supported by wood posts. There is an octagonal bay on the south elevation that opens onto an uncovered deck that spans most of the elevation. The exterior is clad with board and batten siding, and the windows are multi-light sash (material not discernible). The house has a corrugated metal roof, and it sits on a continuous brick foundation (Figure 15).

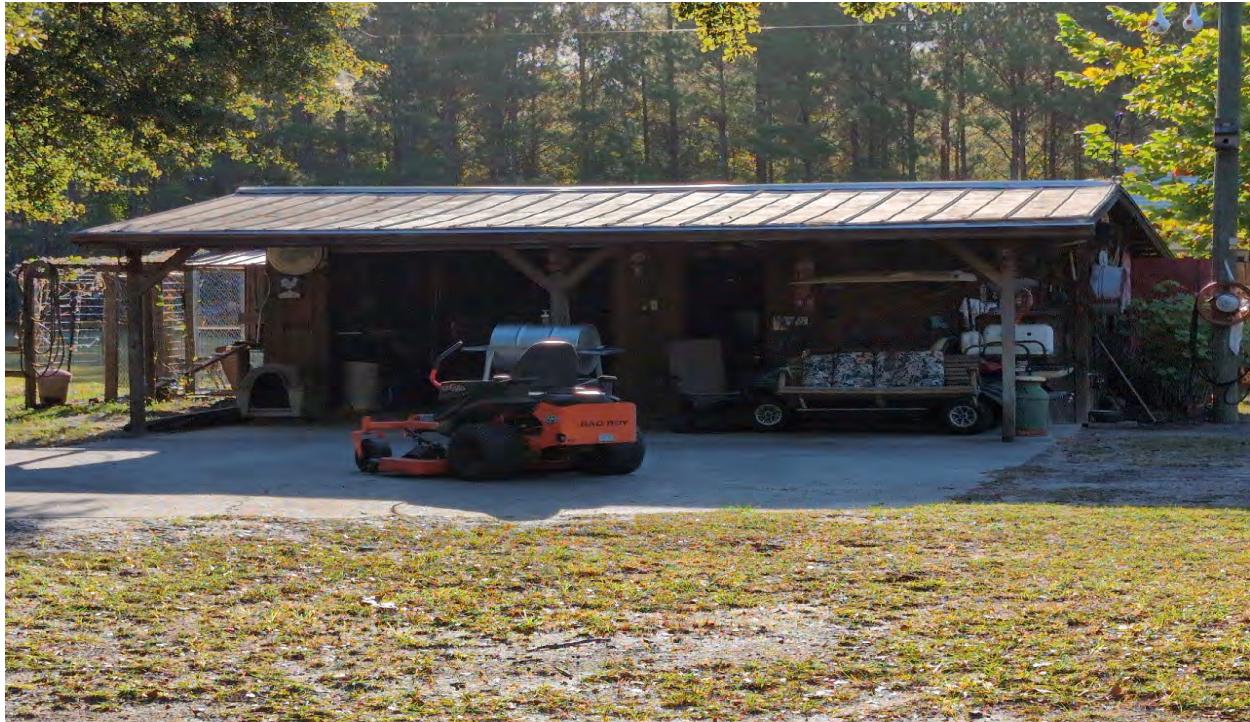
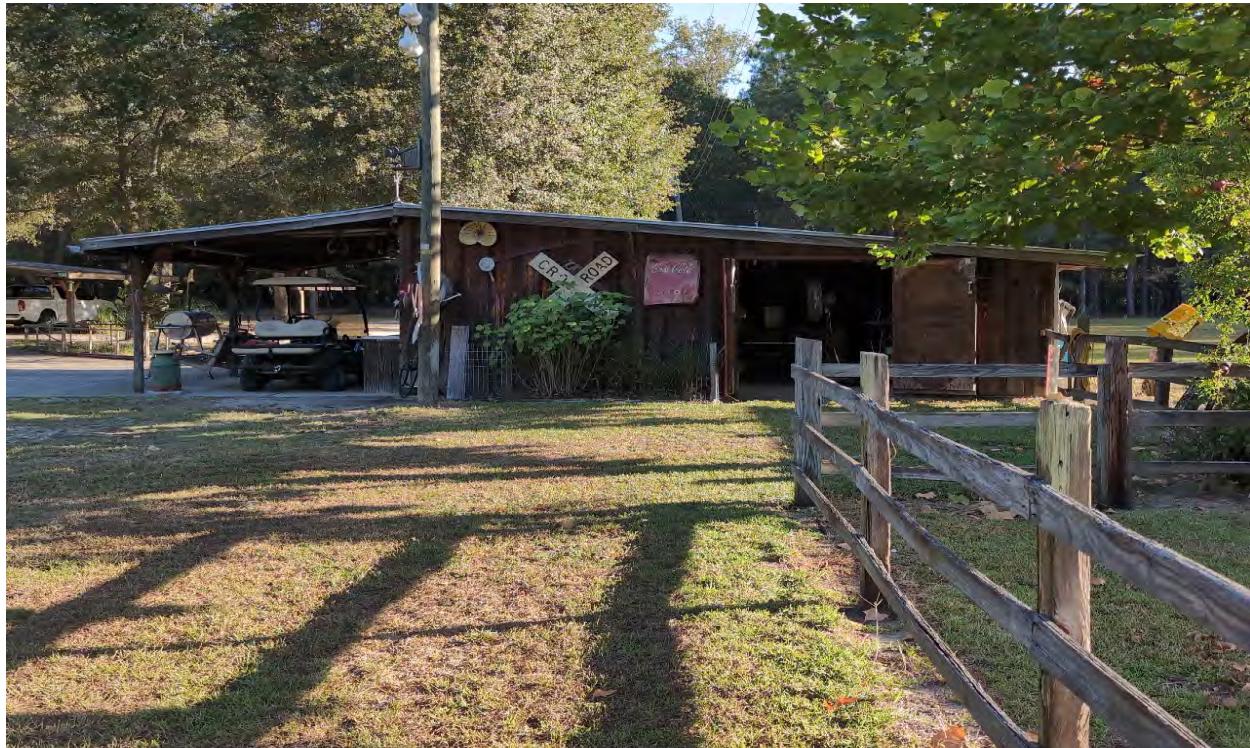
Figure 16.  
SHPO Site Number 0572.01 - Carport/Storage Shed

A. Right Oblique, Facing Northeast

B. South Elevation, Facing North

SHPO Site Number 0572.01 is a laterally gabled frame carport/storage shed with board and batten siding and a corrugated metal roof. The front slope extends the length of an average car, and the space accommodates two vehicles, while the rear slope extends more than twice as long and covers the interior storage shed area. There is both a doorway and a garage door on the primary (west) elevation and a side-hinged double door on the south elevation. The concrete parking pad extending from the west elevation stretches well beyond the roofline (Figure 16).

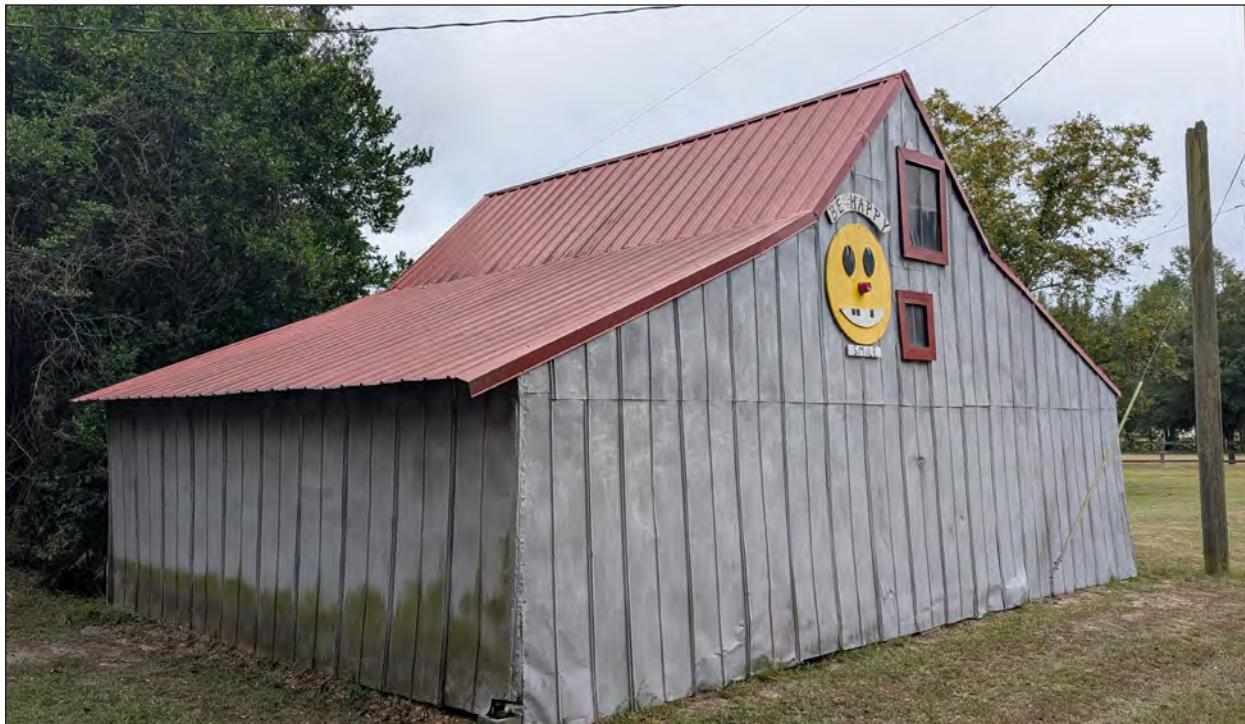
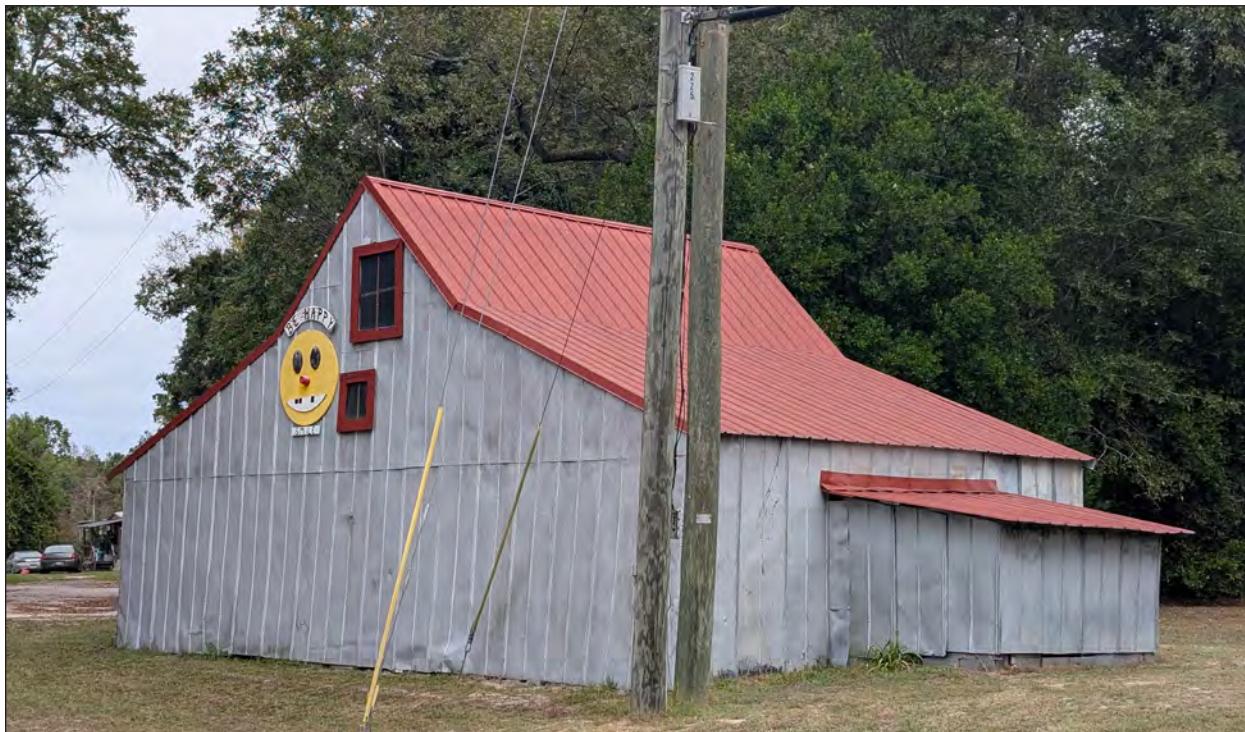
Figure 17.  
SHPO Site Number 0572.02 – Monitor Barn

A. Left Oblique, Facing Southeast

B. Right Oblique, Facing Northeast

SHPO Site Number 0572.02 is a monitor barn with corrugated metal for both exterior and roof cladding. The gabled core is flanked on both sides by shed-roof wings, and there are two fixed windows centered in the upper street-facing elevation, but there are no other visible openings from the ROW. A concrete block pier and a portion of the historic wood structure (sill beam) are visible at the northwest corner, where a section of metal siding is peeled back (Figure 17).
