Biological Evaluation

**Interstate 26 (I-26) Corridor Improvements
Project MM 145-172**

Orangeburg and Dorchester Counties, South Carolina

SCDOT Project ID: P041967 & P042454

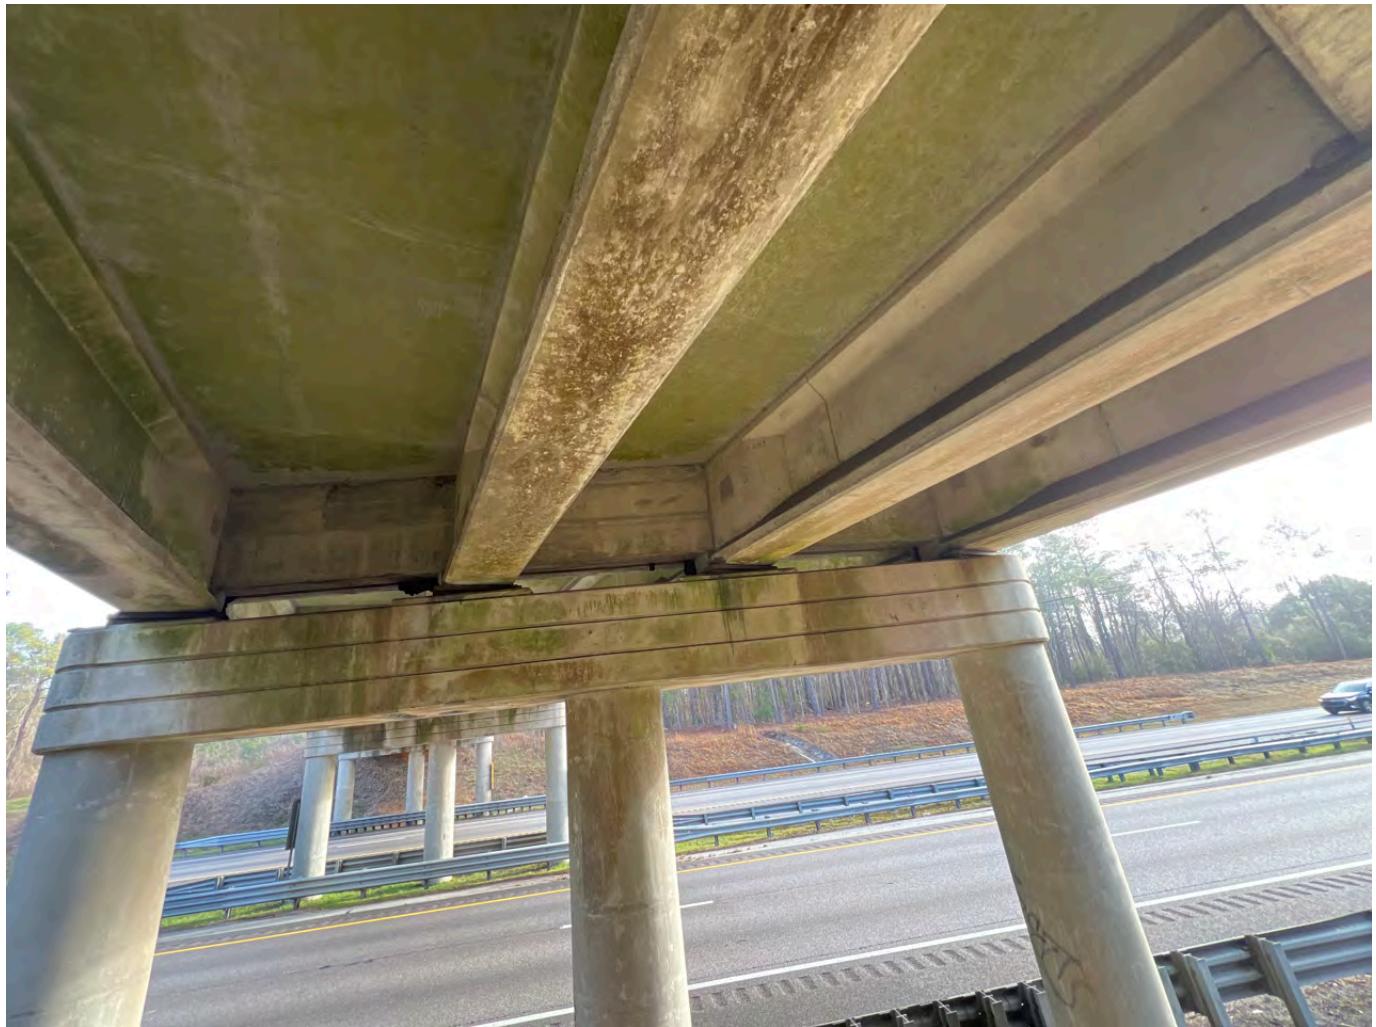
Bridge/Culvert Bat Assessment Form

Date & Time: 02/03/2025	DOT Proj No. or IPaC Code: P041967 & P042454 / 2024-0138645	Route/Facility Carried: Big Buck Blvd over I-26	County: Orangeburg
Federal Structure ID: 3870019600200	Structure Coordinates: 33.450361, -80.721065	Structure Height (approx.): 16'	Structure Length: ~230'
Structure Type (check one) Bridge Construction Style		Structure Material (check all that apply)	
<input checked="" type="checkbox"/> Cast-in-place	<input type="checkbox"/> Pre-stressed Girder	<input type="checkbox"/> Metal	<input type="checkbox"/> None
<input type="checkbox"/> Flat Slab	<input type="checkbox"/> Steel I-beam	<input checked="" type="checkbox"/> Concrete	<input checked="" type="checkbox"/> Concrete
<input type="checkbox"/> Truss	<input type="checkbox"/> Covered	<input type="checkbox"/> Timber	<input type="checkbox"/> Steel
<input type="checkbox"/> Parallel Box Beam	<input type="checkbox"/> Other: Click to enter text.	<input type="checkbox"/> Open Grid	<input type="checkbox"/> Timber

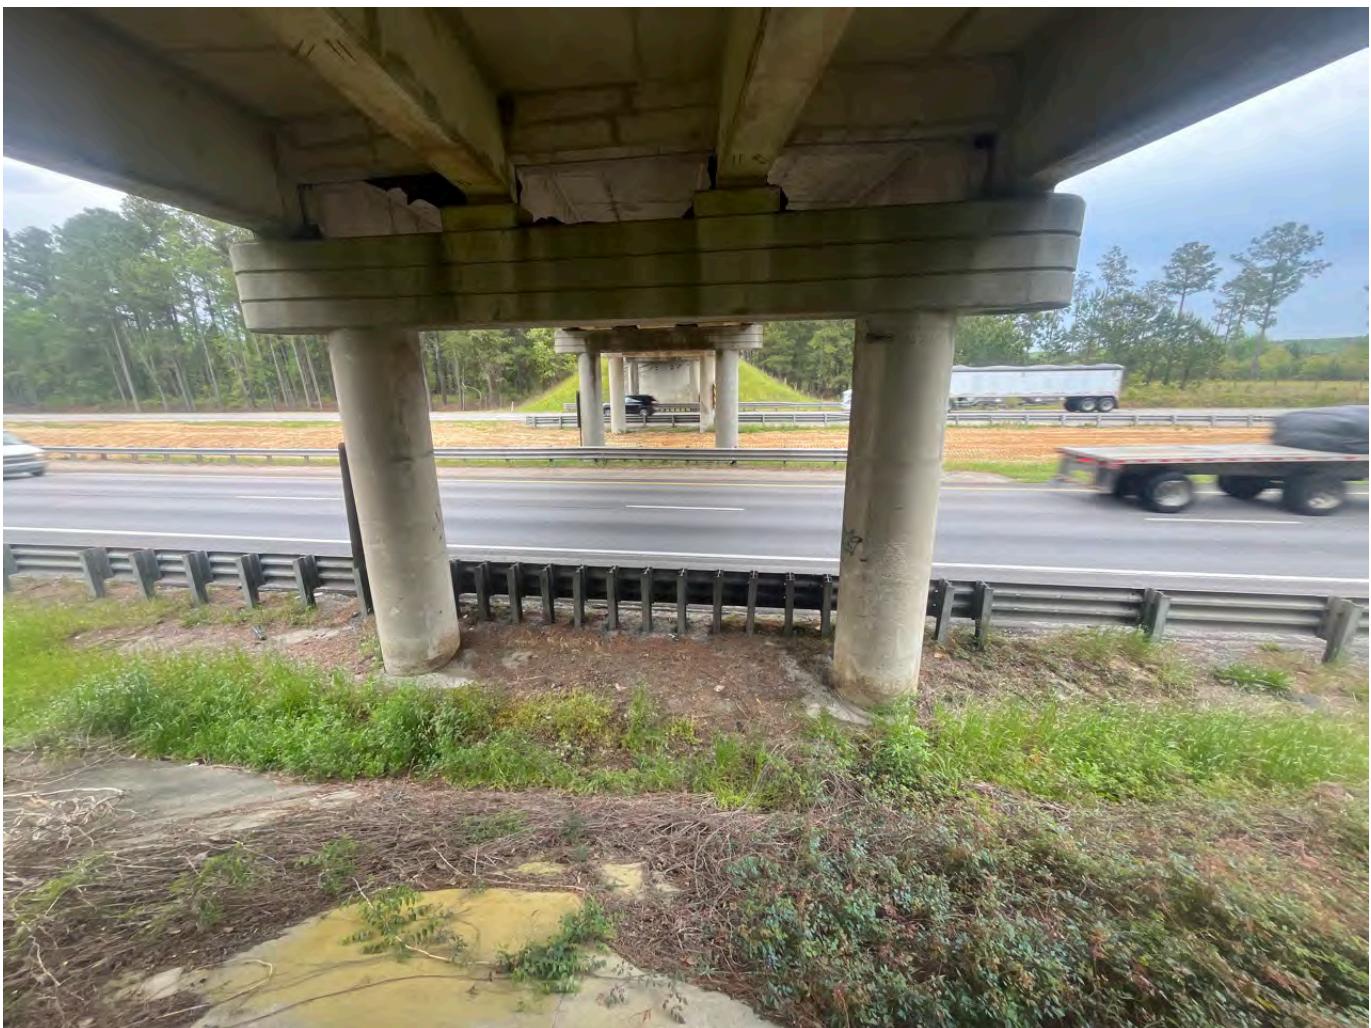
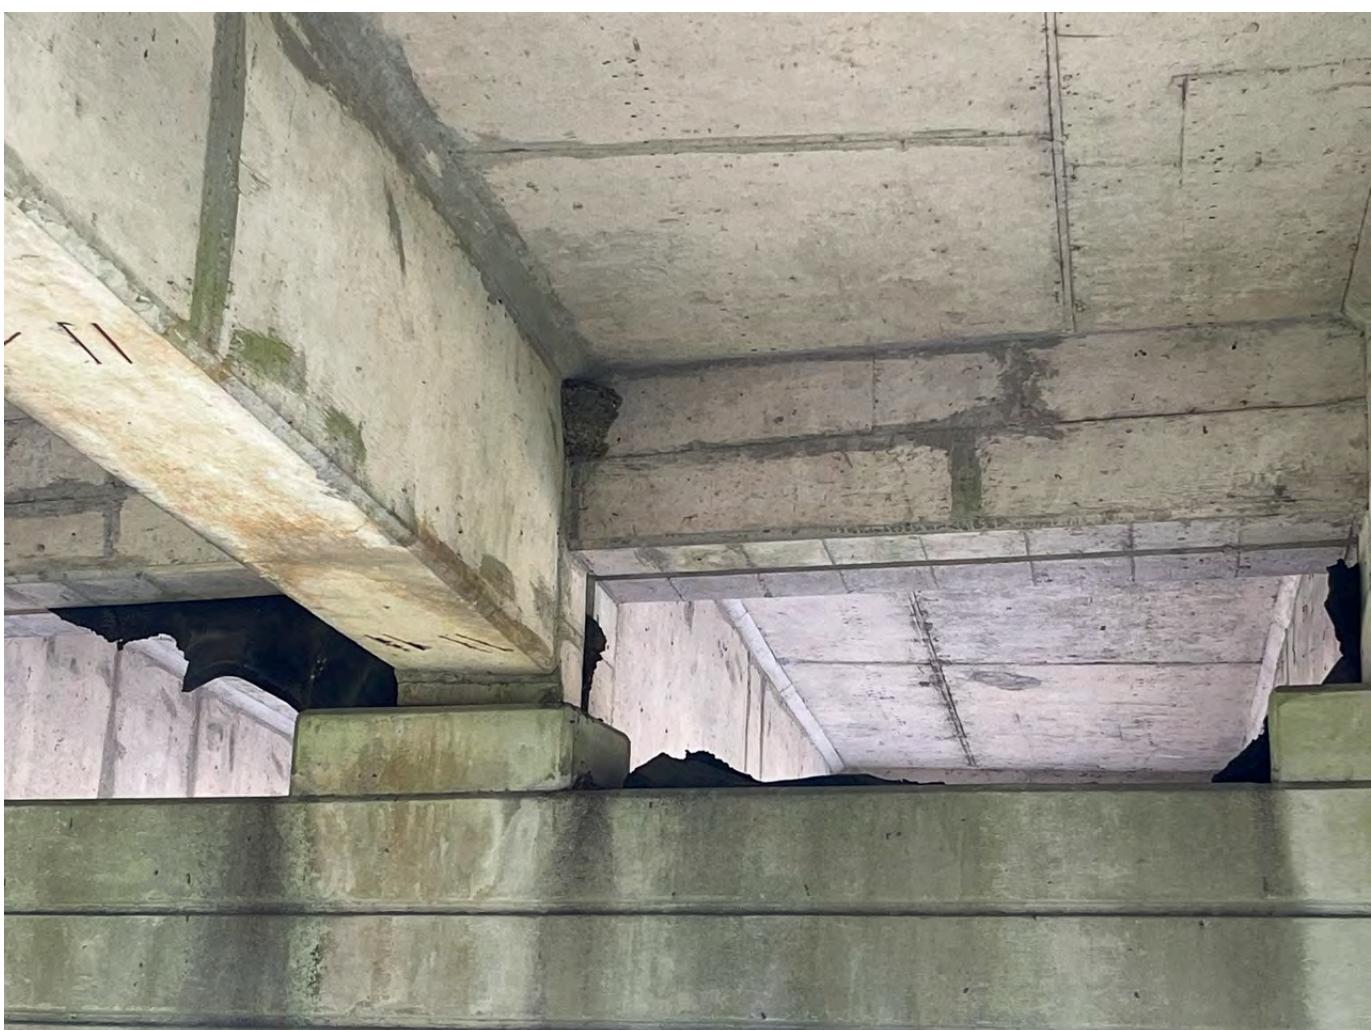
Bridge/Culvert Bat Assessment Form

Date & Time: 02/03/2025	DOT Proj No. or IPaC Code: P041967 & P042454 / 2024-0138645	Route/Facility Carried: Ebenezer Rd over I-26	County: Orangeburg				
Federal Structure ID: 3870009200200	Structure Coordinates: 33.377747, -80.618489	Structure Height (approx.): 16'1"	Structure Length: ~250'				
Structure Type (check one) Bridge Construction Style		Structure Material (check all that apply)					
<input checked="" type="checkbox"/> Cast-in-place	<input type="checkbox"/> Pre-stressed Girder	<input type="checkbox"/> Metal	<input type="checkbox"/> None	<input checked="" type="checkbox"/> Concrete			
<input type="checkbox"/> Flat Slab	<input type="checkbox"/> Steel I-beam	<input checked="" type="checkbox"/> Concrete	<input checked="" type="checkbox"/> Concrete	<input type="checkbox"/> Timber			
<input type="checkbox"/> Truss	<input type="checkbox"/> Covered	<input type="checkbox"/> Timber	<input type="checkbox"/> Steel	<input type="checkbox"/> Stone/Masonry

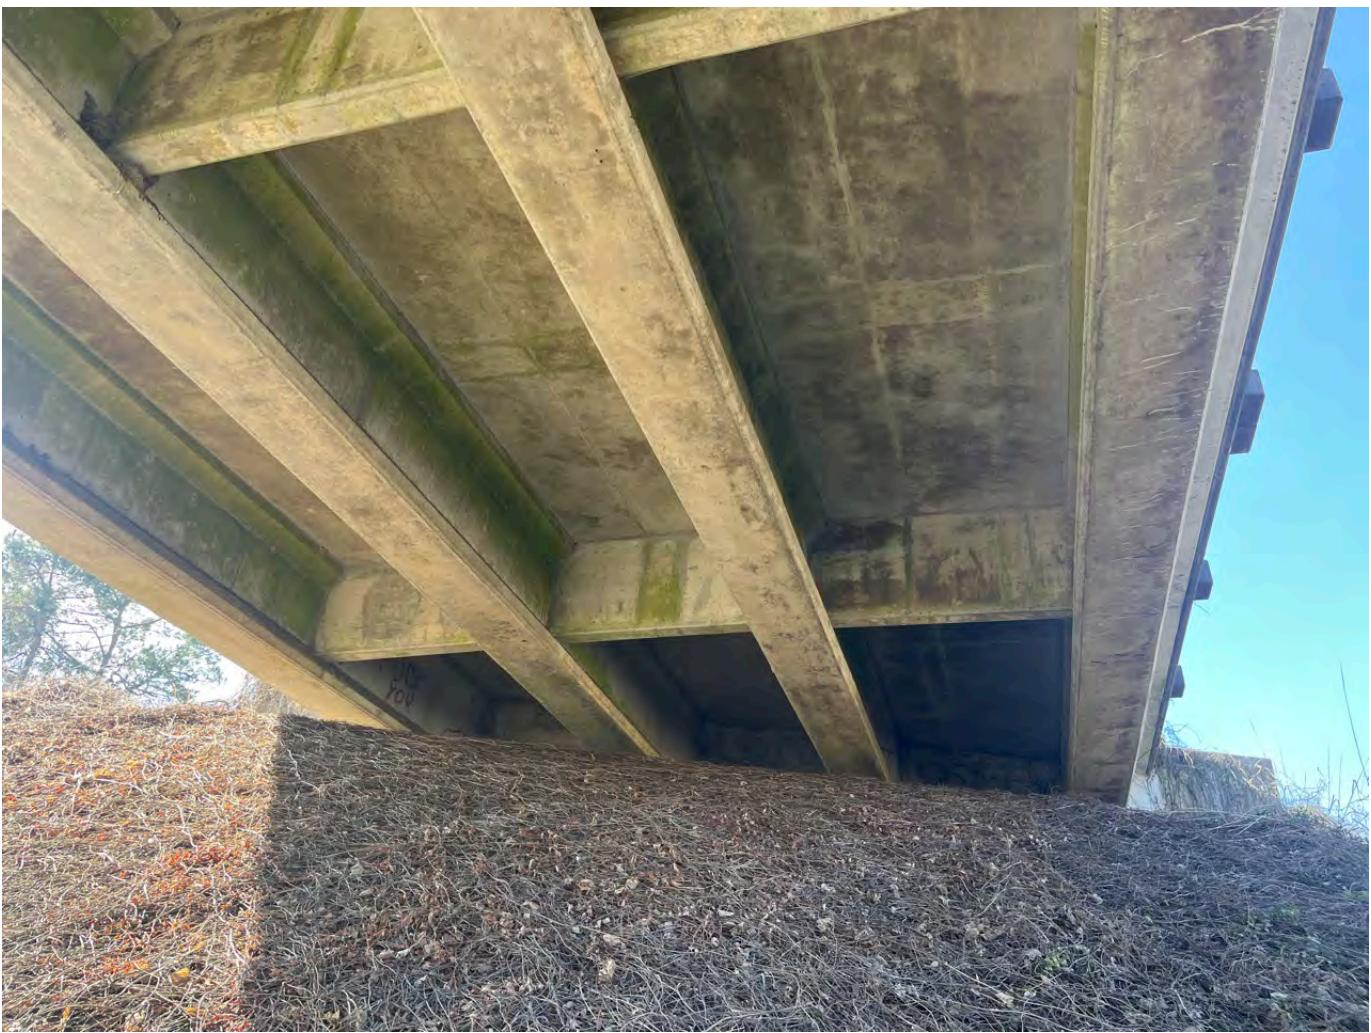
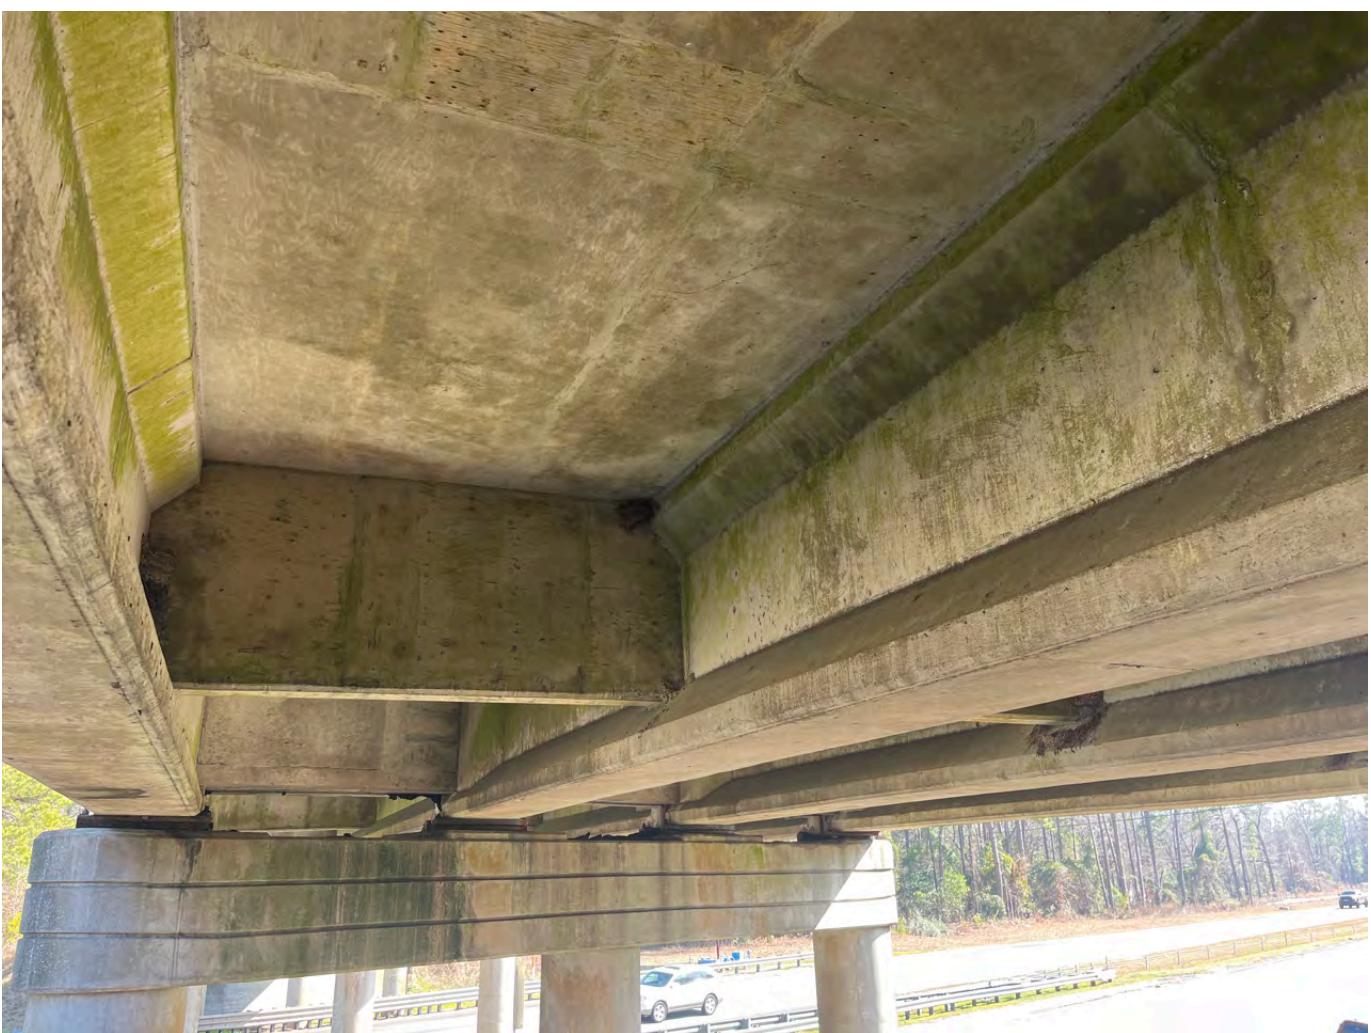
Bridge/Culvert Bat Assessment Form

Date & Time: 02/03/2025	DOT Proj No. or IPaC Code: P041967 & P042454 / 2024-0138645	Route/Facility Carried: Homestead Rd over I-26	County: Orangeburg		
Federal Structure ID: 3870003600300	Structure Coordinates: 33.414, -80.667685	Structure Height (approx.): 16'2"	Structure Length: ~250'		
Structure Type (check one) Bridge Construction Style		Structure Material (check all that apply)			
<input checked="" type="checkbox"/> Cast-in-place	<input type="checkbox"/> Pre-stressed Girder	<input type="checkbox"/> Metal	<input type="checkbox"/> None		
<input type="checkbox"/> Flat Slab	<input type="checkbox"/> Steel I-beam	<input checked="" type="checkbox"/> Concrete	<input checked="" type="checkbox"/> Concrete		
<input type="checkbox"/> Truss	<input type="checkbox"/> Covered	<input type="checkbox"/> Timber	<input type="checkbox"/> Steel		
<input type="checkbox"/> Parallel Box Beam	<input type="checkbox"/> Other: Click to enter text.	<input type="checkbox"/> Open Grid	<input type="checkbox"/> Timber

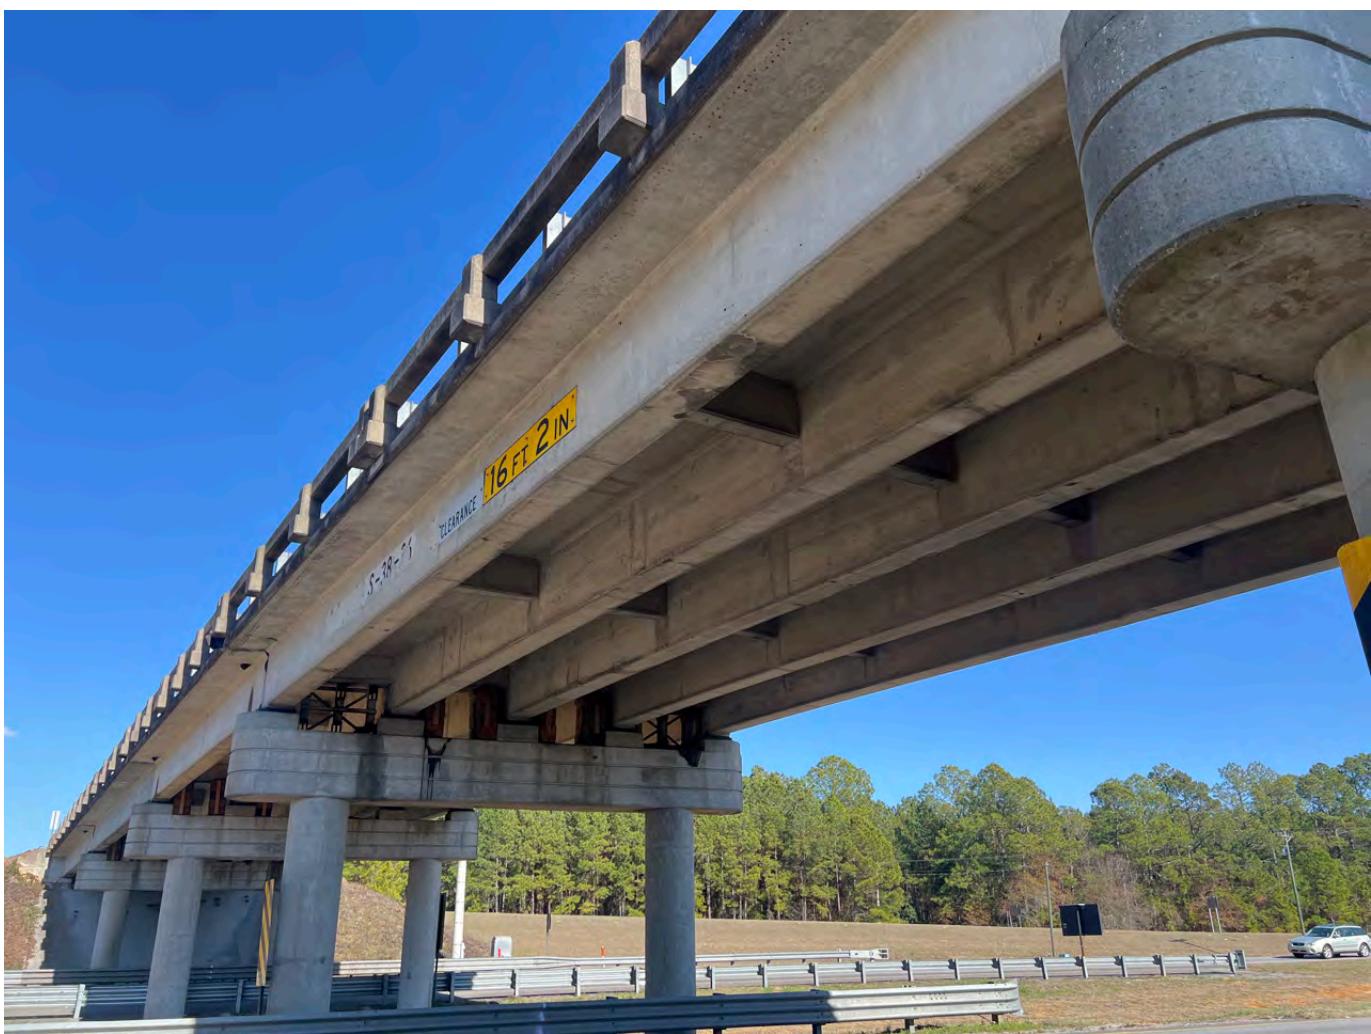
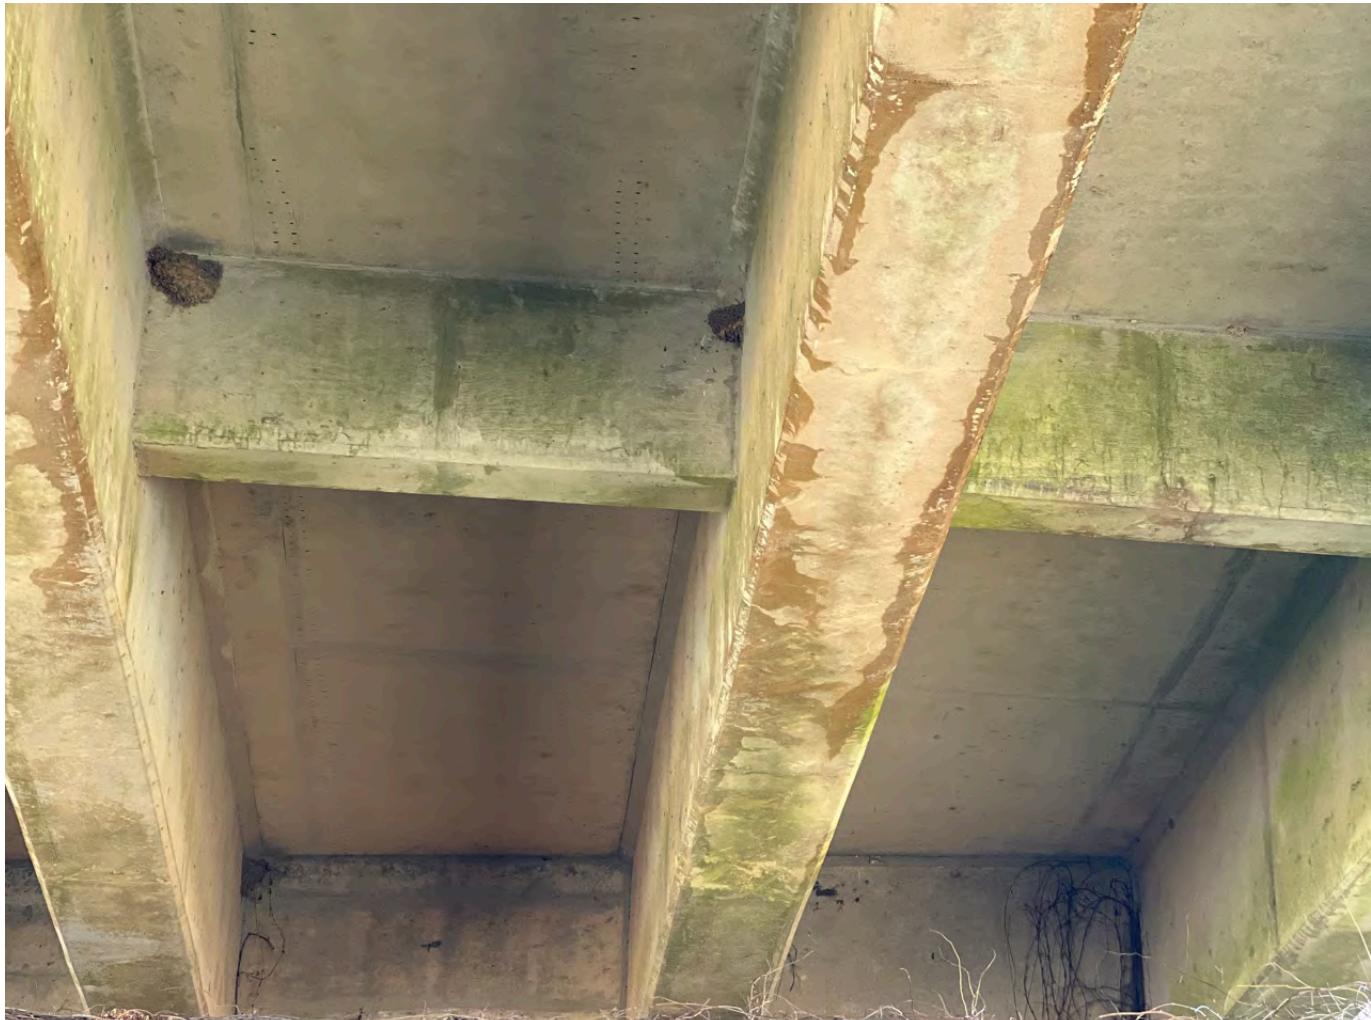
Bridge/Culvert Bat Assessment Form

Date & Time: 02/03/2025	DOT Proj No. or IPaC Code: P041967 & P042454 / 2024-0138645	Route/Facility Carried: I-26 E over Cameron Rd	County: Orangeburg		
Federal Structure ID: 3810002620500	Structure Coordinates: 33.519497, -80.790878	Structure Height (approx.): 24'8"	Structure Length: ~275'		
Structure Type (check one) Bridge Construction Style		Structure Material (check all that apply)			
<input type="checkbox"/> Cast-in-place	<input type="checkbox"/> Pre-stressed Girder	<input type="checkbox"/> Metal	<input type="checkbox"/> None	<input checked="" type="checkbox"/> Concrete	
<input type="checkbox"/> Flat Slab	<input checked="" type="checkbox"/> Steel I-beam	<input checked="" type="checkbox"/> Concrete	<input type="checkbox"/> Concrete	<input type="checkbox"/> Timber	
<input type="checkbox"/> Truss	<input type="checkbox"/> Covered	<input type="checkbox"/> Timber	<input checked="" type="checkbox"/> Steel	<input type="checkbox"/> Stone/Masonry

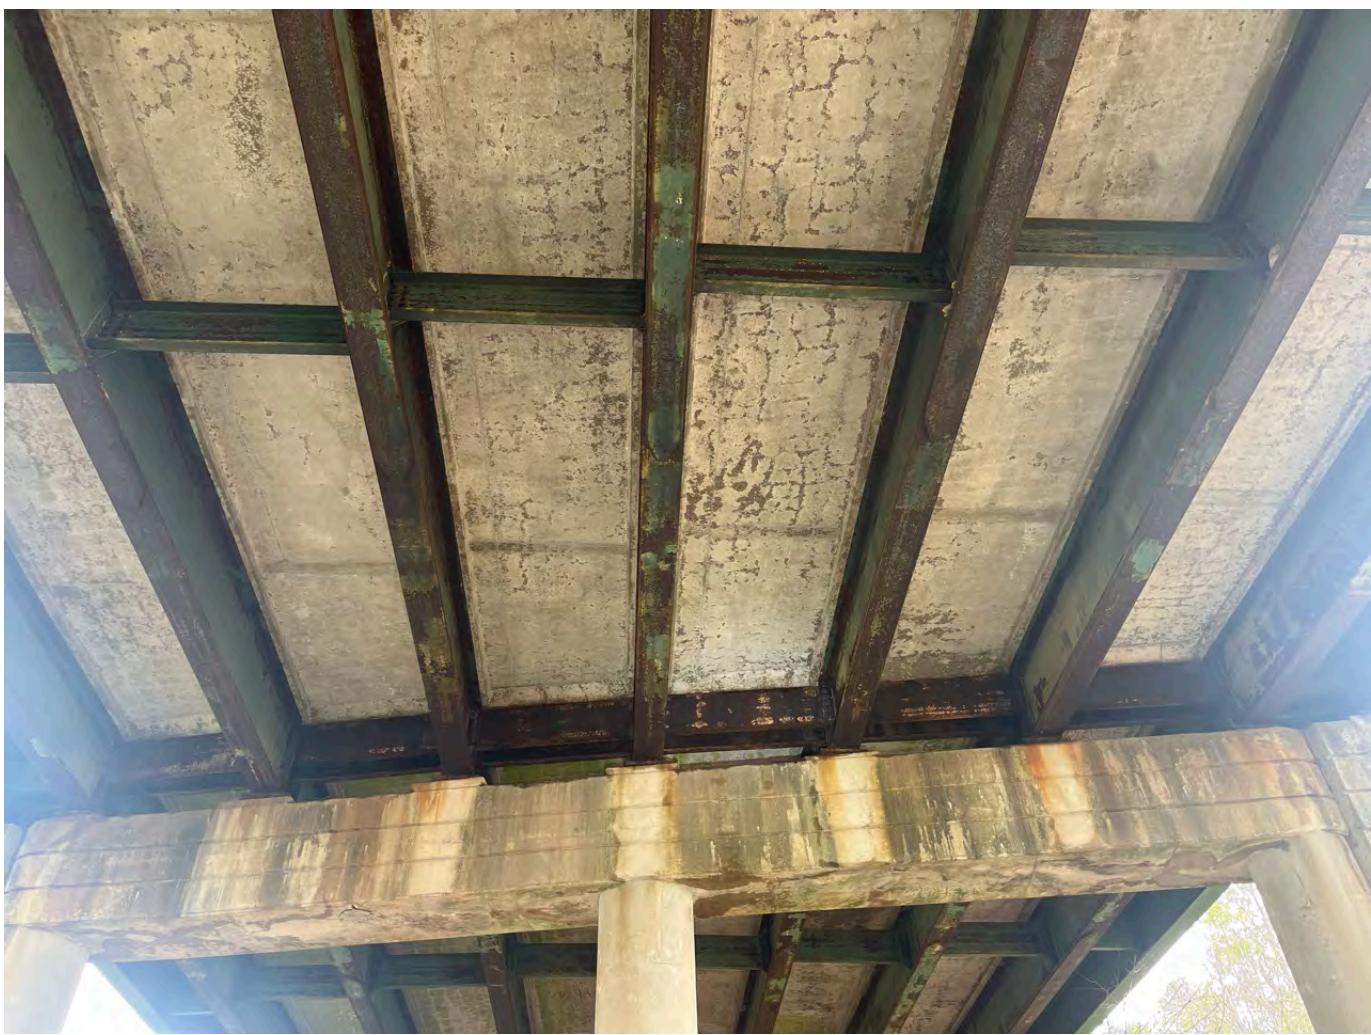
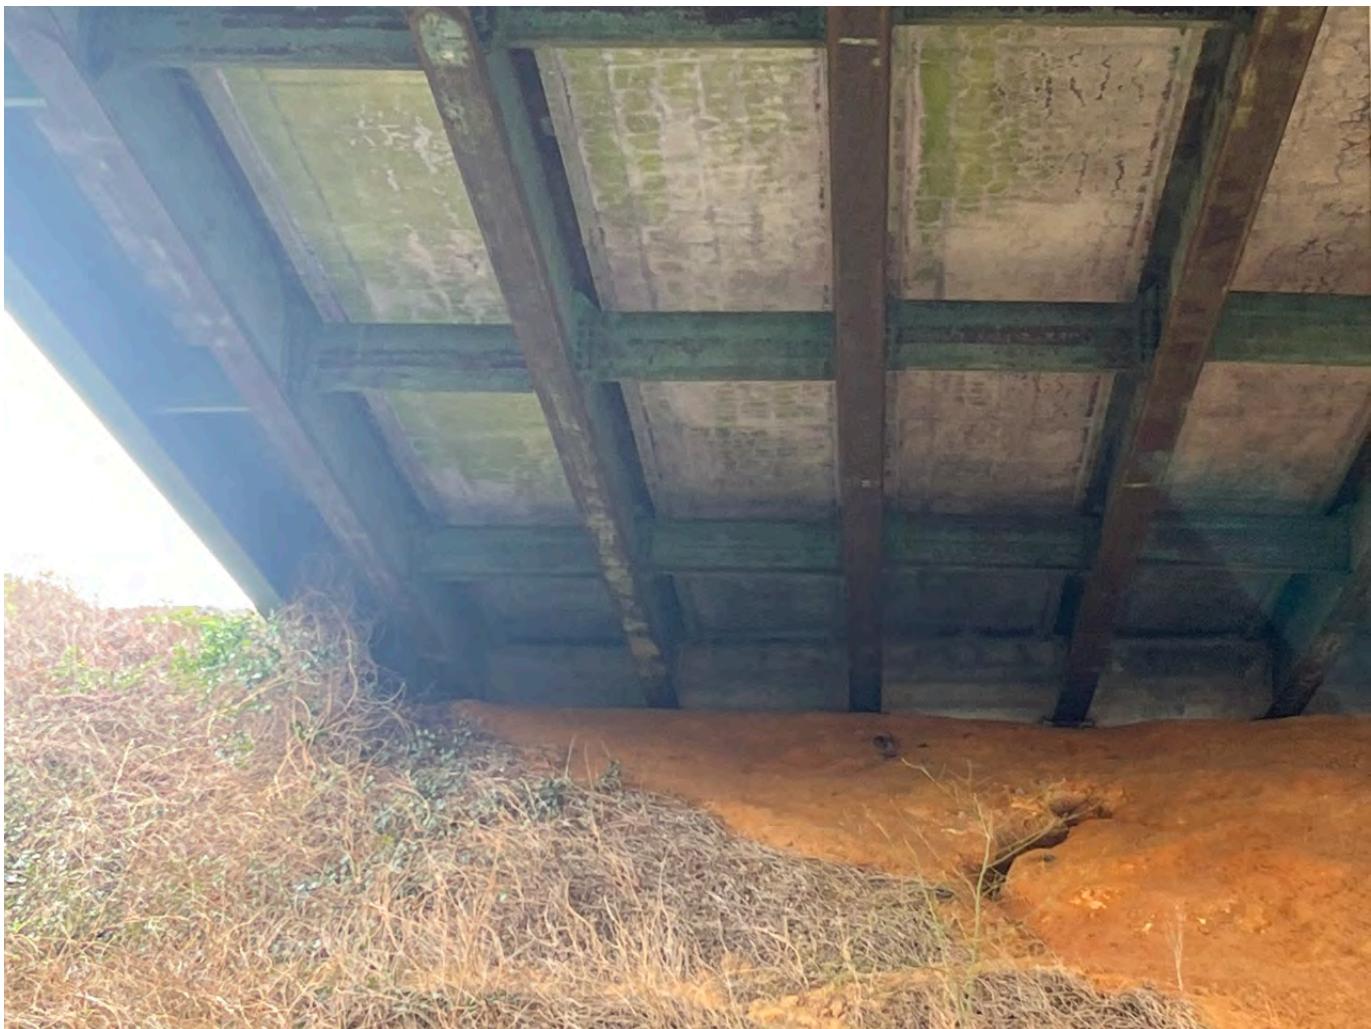
Bridge/Culvert Bat Assessment Form

Date & Time: 02/03/2025	DOT Proj No. or IPaC Code: P041967 & P042454 / 2024-0138645	Route/Facility Carried: I-26 E over Cow Castle Creek	County: Orangeburg
Federal Structure ID: 3810002620900	Structure Coordinates: 33.346495, -80.578084	Structure Height (approx.): 8'	Structure Length: ~250'
Structure Type (check one) Bridge Construction Style		Structure Material (check all that apply)	
<input checked="" type="checkbox"/> Cast-in-place	<input type="checkbox"/> Pre-stressed Girder	<input type="checkbox"/> Metal	<input type="checkbox"/> None
<input type="checkbox"/> Flat Slab	<input type="checkbox"/> Steel I-beam	<input checked="" type="checkbox"/> Concrete	<input checked="" type="checkbox"/> Concrete
<input type="checkbox"/> Truss	<input type="checkbox"/> Covered	<input type="checkbox"/> Timber	<input type="checkbox"/> Steel
<input type="checkbox"/> Parallel Box Beam	<input type="checkbox"/> Other: Click to enter text.	<input type="checkbox"/> Open Grid	<input type="checkbox"/> Timber

The existing bridges over Cow Castle Creek currently utilize scuppers that discharge bridge deck runoff directly into the waterbody below. SCDOT does not propose to pre-treat post-construction stormwater runoff from the replacement bridge decks prior to discharge into waters below.

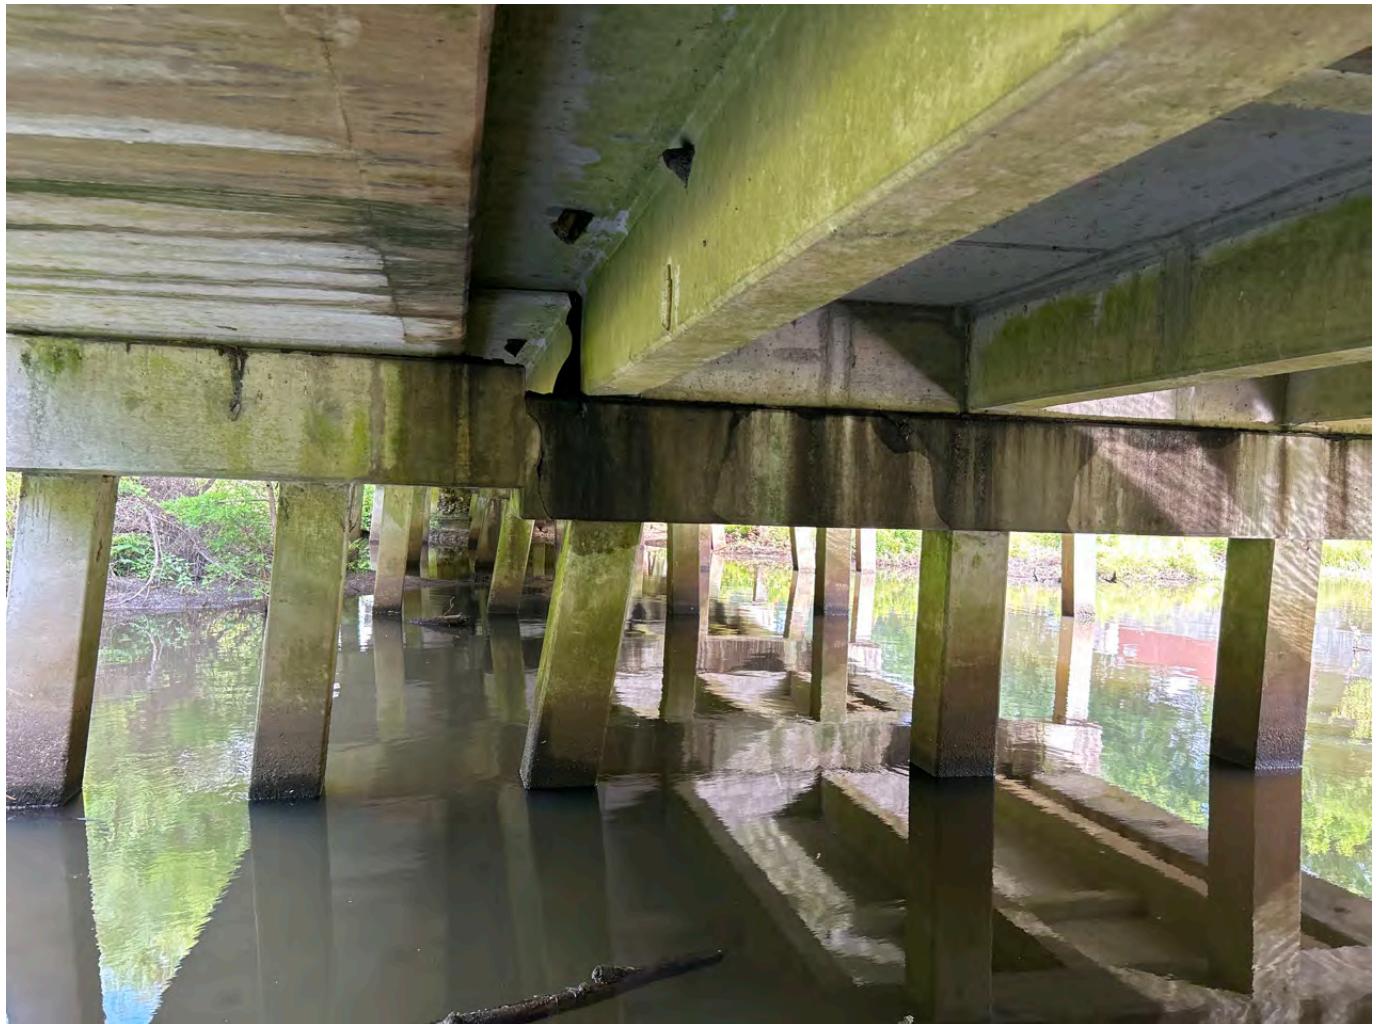
Bridge/Culvert Bat Assessment Form

Date & Time: 02/03/2025	DOT Proj No. or IPaC Code: P041967 & P042454 / 2024-0138645	Route/Facility Carried: I-26 W over Cameron Rd	County: Orangeburg	
Federal Structure ID: 3810002640500	Structure Coordinates: 33.51958, -80.790698	Structure Height (approx.): 24'8"	Structure Length: ~275'	
Structure Type (check one) Bridge Construction Style		Structure Material (check all that apply)		
<input type="checkbox"/> Cast-in-place	<input type="checkbox"/> Pre-stressed Girder	<input type="checkbox"/> Metal	<input type="checkbox"/> None	
<input type="checkbox"/> Flat Slab	<input checked="" type="checkbox"/> Steel I-beam	<input checked="" type="checkbox"/> Concrete	<input type="checkbox"/> Concrete	
<input type="checkbox"/> Truss	<input type="checkbox"/> Covered	<input type="checkbox"/> Timber	<input checked="" type="checkbox"/> Steel	
<input type="checkbox"/> Parallel Box Beam	<input type="checkbox"/> Other: Click to enter text.	<input type="checkbox"/> Open Grid	<input type="checkbox"/> Timber

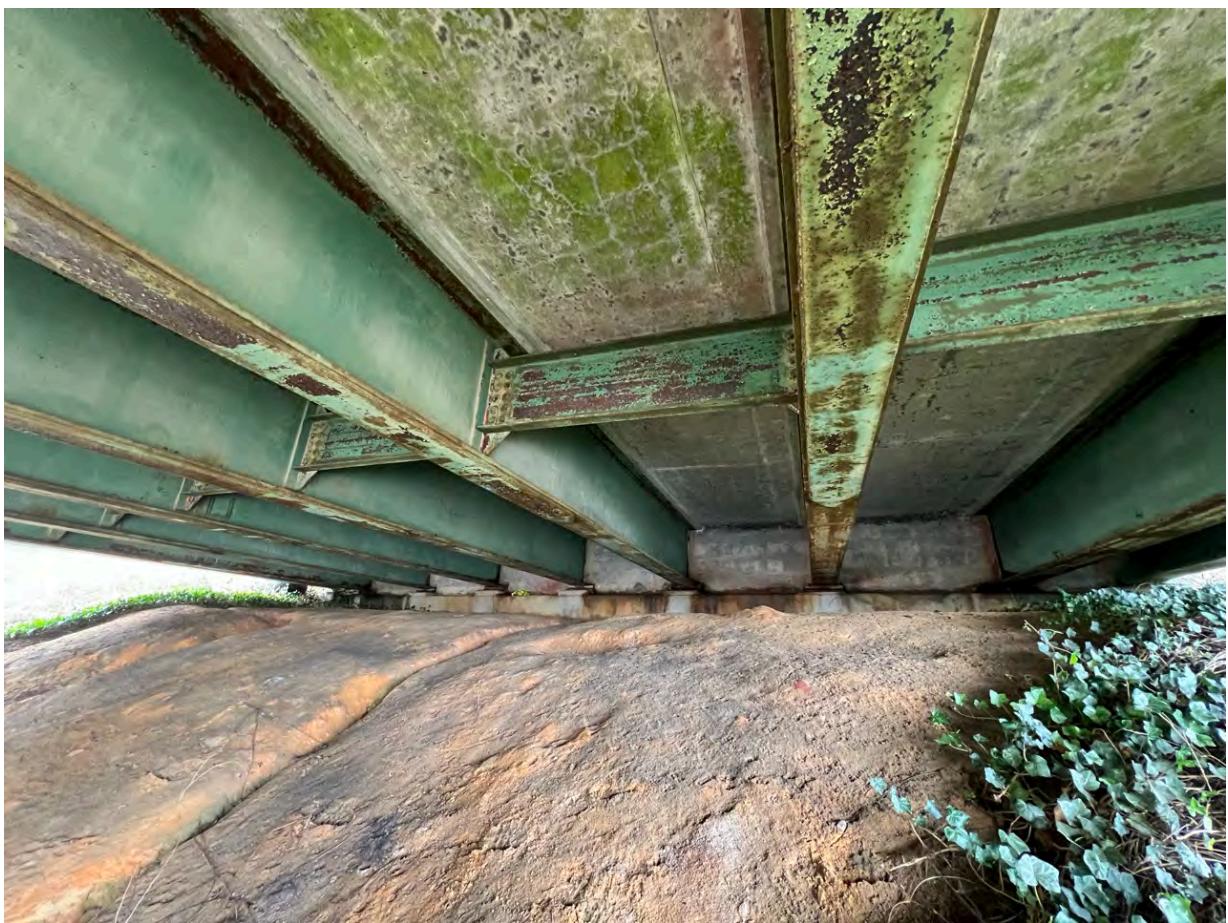
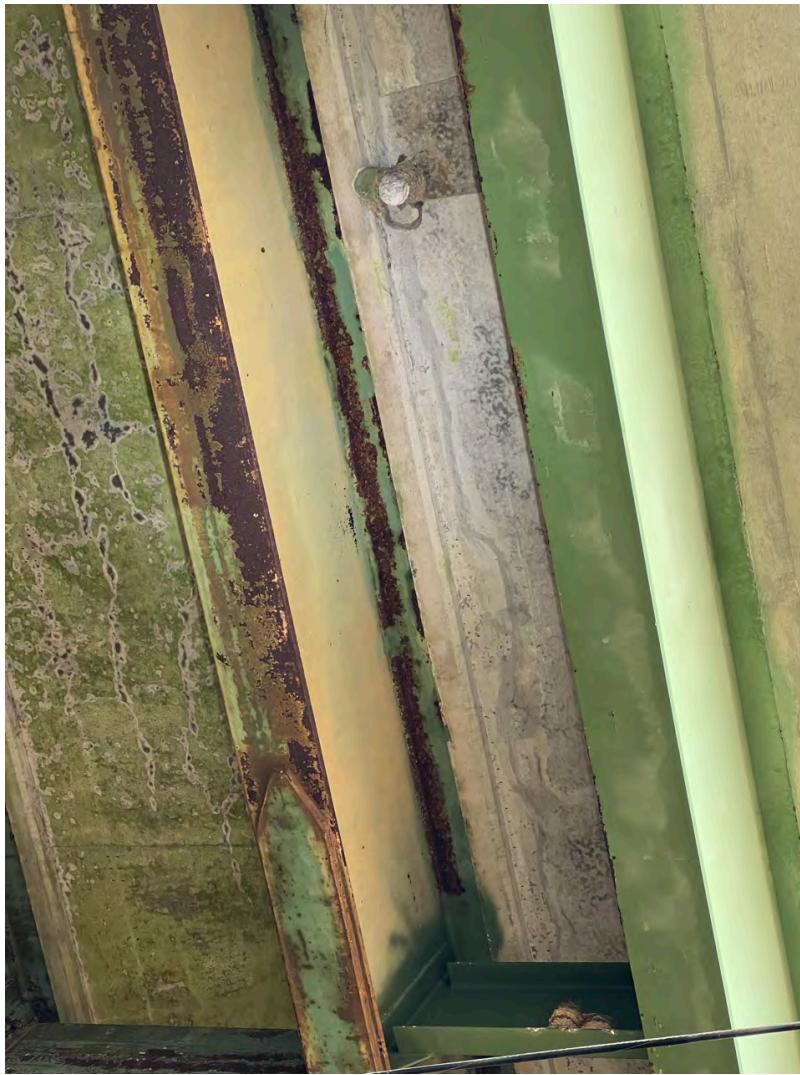
Bridge/Culvert Bat Assessment Form

Date & Time: 02/03/2025	DOT Proj No. or IPaC Code: P041967 & P042454 / 2024-0138645	Route/Facility Carried: I-26 W over Cow Castle Creek	County: Orangeburg	
Federal Structure ID: 3810002640900	Structure Coordinates: 33.346709, -80.577801	Structure Height (approx.): 8'	Structure Length: ~250'	
Structure Type (check one) Bridge Construction Style		Structure Material (check all that apply)		
<input checked="" type="checkbox"/> Cast-in-place	<input type="checkbox"/> Pre-stressed Girder	<input type="checkbox"/> Metal	<input type="checkbox"/> None	
<input type="checkbox"/> Flat Slab	<input type="checkbox"/> Steel I-beam	<input checked="" type="checkbox"/> Concrete	<input checked="" type="checkbox"/> Concrete	
<input type="checkbox"/> Truss	<input type="checkbox"/> Covered	<input type="checkbox"/> Timber	<input type="checkbox"/> Steel	
<input type="checkbox"/> Parallel Box Beam	<input type="checkbox"/> Other: Click to enter text.	<input type="checkbox"/> Open Grid	<input type="checkbox"/> Timber

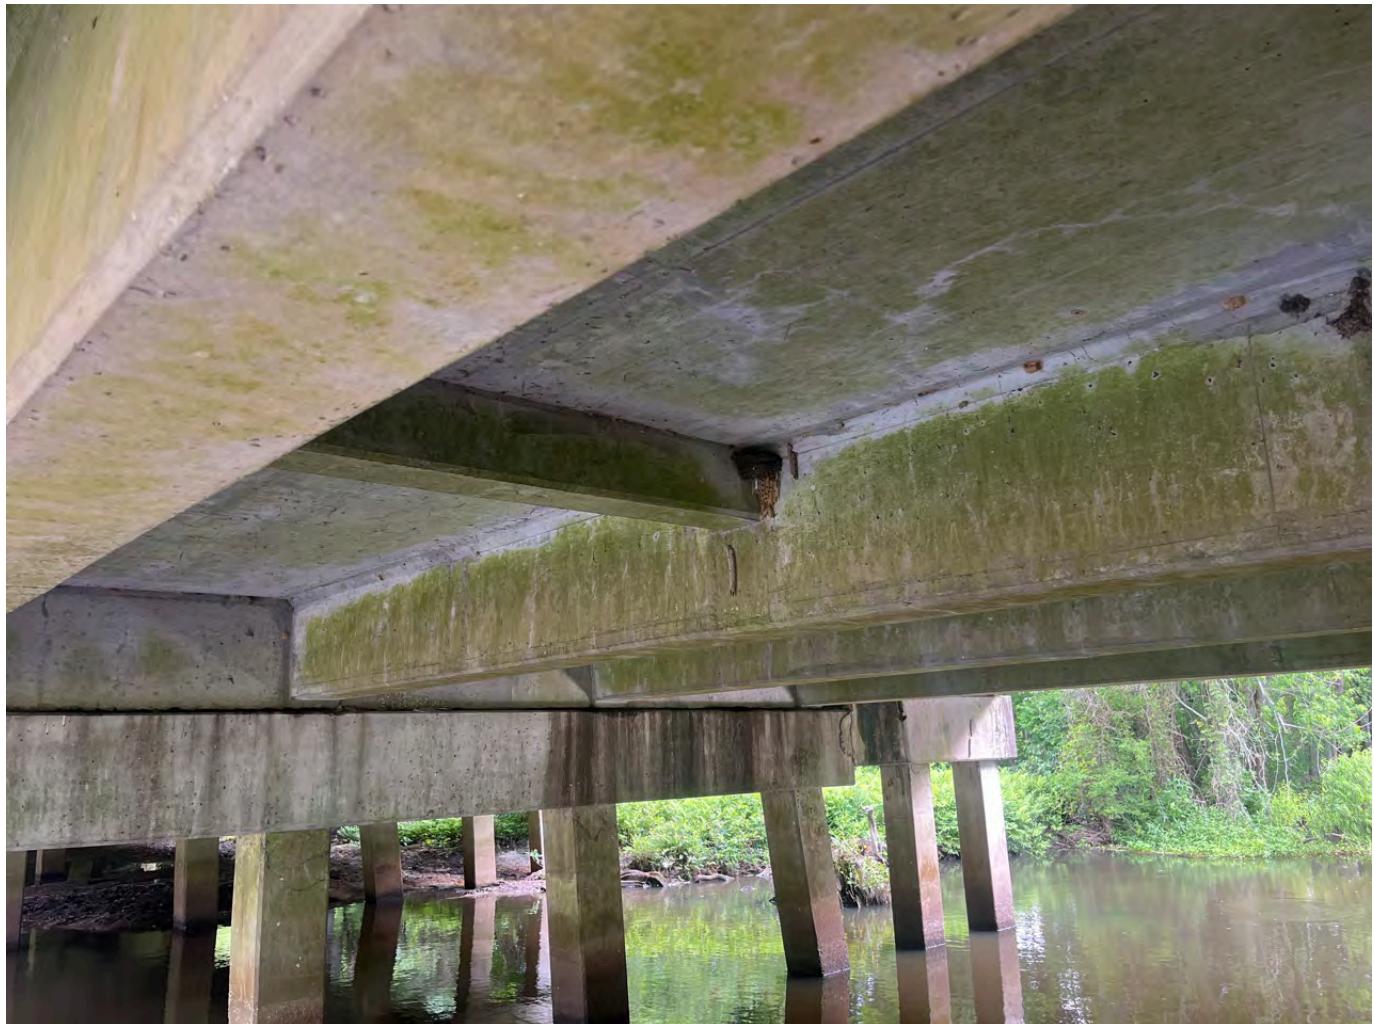
Bridge/Culvert Bat Assessment Form

Date & Time: 02/03/2025	DOT Proj No. or IPaC Code: P041967 & P042454 / 2024-0138645	Route/Facility Carried: Log Cabin Rd over I-26	County: Orangeburg		
Federal Structure ID: 3870130300100	Structure Coordinates: 33.426839, -80.68655	Structure Height (approx.): 16'	Structure Length: ~180'		
Structure Type (check one) Bridge Construction Style		Structure Material (check all that apply)			
<input checked="" type="checkbox"/> Cast-in-place	<input type="checkbox"/> Pre-stressed Girder	<input type="checkbox"/> Metal	<input type="checkbox"/> None		
<input type="checkbox"/> Flat Slab	<input type="checkbox"/> Steel I-beam	<input checked="" type="checkbox"/> Concrete	<input checked="" type="checkbox"/> Concrete		
<input type="checkbox"/> Truss	<input type="checkbox"/> Covered	<input type="checkbox"/> Timber	<input type="checkbox"/> Steel		
<input type="checkbox"/> Parallel Box Beam	<input type="checkbox"/> Other: Click to enter text.	<input type="checkbox"/> Open Grid	<input type="checkbox"/> Timber

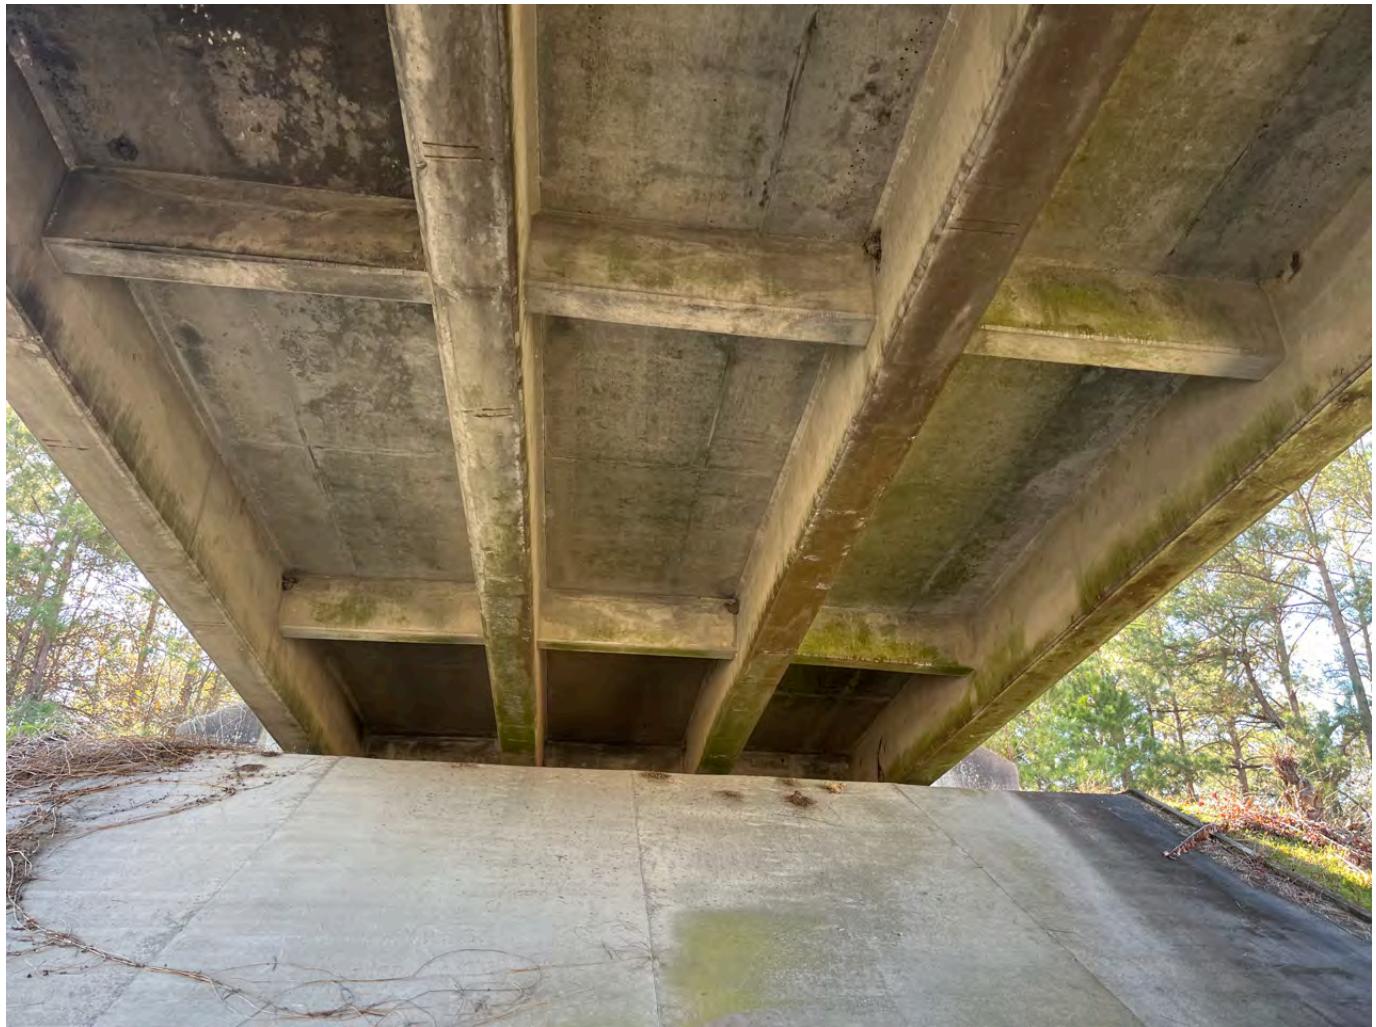
Bridge/Culvert Bat Assessment Form

Date & Time: 02/03/2025	DOT Proj No. or IPaC Code: P041967 & P042454 / 2024-0138645	Route/Facility Carried: Old Elloree Rd over I-26	County: Orangeburg	
Federal Structure ID: 3870047000100	Structure Coordinates: 33.486125, -80.759922	Structure Height (approx.): 16'5"	Structure Length: ~250'	
Structure Type (check one) Bridge Construction Style		Structure Material (check all that apply)		
<input checked="" type="checkbox"/> Cast-in-place	<input type="checkbox"/> Pre-stressed Girder	<input type="checkbox"/> Metal	<input type="checkbox"/> None	
<input type="checkbox"/> Flat Slab	<input type="checkbox"/> Steel I-beam	<input checked="" type="checkbox"/> Concrete	<input checked="" type="checkbox"/> Concrete	
<input type="checkbox"/> Truss	<input type="checkbox"/> Covered	<input type="checkbox"/> Timber	<input type="checkbox"/> Steel	
<input type="checkbox"/> Parallel Box Beam	<input type="checkbox"/> Other: Click to enter text.	<input type="checkbox"/> Open Grid	<input type="checkbox"/> Timber
