Biological Evaluation

**Interstate 26 (I-26) Corridor Improvements
Project MM 145-172**

Orangeburg and Dorchester Counties, South Carolina

SCDOT Project ID: P041967 & P042454

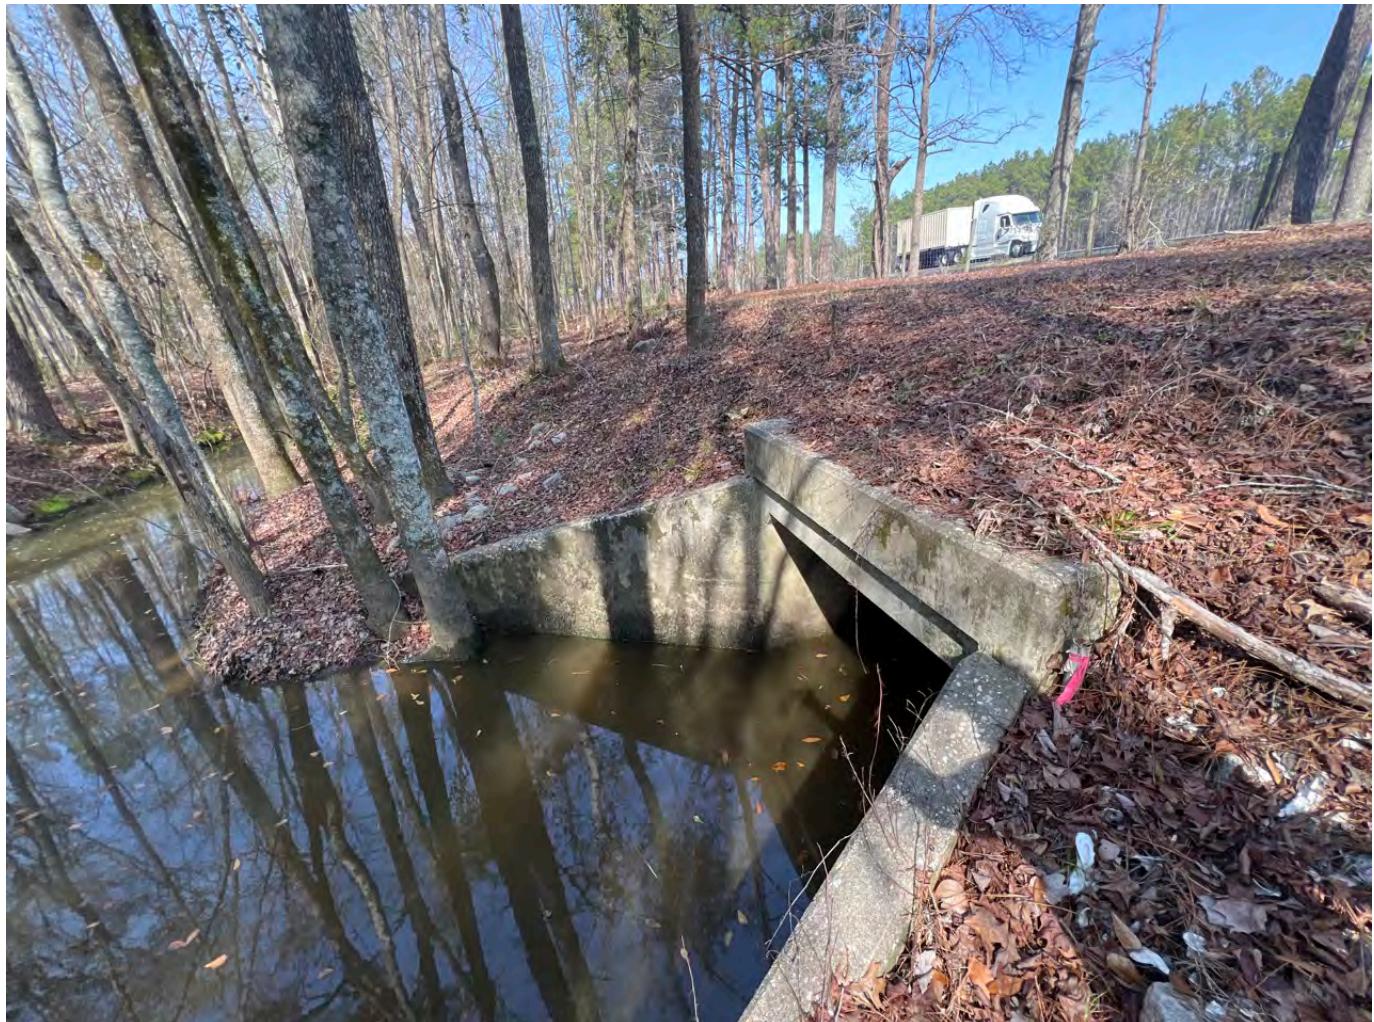
Bridge/Culvert Bat Assessment Form

Date & Time: 02/05/2025	DOT Proj No. or IPaC Code: P041967 & P042454 / 2024-0138645	Route/Facility Carried: Bluff Rd/Trib to Four Hole Swamp	County: Dorchester	
Federal Structure ID: N/A; Culvert 20	Structure Coordinates: 33.305620, -80.533321	Structure Height (approx.): 3'	Structure Length: ~90'	
Structure Type (check one) Bridge Construction Style		Structure Material (check all that apply)		
<input type="checkbox"/> Cast-in-place	<input type="checkbox"/> Pre-stressed Girder	<input type="checkbox"/> Metal	<input type="checkbox"/> None	<input type="checkbox"/> Concrete
<input type="checkbox"/> Flat Slab	<input type="checkbox"/> Steel I-beam	<input type="checkbox"/> Concrete	<input type="checkbox"/> Concrete	<input type="checkbox"/> Timber
<input type="checkbox"/> Truss	<input type="checkbox"/> Covered	<input type="checkbox"/> Timber	<input type="checkbox"/> Steel	<input type="checkbox"/> Stone/Masonry

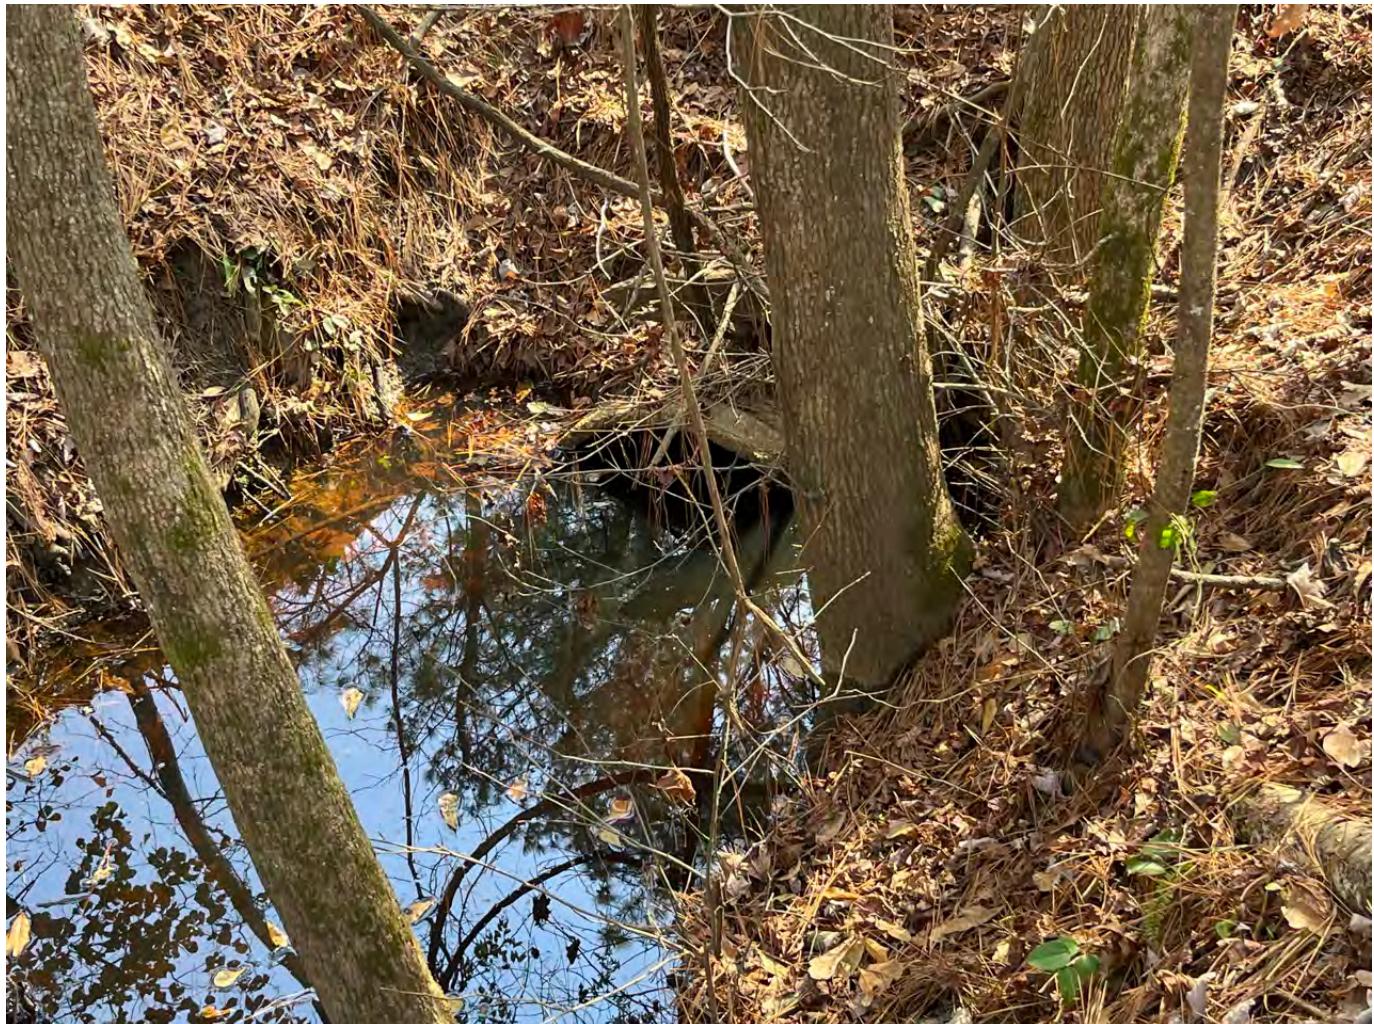
Bridge/Culvert Bat Assessment Form

Date & Time: 02/05/2025	DOT Proj No. or IPaC Code: P041967 & P042454 / 2024-0138645	Route/Facility Carried: Weathers Farm Rd/Trib to Four Hole Swamp	County: Dorchester	
Federal Structure ID: N/A; Culvert 21	Structure Coordinates: 33.305413, -80.533015	Structure Height (approx.): 6x6'	Structure Length: ~55'	
Structure Type (check one) Bridge Construction Style		Structure Material (check all that apply)		
<input type="checkbox"/> Cast-in-place	<input type="checkbox"/> Pre-stressed Girder	<input type="checkbox"/> Metal	<input type="checkbox"/> None	<input type="checkbox"/> Concrete
<input type="checkbox"/> Flat Slab	<input type="checkbox"/> Steel I-beam	<input type="checkbox"/> Concrete	<input type="checkbox"/> Concrete	<input type="checkbox"/> Timber
<input type="checkbox"/> Truss	<input type="checkbox"/> Covered	<input type="checkbox"/> Timber	<input type="checkbox"/> Steel	<input type="checkbox"/> Stone/Masonry

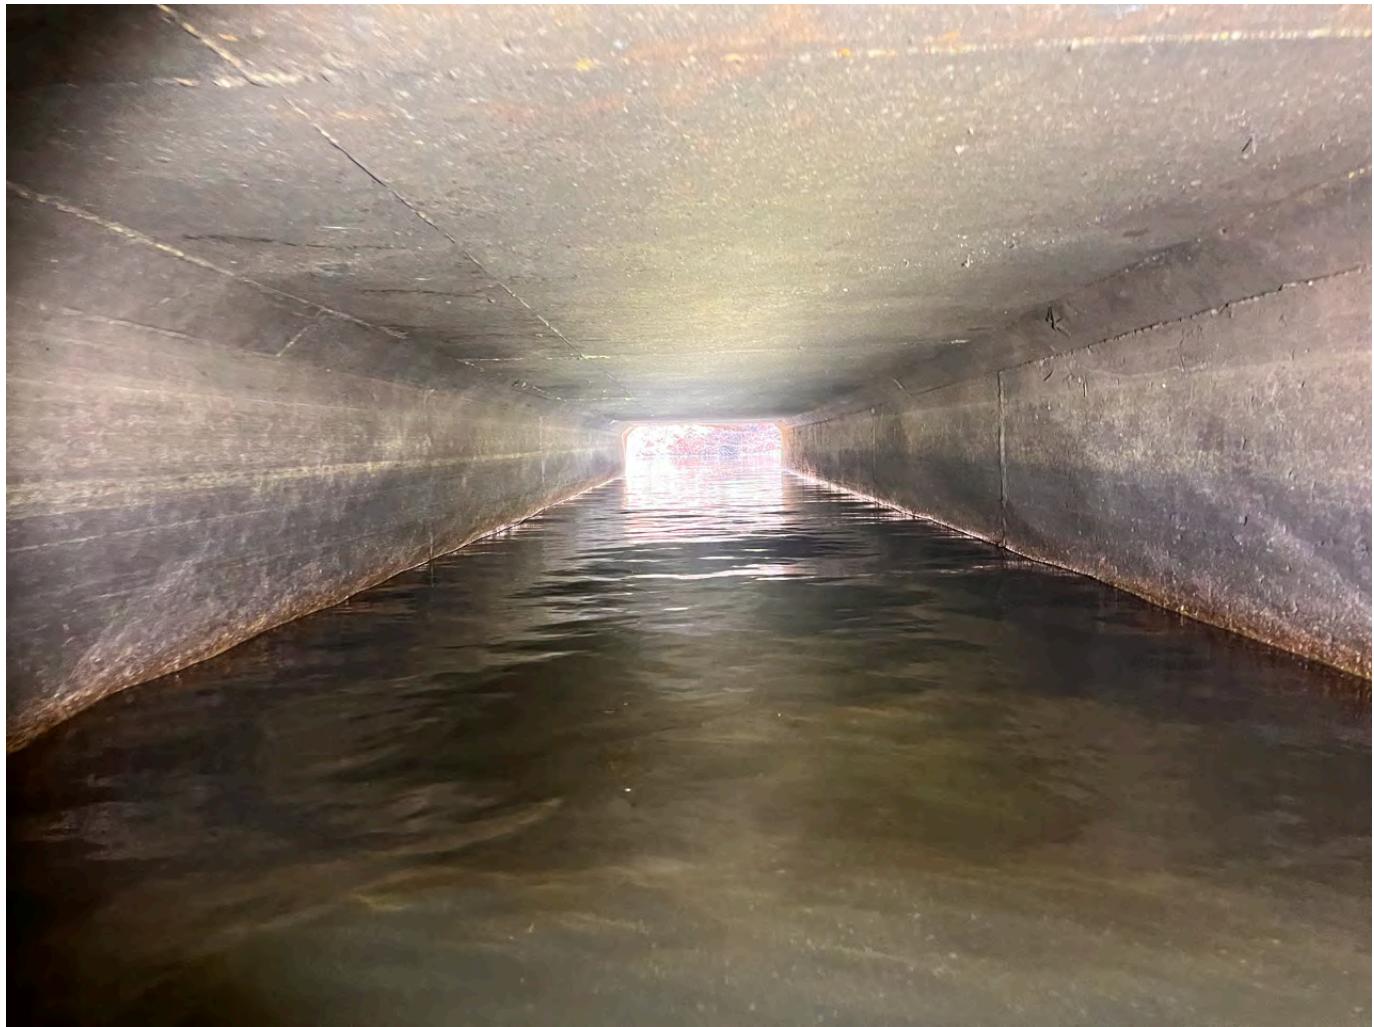
Bridge/Culvert Bat Assessment Form

Date & Time: 02/05/2025	DOT Proj No. or IPaC Code: P041967 & P042454 / 2024-0138645	Route/Facility Carried: I-26	County: Orangeburg
Federal Structure ID: N/A, Culvert #22	Structure Coordinates: 33.446179, -80.714863	Structure Height (approx.): 6'	Structure Length: ~150'
Structure Type (check one) Bridge Construction Style		Structure Material (check all that apply)	
<input type="checkbox"/> Cast-in-place	<input type="checkbox"/> Pre-stressed Girder	<input type="checkbox"/> Metal	<input type="checkbox"/> None
<input type="checkbox"/> Flat Slab	<input type="checkbox"/> Steel I-beam	<input type="checkbox"/> Concrete	<input type="checkbox"/> Concrete
<input type="checkbox"/> Truss	<input type="checkbox"/> Covered	<input type="checkbox"/> Timber	<input type="checkbox"/> Steel
<input type="checkbox"/> Parallel Box Beam	<input type="checkbox"/> Other: Click to enter text.	<input type="checkbox"/> Open Grid	<input type="checkbox"/> Timber
